A. GOULD HISTORIC
HOME REPORT

INSPECTION AND ESTIMATE COMPILATION

515 N WASHINGTON, OWOSSO MI 48867

Home Inspection Report

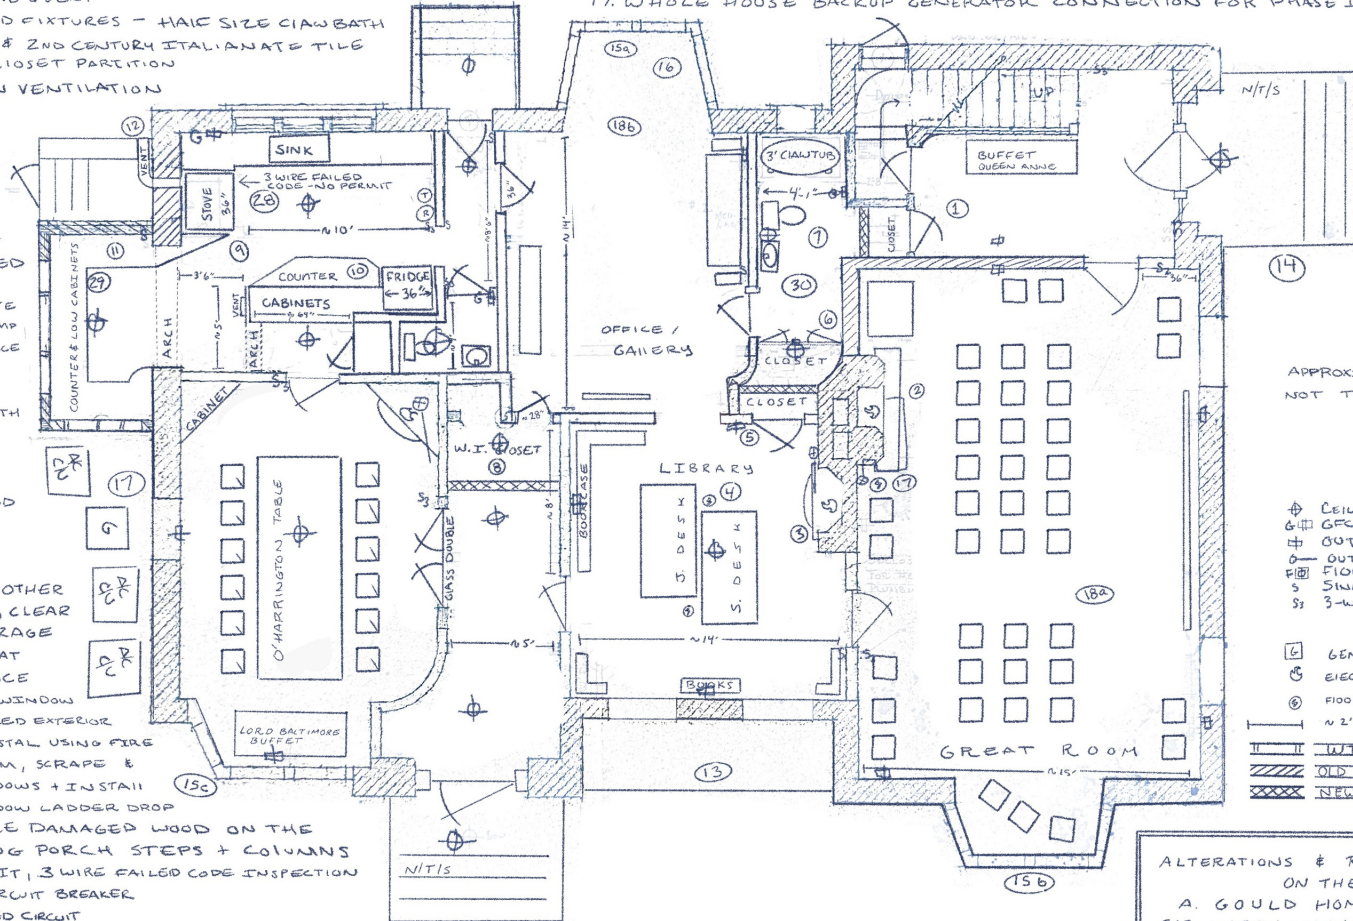
MAIN FLOOR

1. REINFORCE HANDRAIL OVER MAIN STAIRS
2. DRYWALL CRACK ALONG CHIMNEY STACK EDGE
MAY BE RELATED TO SIMILAR CRACK RUNNING THROUGH GALLERY ON FIRST FLOOR - ADD SUPPORT BEAMS & STEEL RODS IN BASEMENT AND REPAIR JOIST IN THE BASEMENT (SEE SHEET 3)

- A, B, C, WINDOWS/EGRESS-REPAIR & RESTORE WINDOW FUNCTION
 - FIRE ESCAPE LADDER NOT INSTALLED IN BEDROOMS - INSTALL 2
4. ATTIC ACCESS ABOVE STAIRS, NO LADDER - RELOCATE & ADD DROP

5. BATH LOCATION ABOVE SUSPECTED MOISTURE RELATED PLASTER CEILING DAMAGES OVER FIRST FLOOR BED ROOM SEAL TILE/GROUT & LEAK TEST ALL FIXTURES
6. OPEN CRACKS & SEAMS ON STAIRS & TRIM
BASEMENT SUPPORT BEAMS SHOULD RESOLVE

7. TILE SHOWS SIGNS OF MOISTURE BARRIER FAILURE, STRIP, GROUT & RESEAL
8. JULIET BALCONY IRON FENCE RUSTED
9. CHIMNEY STACK, STATUS UNKNOWN - INSPECT & SCOPE TO DETERMINE SERVICABILITY OR CAP

10. CLEAN OR REPLACE CARPET
11. REPLACE KNOB & TUBE WIRES AND BRING TO CODE. ADD OUTLETS THROUGHOUT. UPDATE GFCI IN ALL ROOMS WITH WATER FIXTURES.
12. INSTALL MOISTURE MITIGATION VAPOR BARRIER AND VENTILATION IN ALL ROOMS WITH WATER FIXTURES

13. REMOVE DAMAGED CARPET & ASSESS SUBFLOOR/ ORIG. FLOOR
14. REPAIR PLASTER & WALLPAPER THROUGHOUT

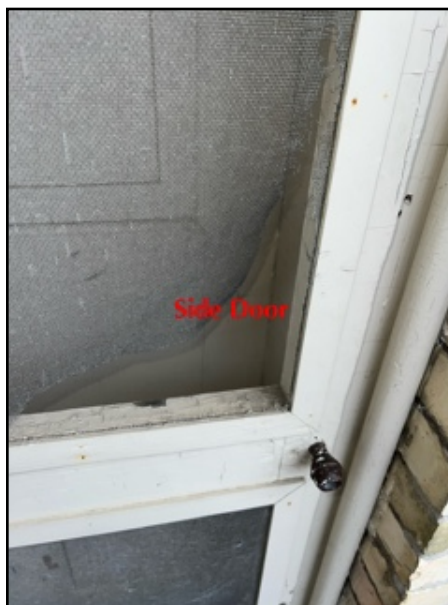
Comment 3:

Picture of the torn screen side door.

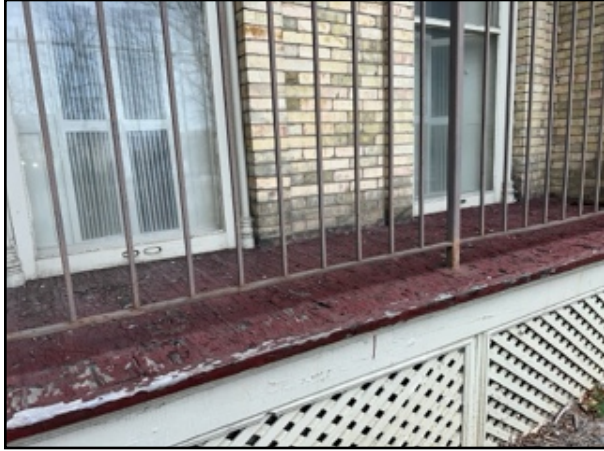
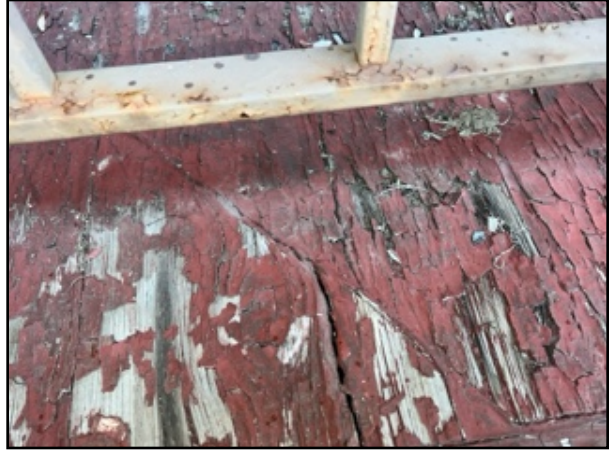
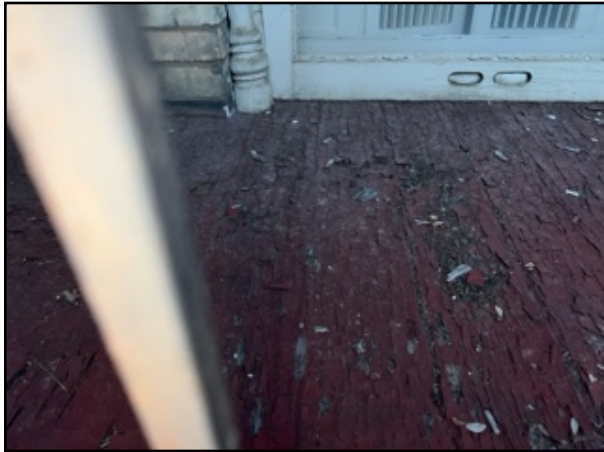
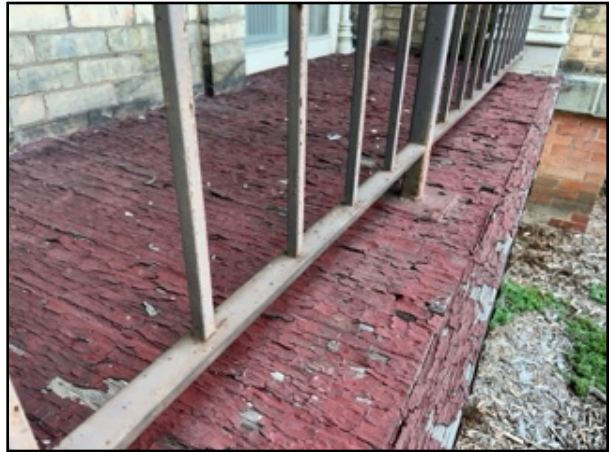
Comment 4:
Picture of the balcony with deterioration.

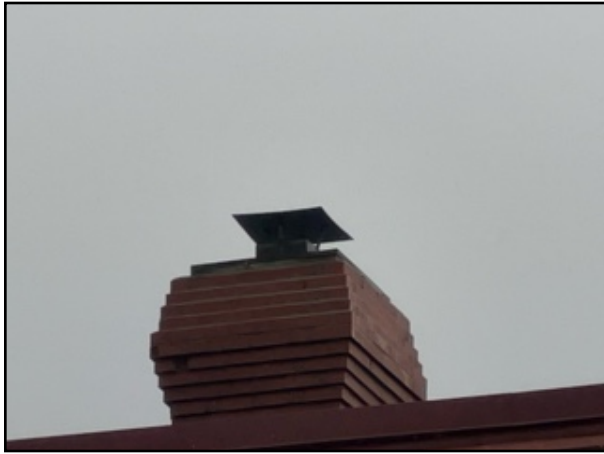
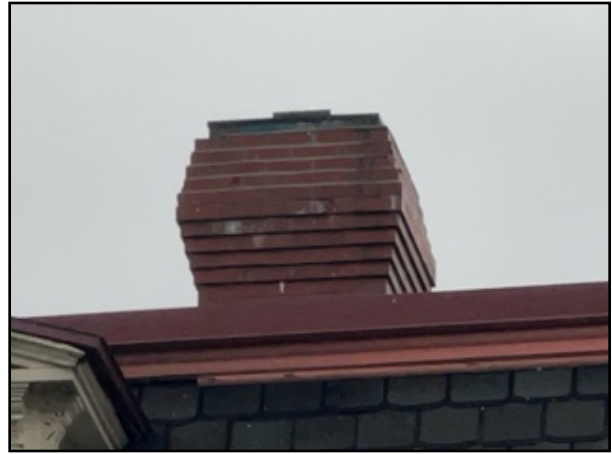
Comment 7:
Picture of the chimneys.

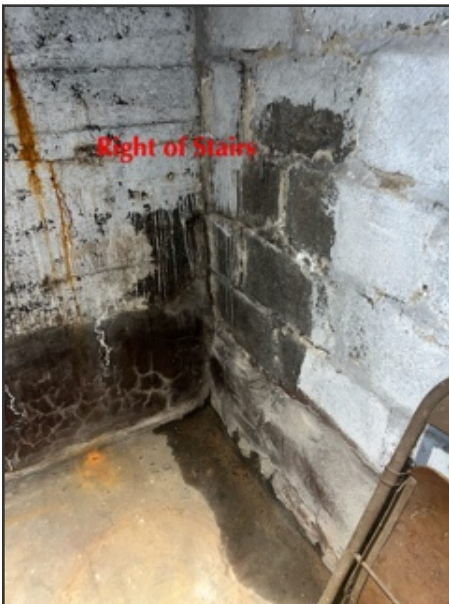
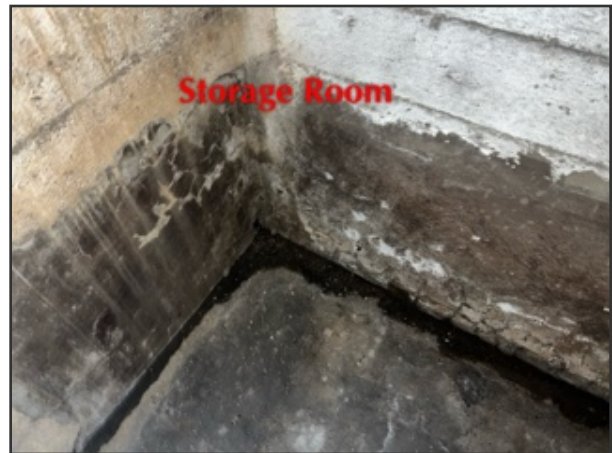
Signs of Water Penetration:

Dampness, Stains, Water
Condition: Repair or Replace

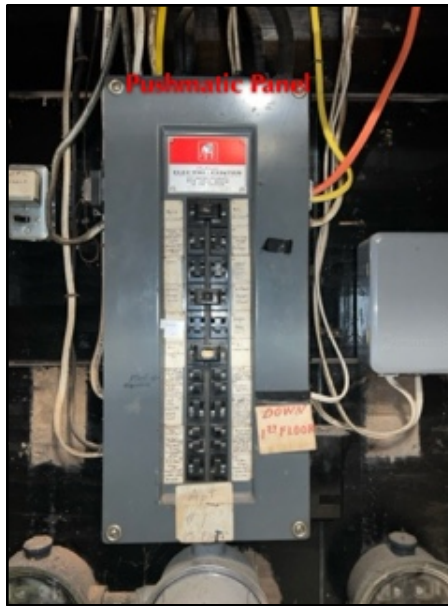
Type of Service:	Overhead
Main Disconnect Location:	Service Panel
Service Panel Location:	Basement
Service Panel Manufacturer:	Pushmatic
	Condition: Further Evaluation Required

A pushmatic Panel is present. This is a panel that was used primarily between the 1950s and early 1980s. Unlike today's panels it does not operate from left to right. It pushes inward. A significant safety issue is the spring located behind the breaker. Over the years it can become corroded, rusted and brittle. This can result in the breaker not tripping if needed or if tripped by hand the circuit may not reset and remain with no power. Replacement parts are almost impossible to find and there are parts that are labeled pushmatic compatible. However these parts are not approved under the electrical code. Pushmatic breakers use a thermal design mechanism to trip the breakers and current breakers use a thermal and magnetic mechanism to trip the breakers which is safe and reliable. A licensed electrician will be needed to upgrade the electrical panel to meet current standards for safety.

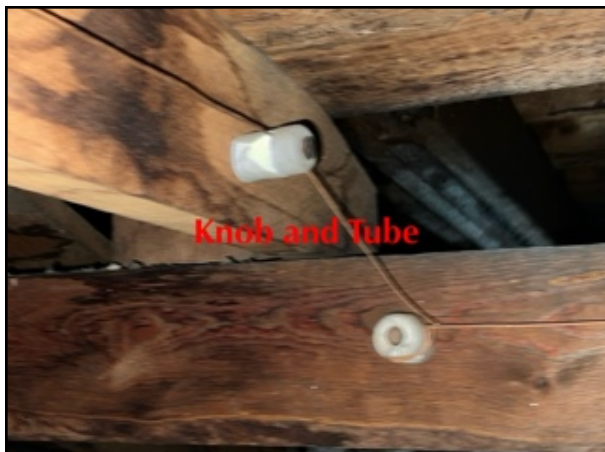
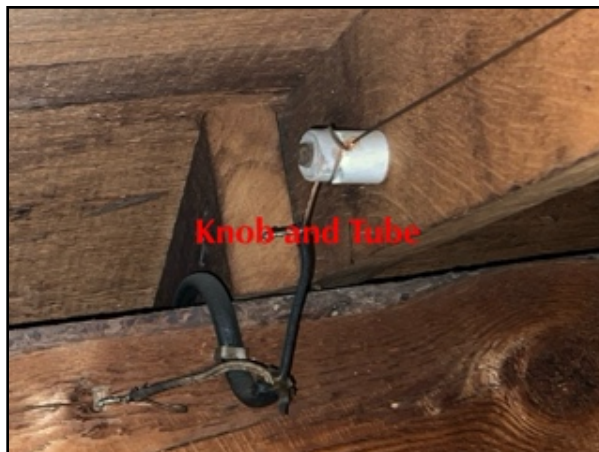
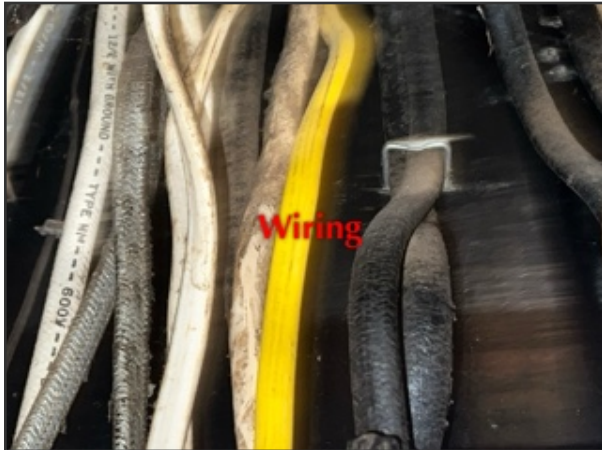
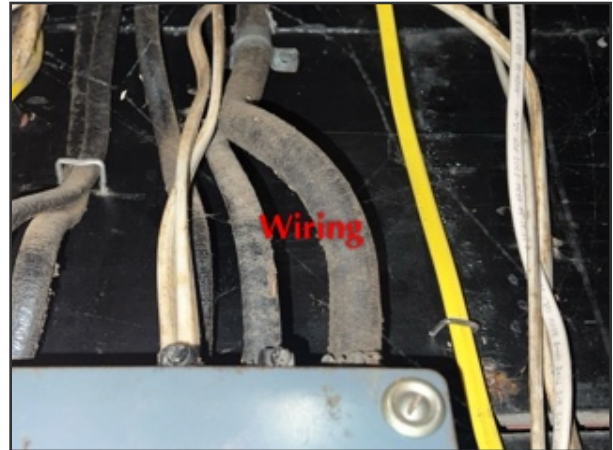
Service Line Material:	Aluminum
	Condition: Satisfactory
Service Voltage:	240 volts
Service Amperage:	100 amps
Service Panel Ground:	Unknown Not Visable
Branch Circuit Wiring:	Knob and Tube in Attic, Cloth Wires
	Condition: Repair or Replace

Comment 11:

Cloth wiring is very common to the age of this house. Although at that time it was standard building practice. I would highly recommend the wiring updated to meet today's standards for added safety.

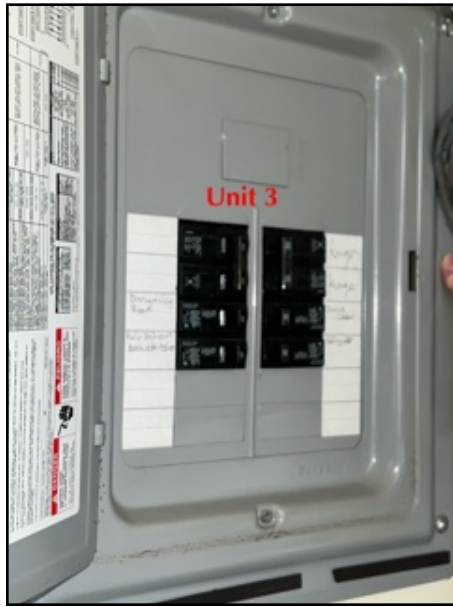
Figure 16-1

Comment 16:
Pictures of the sub panels in the basement. Sub panels are used for the air conditioner and units number two and three. Unit number one has the air conditioner powered from the main panel.

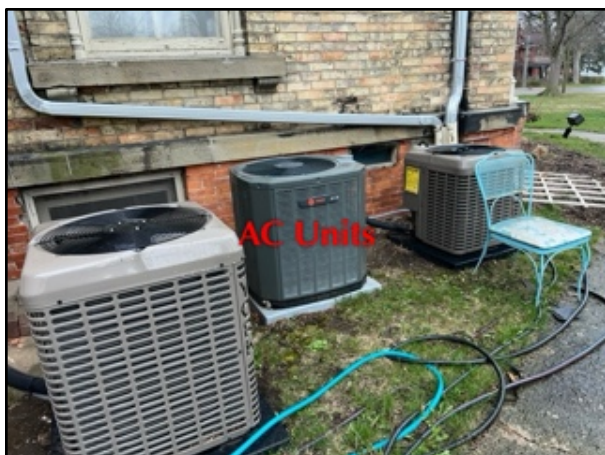
Figure 18-1

Comment 18:

When the temperatures are below 65° I am not permitted to operate an air conditioner because it can cause damage to the system.

Air conditioners over 10 years old and heat pumps over 5 years old should be checked, cleaned and serviced yearly by a licensed contractor.

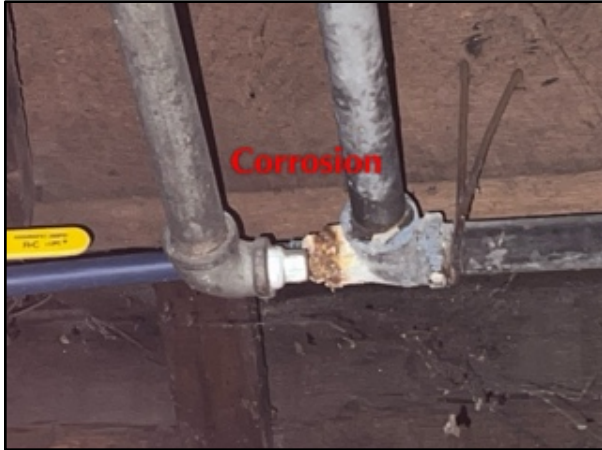
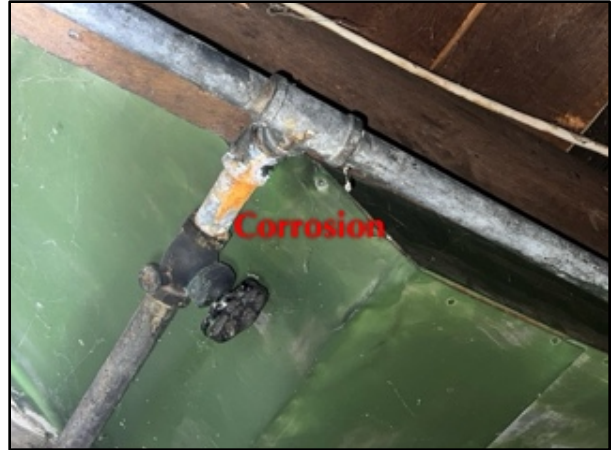
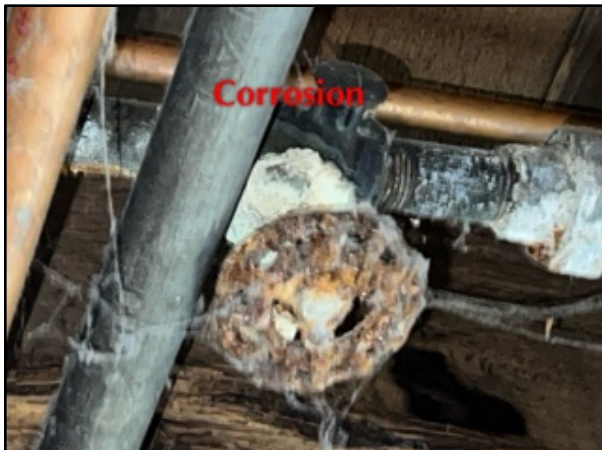
Galvanized, PEX

Condition: Repair or Replace

Galvanized supply lines are outdated and no longer used in today's construction. Galvanized piping can corrode from within and reduce water pressure depositing the metal flakes into the water. The pictures are examples of areas with corrosion.

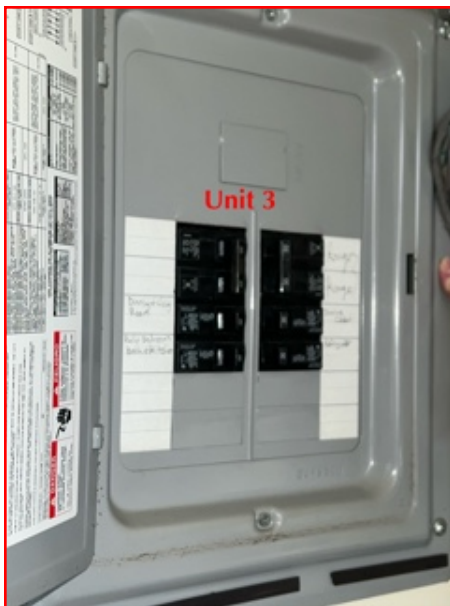
Figure 16-1

14) Pictures of the sub panels in the basement. Sub panels are used for the air conditioner and units number two and three. Unit number one has the air conditioner powered from the main panel.
