SUBJECT: 21 Day Posting – \$237,000 offer to purchase the Gould House

A. GOULD HISTORIC HOME REPORT

INSPECTION AND ESTIMATE COMPILATION

A. GOULD HOMESTEAD
 FOR SEAN & JANEL HARRINGTON
 515 NORTH WASHINGTON ST
 OWOSSO, MICHIGAN 48867
 APRIL 6, 2024 SHEET 2

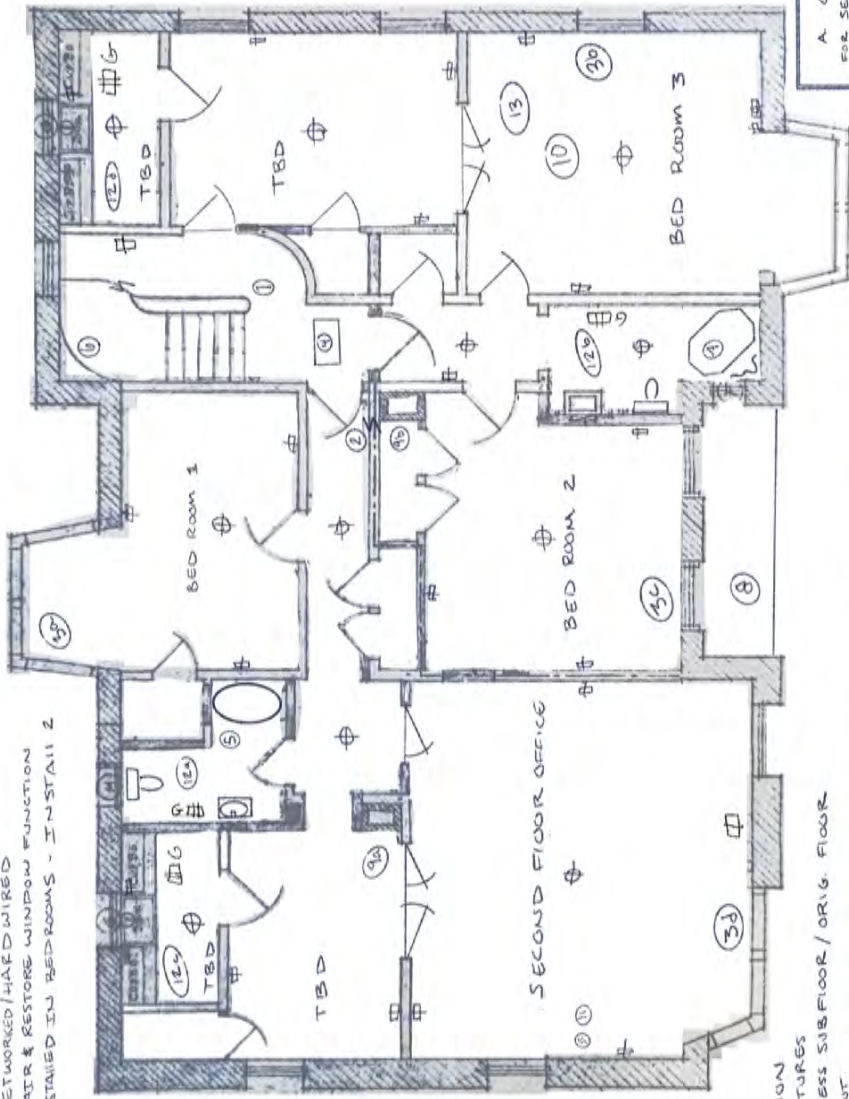
1. REINFORCE HANDRAIL OVER MAIN STAIRS
2. DRYSAL CRACK ALONG CHIMNEY STACK EDGE MAY BE RELATED TO SIMILAR CRACK RUNNING THROUGH GALLERY ON FIRST FLOOR - ADD SUPPORT BEAMS & STEEL RODS IN BASEMENT AND REPAIR JOIST IN THE BASEMENT (SEE SHEET 3)

- A, B, C, WINDOWS/EGRESS- REPAIR & RESTORE WINDOW FUNCTION
 - FIRE ESCAPE LADDER NOT INSTALLED IN BEDROOMS - INSTALL 2
4. ATTIC ACCESS ABOVE STAIRS, NO LADDER - RELOCATE & ADD DROP

5. BATH LOCATION ABOVE SUSPECTED MOISTURE RELATED PLASTER CEILING DAMAGES OVER FIRST FLOOR BED ROOM SEAL TILE/GROUT & LEAK TEST ALL FIXTURES
6. OPEN CRACKS & SEAMS ON STAIRS & TRIM BASEMENT SUPPORT BEAMS SHOULD RESOLVE MOISTURE BARRIER FAILURE, STRIP, GROUT & RESEAL

7. TILE SHOWS SIGNS OF MOISTURE BARRIER FAILURE, STRIP, GROUT & RESEAL
8. JULIET BALCONY IRON FENCE RUSTED
9. CHIMNEY STACK, STATUS UNKNOWN - INSPECT & SCOPE TO DETERMINE SERVICABILITY OR CAP

10. CLEAN OR REPLACE CARPET
11. REPLACE KNOB & TUBE WIRES AND BRING TO CODE. ADD OUTLETS THROUGHOUT. UPDATE GFCI IN ALL ROOMS WITH WATER FIXTURES.
12. INSTALL MOISTURE MITIGATION VAPOR BARRIER AND VENTILATION IN ALL ROOMS WITH WATER FIXTURES

13. REMOVE DAMAGED CARPET & ASSESS SUB FLOOR / ORIG. FLOOR
14. REPAIR PLASTER & WALLS PER THROUGHOUT

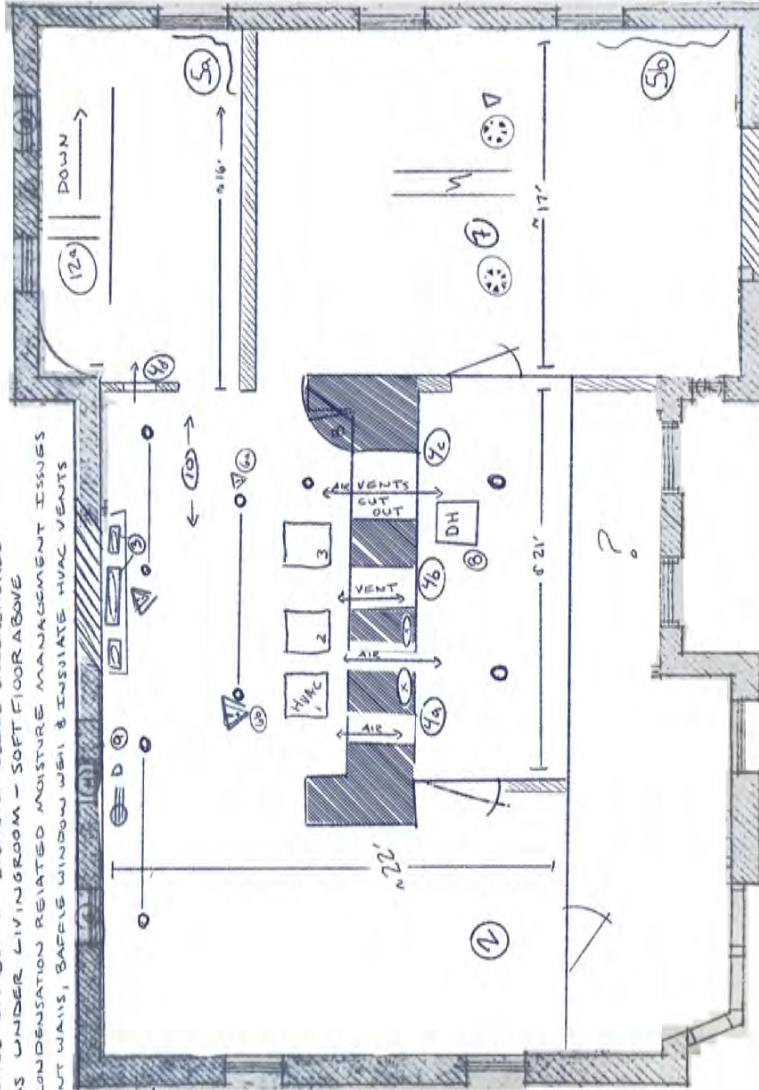
A. GOULD HOMESTEAD
FOR SENJ & JAEI HARRINGTON
515 NORTH WASHINGTON ST
OWOSSO MICHIGAN 48867
APRIL 6, 2024 SHEET 3

1. WOOD SHUTTER OVER DAMAGED WINDOW, DAMAGE TO WINDOW WELLS

4. CENTRAL FOUNDATION WALL MISSING, DAMAGED OR REMOVED LARGE HOLES THROUGH CENTER SUPPORT WALL FOR HVAC BELOW FLOORS WITH SIGNS OF SETTLING GREATER THAN 50%. OFF ESSENTIAL SUPPORT HAS BEEN LOST AND SECONDARY STEEL RODS & BEAMS SHOW SIGNS OF SHEARING & FAILURE ADDITIONAL DAMAGE AND REMOVAL THROUGHOUT OTHER SECONDARY WALLS ALSO MAY CONTRIBUTE TO 1B & 2ND FLOOR DAMAGES

5. WATER INFILTRATION AT BASE OF EXTERIOR WALL - APPLY OCCUSION SEAL

7. MISSING SUPPORT BEAMS UNDER LIVINGROOM - SOFT FLOOR ABOVE

8. DEHUMIDIFIER & EVIDENCE OF CONDENSATION RELATED MOISTURE MANAGEMENT ISSUES

11. WATER MAIN - CORROSION

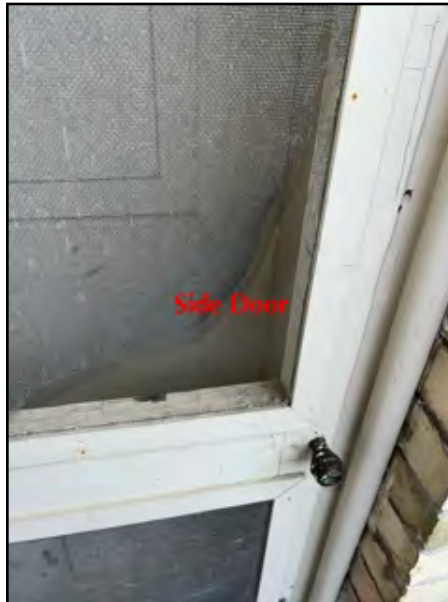
Comment 3:

Condition: Repair or Replace

Picture of the torn screen side door.

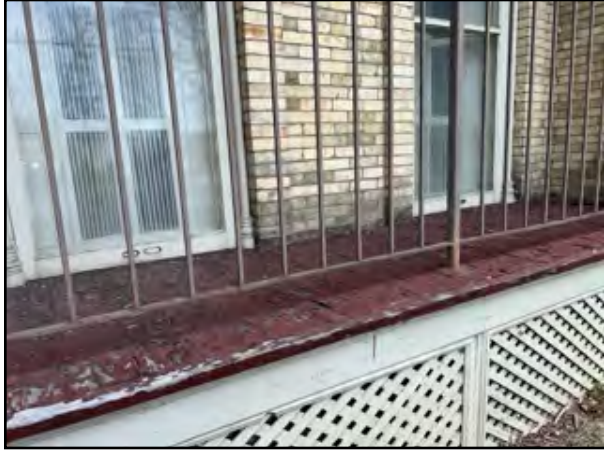
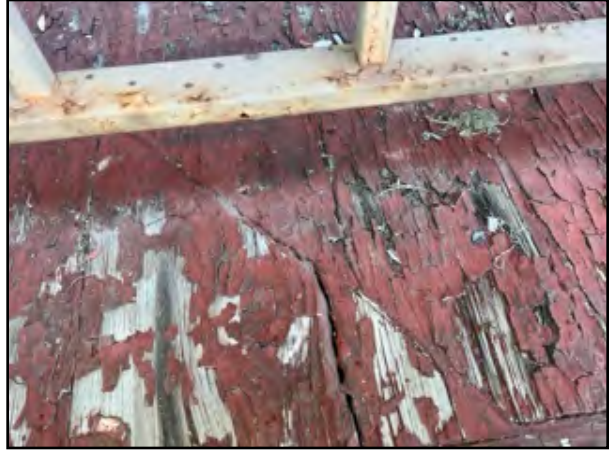
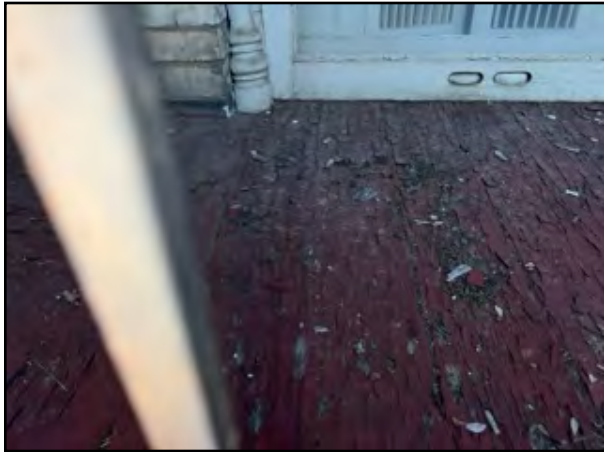
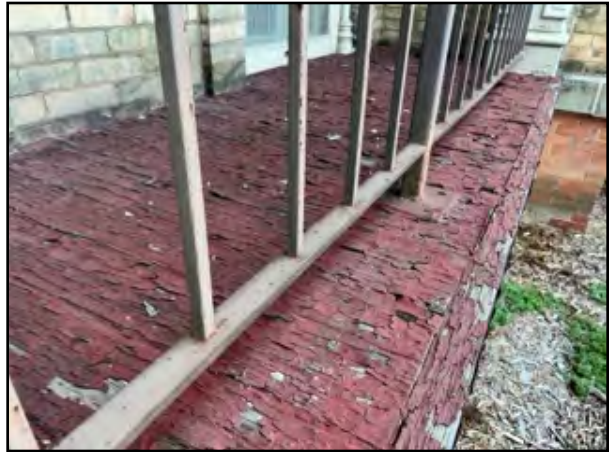
Condition: Repair or Replace

Comment 4:
Picture of the balcony with deterioration.

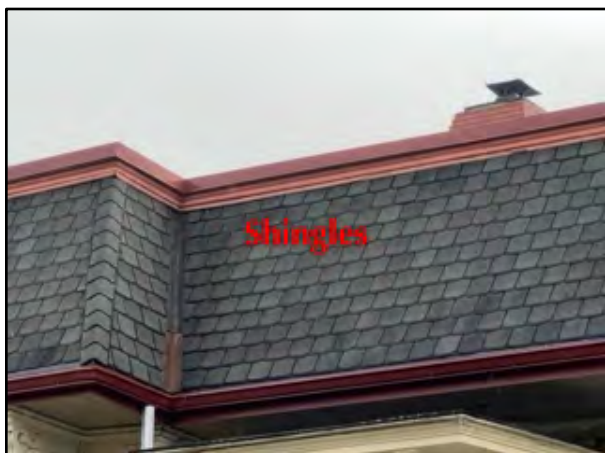
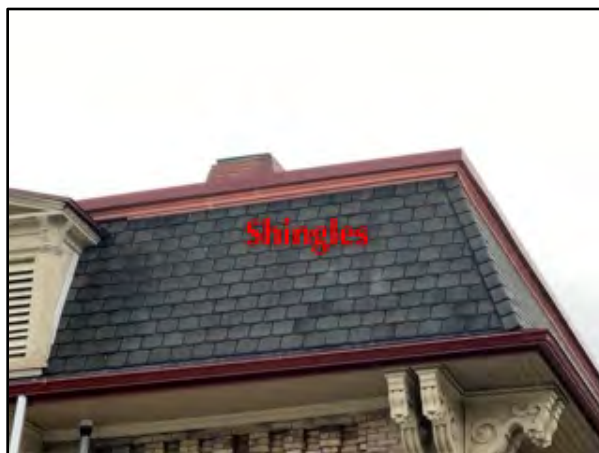
Inspection Method:	Ground
Roof Design:	Flat
Roof Covering:	Architectural shingles
	Condition: Satisfactory

Comment 6:
Picture of the visible shingles.

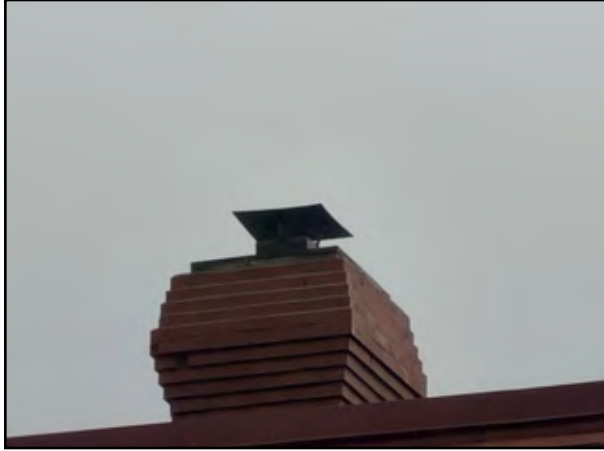
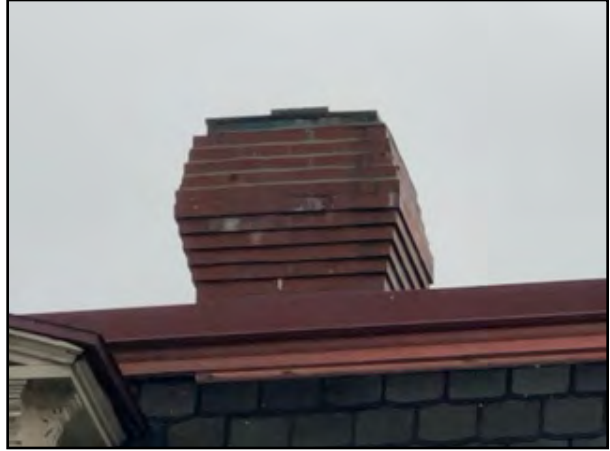
Condition: Satisfactory

Comment 7:
Picture of the chimneys.

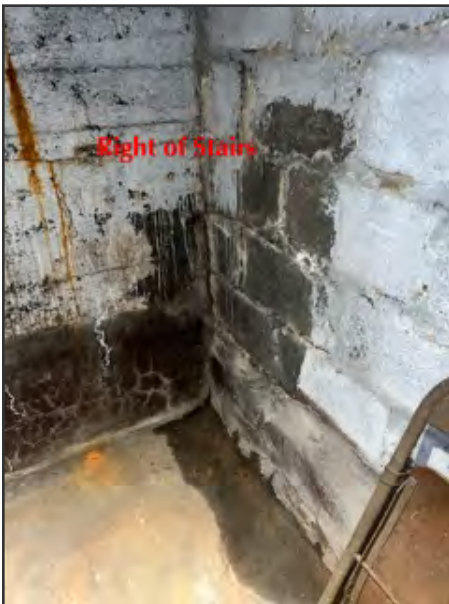
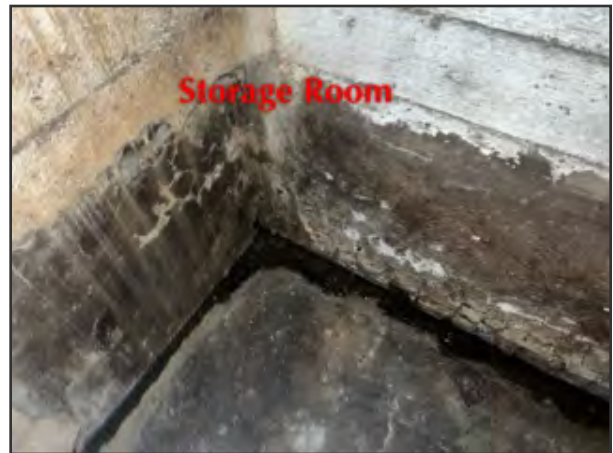
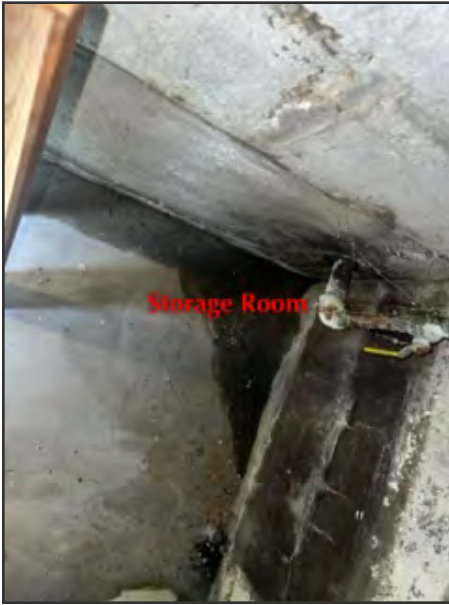
Dampness, Stains, Water
Condition: Repair or Replace

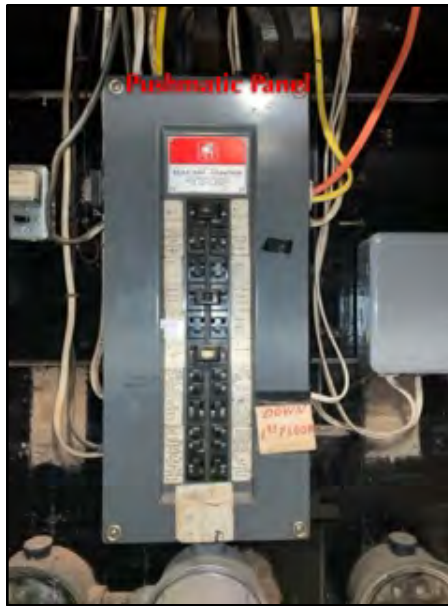
Type of Service:	Overhead
Main Disconnect Location:	Service Panel
Service Panel Location:	Basement
Service Panel Manufacturer:	Pushmatic
	Condition: Further Evaluation Required

A pushmatic Panel is present. This is a panel that was used primarily between the 1950s and early 1980s. Unlike today's panels it does not operate from left to right. It pushes inward. A significant safety issue is the spring located behind the breaker. Over the years it can become corroded, rusted and brittle. This can result in the breaker not tripping if needed or if tripped by hand the circuit may not reset and remain with no power. Replacement parts are almost impossible to find and there are parts that are labeled pushmatic compatible. However these parts are not approved under the electrical code. Pushmatic breakers use a thermal design mechanism to trip the breakers and current breakers use a thermal and magnetic mechanism to trip the breakers which is safe and reliable. A licensed electrician will be needed to upgrade the electrical panel to meet current standards for safety.

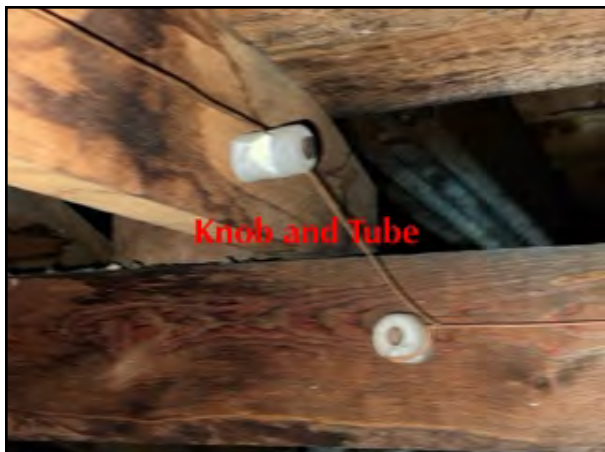
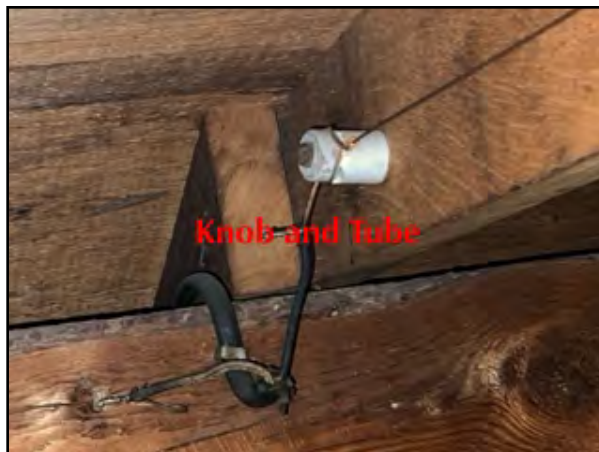
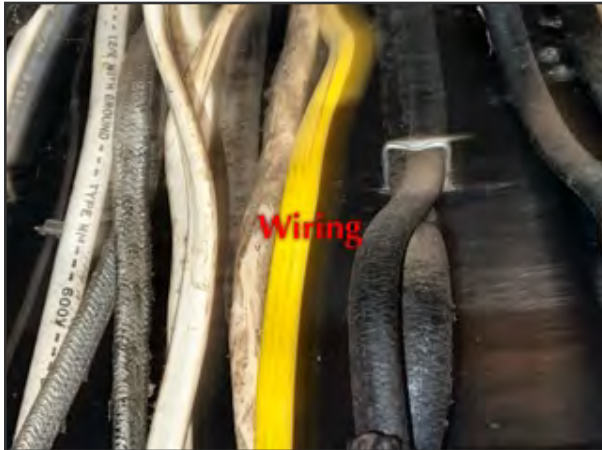
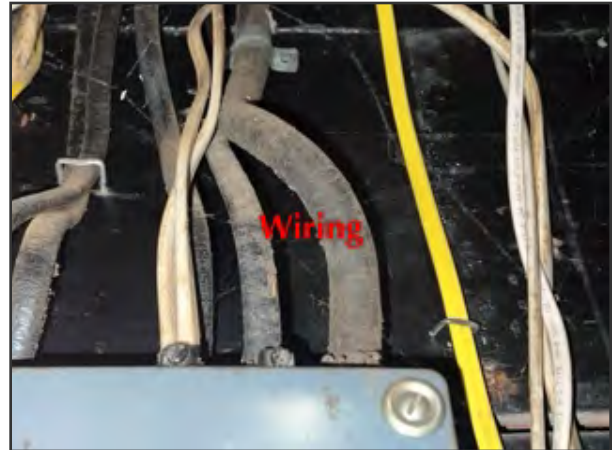
Comment 11:

Service Line Material:	Aluminum
Service Voltage:	Condition: Satisfactory
Service Amperage:	240 volts
Service Panel Ground:	100 amps
Branch Circuit Wiring:	Unknown Not Visable
	Knob and Tube in Attic, Cloth Wires
	Condition: Repair or Replace

Cloth wiring is very common to the age of this house. Although at that time it was standard building practice. I would highly recommend the wiring updated to meet today's standards for added safety.

Knob and tube was found in the attic. This is outdated wiring, and must be removed by a licensed electrician. Knob and tube is considered a safety issue based on its age. The knob and two is most likely 100 years old.

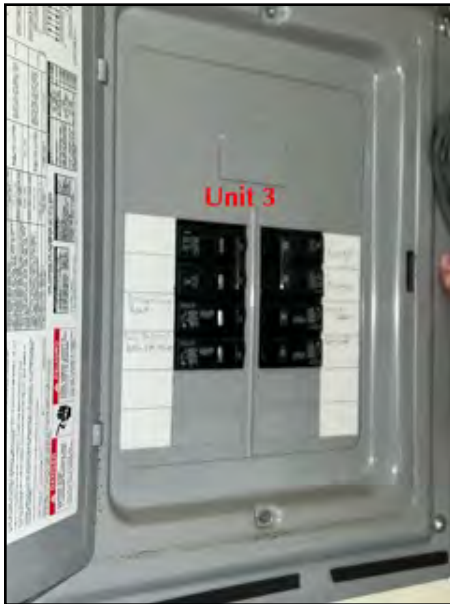
Figure 16-1

Comment 16:
Pictures of the sub panels in the basement. Sub panels are used for the air conditioner and units number two and three. Unit number one has the air conditioner powered from the main panel.

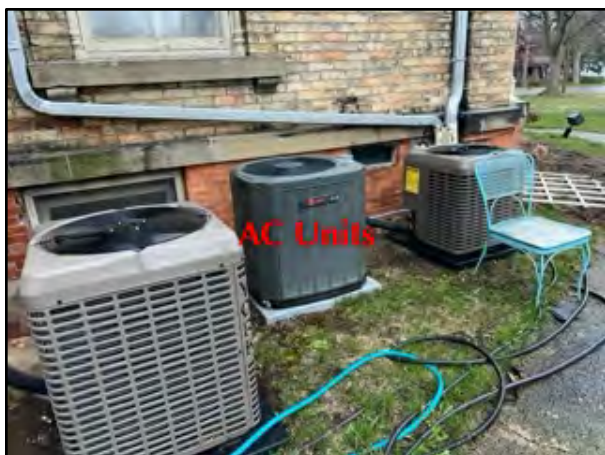
Figure 18-1

When the temperatures are below 65° I am not permitted to operate an air conditioner because it can cause damage to the system.

Air conditioners over 10 years old and heat pumps over 5 years old should be checked, cleaned and serviced yearly by a licensed contractor.

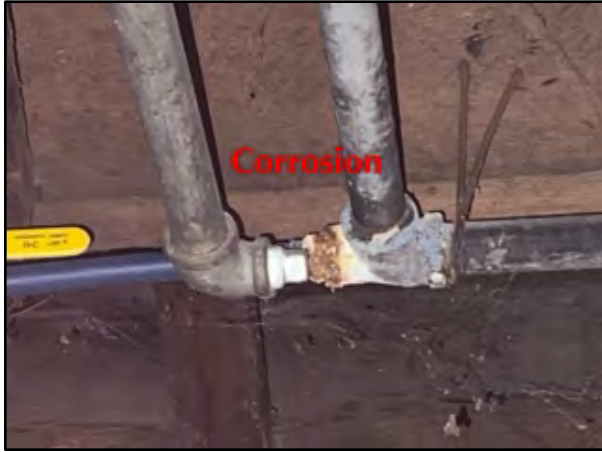
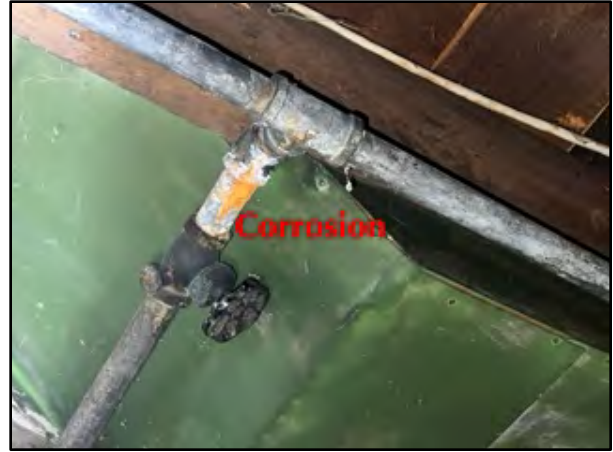
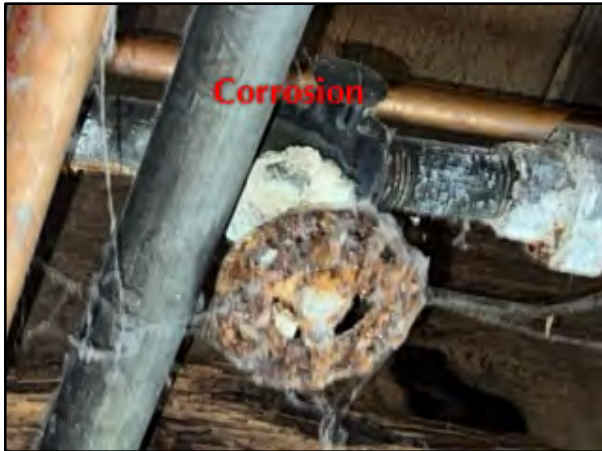
Galvanized, PEX

Condition: Repair or Replace

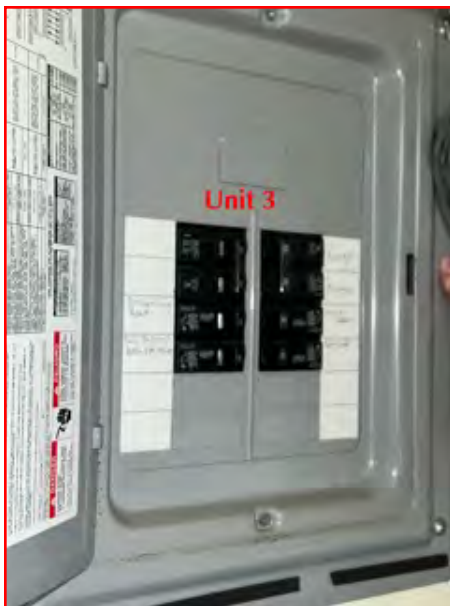
Figure 16-1

14) Pictures of the sub panels in the basement. Sub panels are used for the air conditioner and units number two and three. Unit number one has the air conditioner powered from the main panel.
