Historic District Commission Application for a Certificate of Appropriateness

Owosso Michigan National Guard Armory Building
201 North Water Street, Owosso, MI

Historic Preservation Certification Application – Part 2

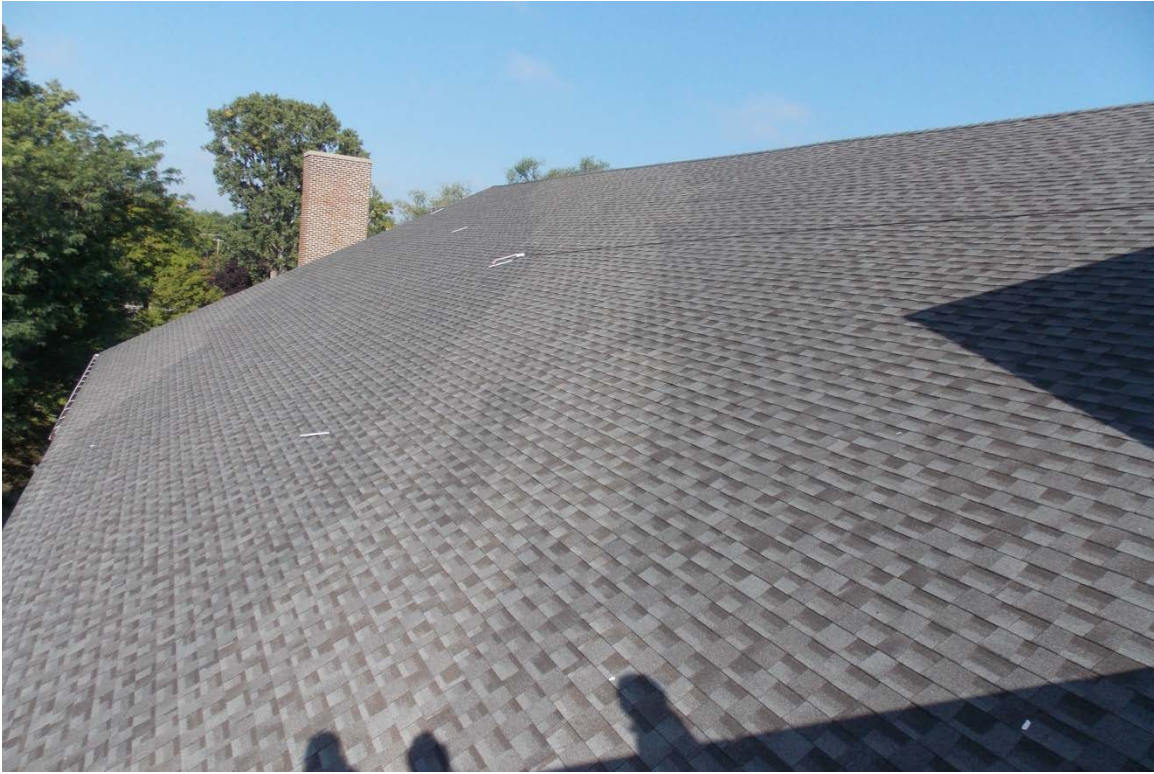
Figure #19: Drill Deck Roof, looking west. 8/29/13.

The Drill Deck roof is a pitched roof clad in gray shingles in fair condition. The roof over the stage in the drill deck is dropped several feet below the main drill deck roof but has the same slope, and is clad in the same gray shingles. The old basement egress stair at the west side of the North Elevation has a separate, shorter hipped roof, also clad in gray shingles, in fair condition. Gutters and downspouts are located on the edges of the roof, and are in poor condition.

All parapets, turrets, and roof structures will be retained, inspected for damage, and repaired as necessary. See masonry **Item Number #** for the work. The existing roof material on both the Drill Deck and Administrative Section will be left in place and repaired as necessary. Drainage will remain the same but all gutters and downspouts will be removed and replaced with new to match the existing in shape and style as closely as possible. New rooftop mechanical equipment and any required screen walls will not be a noticeable feature when viewed from any of the public streets within a block of the building.

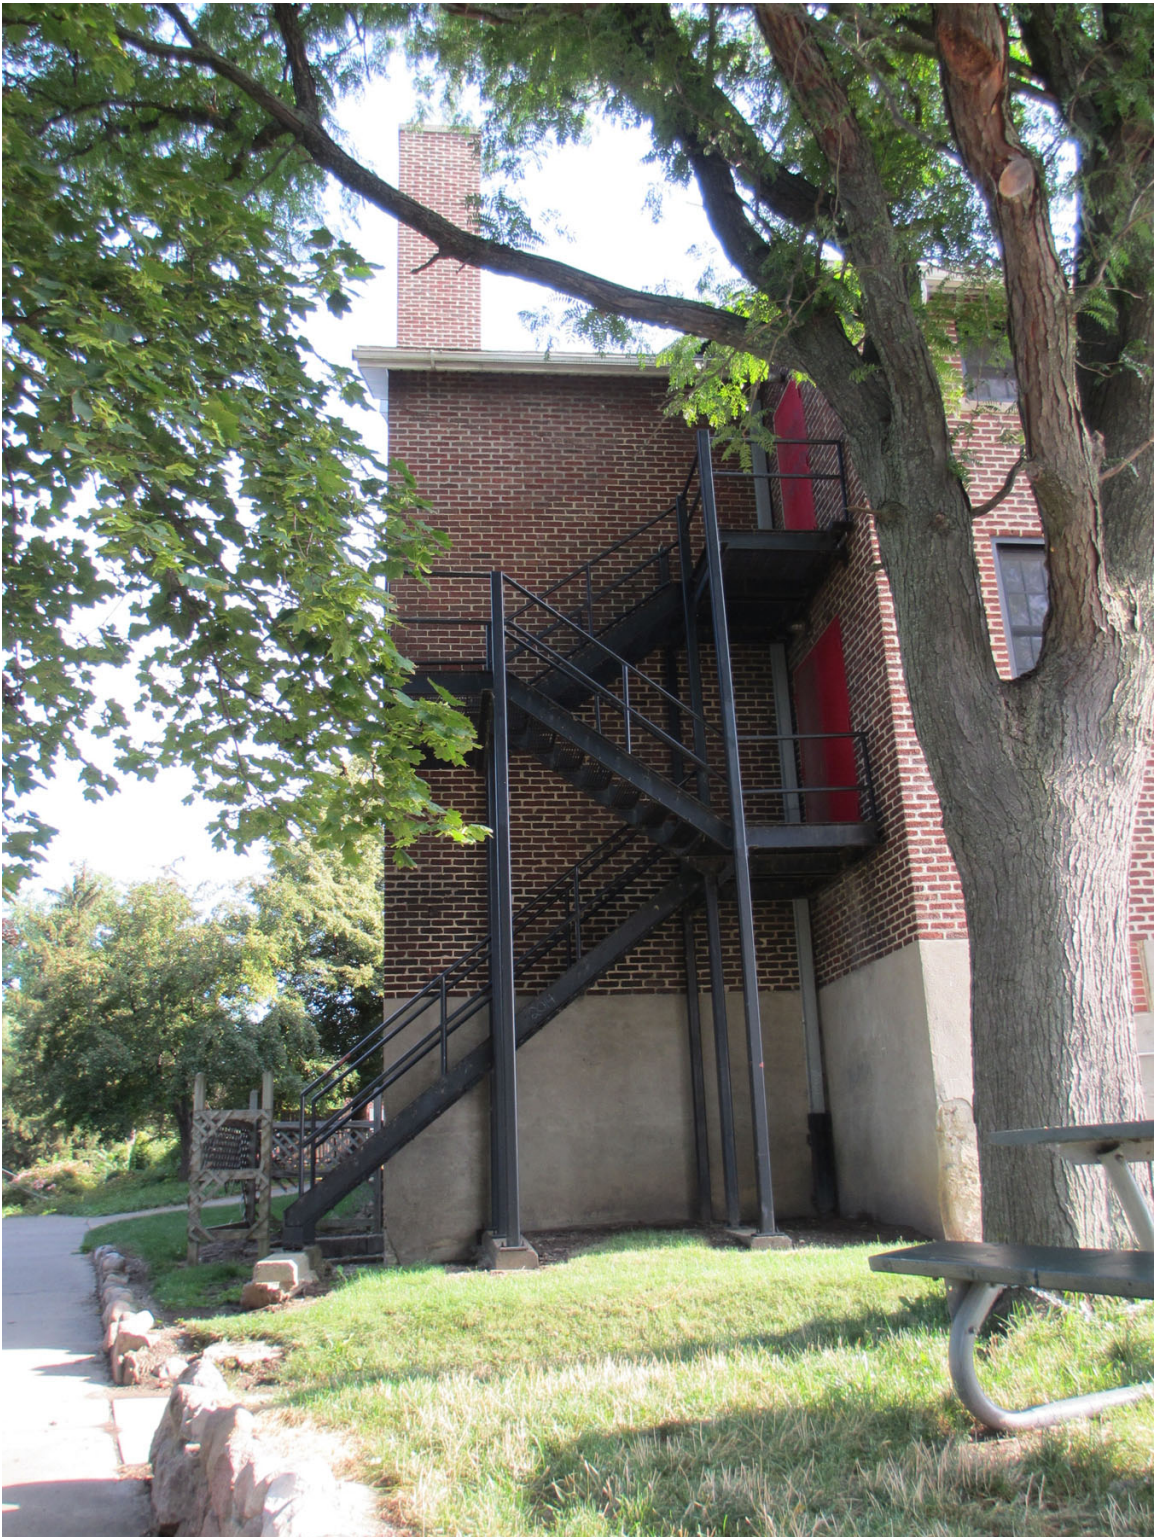
Figure #21: South Elevation Exterior Egress Stair, looking north. 8/8/13.

There are two sets of exterior egress stairs on the building running from the Mezzanine to the exterior ground level, with an additional exit at the 1st Floor Drill Deck. One stair is on the South Elevation and exits toward the river, and the other stair is on the North Elevation and exits toward N. Water St. Both egress stairs are painted black metal in fair condition.

Existing egress stairs are to be retained and rehabilitated as a means of egress from the building. Connections to the building shall be rehabilitated as necessary to ensure structural stability. Any loose or spalling masonry units shall be repaired or reinstalled as necessary. Loose paint shall be stripped and the stairs shall be given a new coat of black paint.

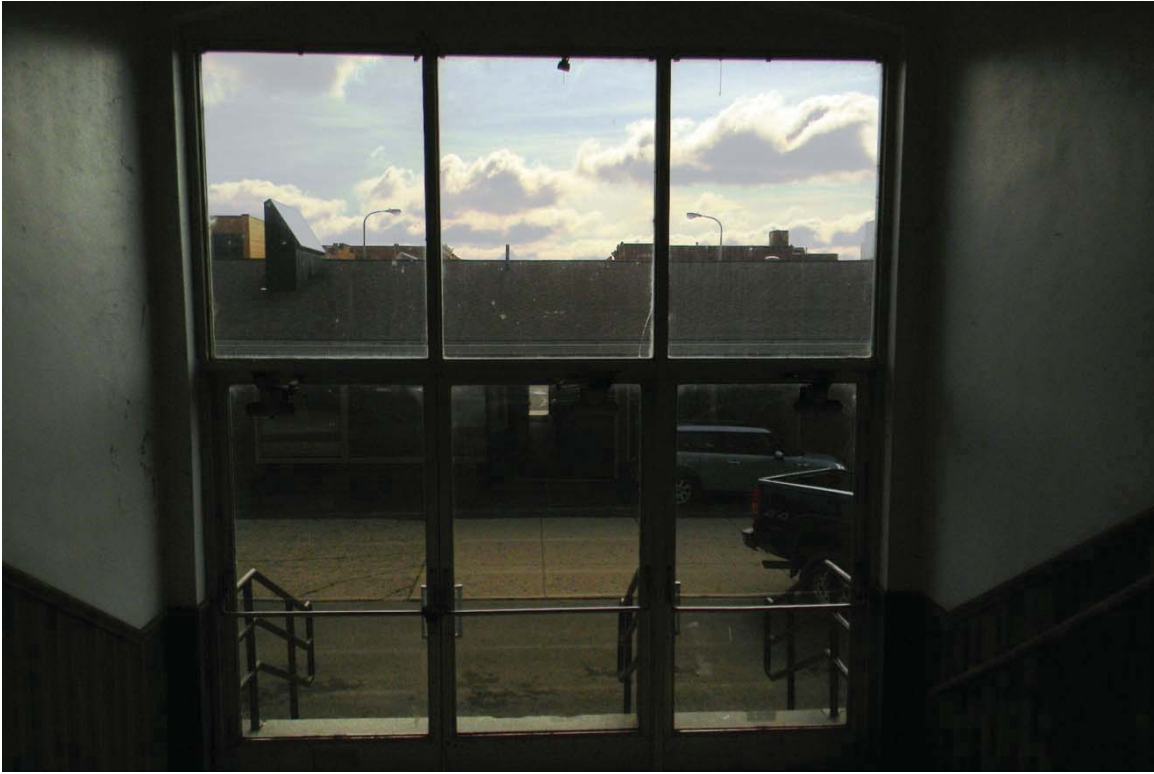
Figure #X: First Floor, Main Entry Doors, looking east. 8/8/13.

The main entry doors and transoms are an aluminum storefront system in fair condition, with some signs of deterioration. The current configuration was installed in 1957, replacing the original large wood barn doors and transom with smaller panes of glass above.

The entry doors are to be replaced with a new aluminum storefront system. The new storefront system shall have two doors and sidelights and a new transom reconfigured to have smaller lites. The new storefront system will be behind new wood carriage doors. Both the new wood carriage doors and the new transom will be compatible with the historic character of the building based on historic photos.

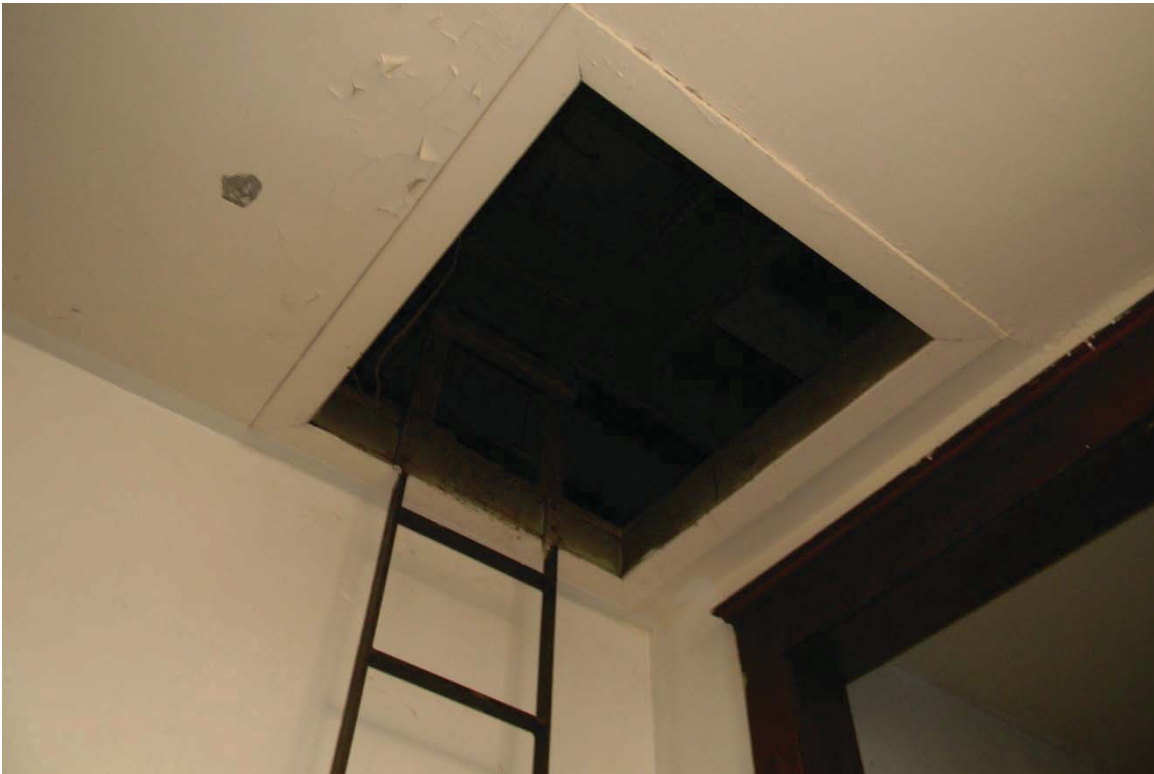
Figure #X: Second Floor, Roof Access Hatch. 8/8/13.

The Administrative Section has a flat white membrane roof in fair condition. Access to the roof is through a roof hatch and ladder on the 2nd Floor. The roof is surrounded on three sides with a crenelated brick parapet and on the fourth by the masonry wall supporting the adjacent hip roof. There are two masonry turrets with partial height access doors on the north east and south east corners of the roof. The brick on the turrets is in fair condition, with few areas of spalling or cracking. See **Item Number #** for masonry work. A skylight is located at the north end of the roof and is in fair condition.

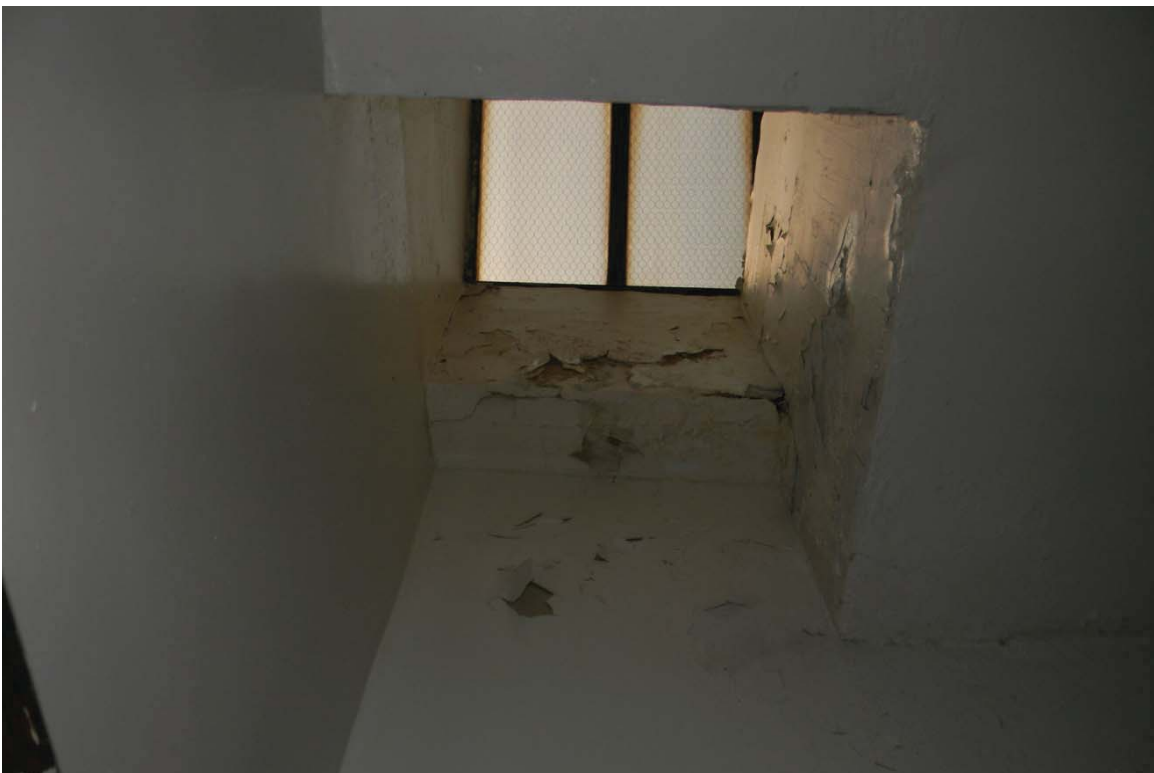
Figure #X: Second Floor, Skylight. 8/8/13.
