ADDENDUM NO. 1

Project: City of Owosso Bridge Engineering Services
Gould Street Bridge over Shiawassee River

BRIDGE MAINTENANCE GRANT APPLICATION

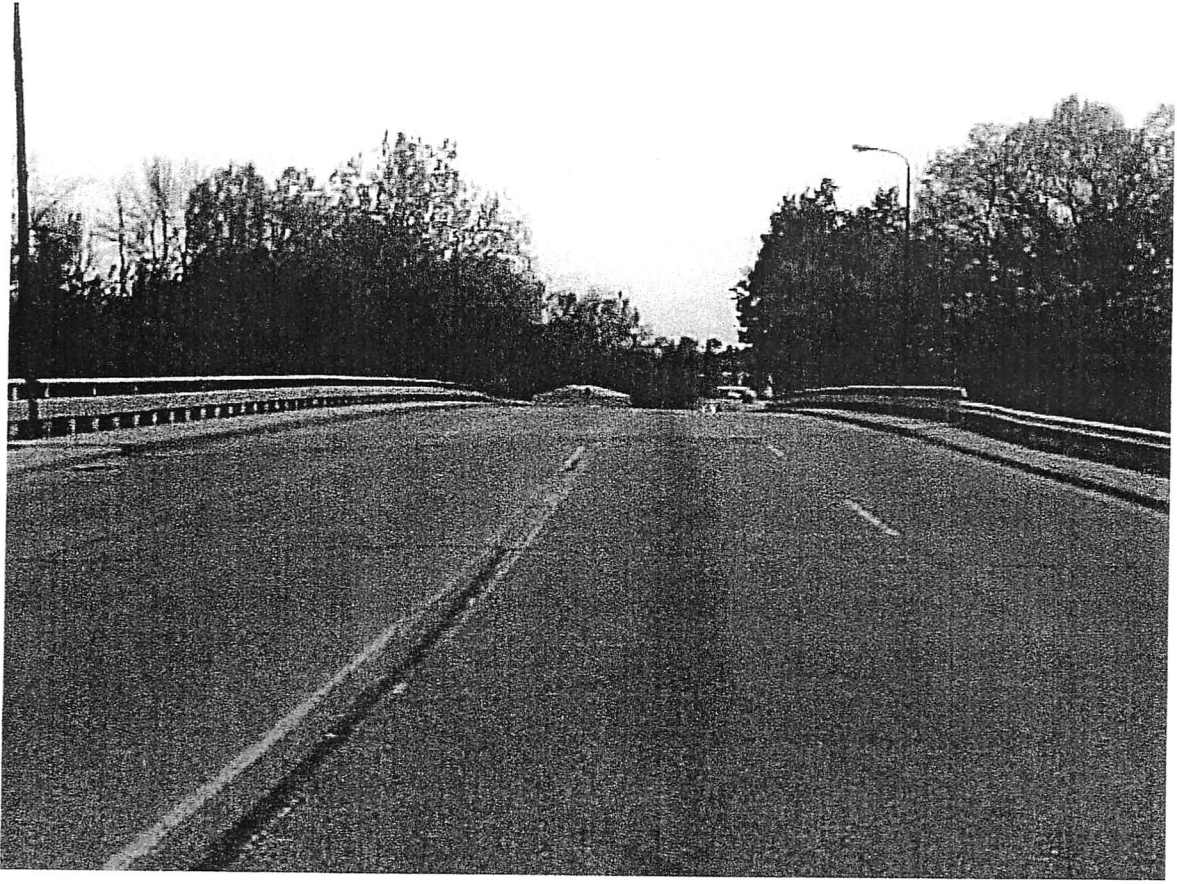
16. Approach Pavt 6 6 5 Deterioration within 5 feet of bridge ends with cold patch. Minor settlement at ends of bridge. (08)
Bituminous settlement 1' (+/-) both sides. Pot holes on north bound lanes, south side. Filled with cold patch. (06)
Bituminous settlement 1' (+/-) both sides. Pot holes on north bound lanes, south side. (04)

GOULD STREET BRIDGE APPROACH LOOKING SOUTH

The sidewalks at the bridge approaches have been replace once and will be replaced again in 2008. The asphalt at the bridge approaches have been milled and repaved once before and needs to be done again. Other than those items, little maintenance has been needed on this bridge.
