Historic District Commission Application for a Certificate of Appropriateness

Owosso Michigan National Guard Armory Building
201 North Water Street, Owosso, MI

Historic Preservation Certification Application – Part 2

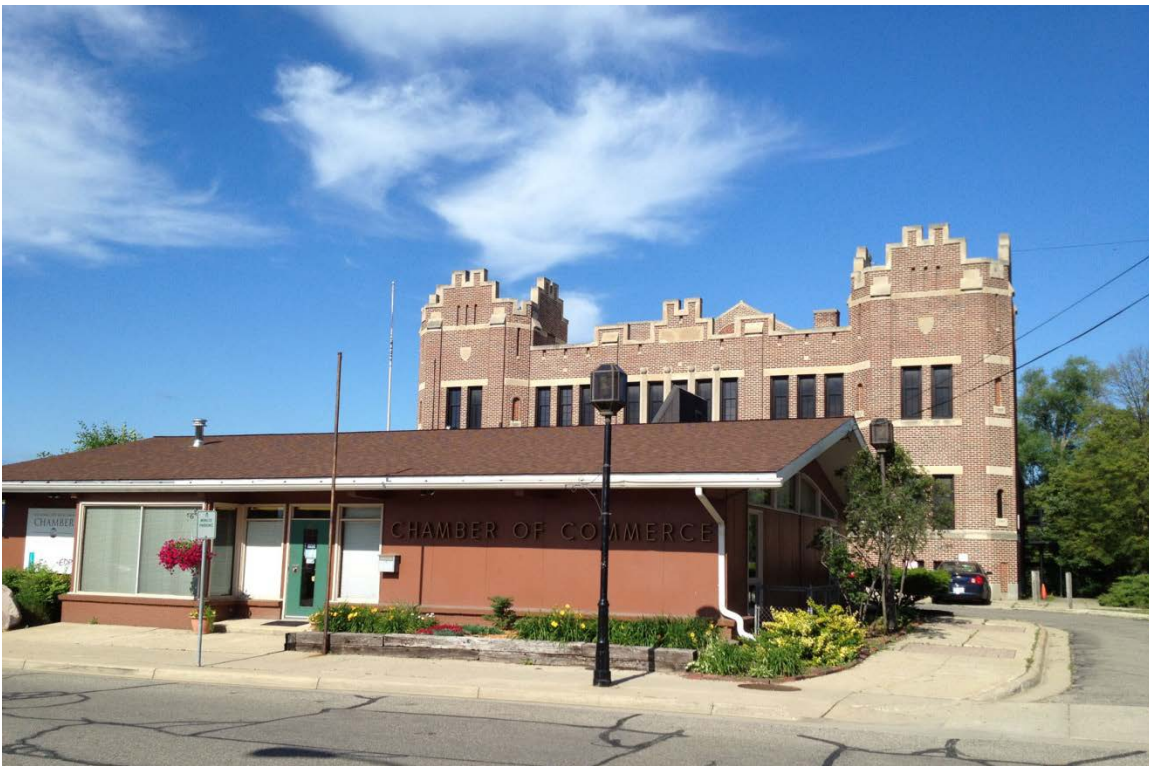
Figure #2: East Elevation, looking west. 8/8/13.

The East Elevation is divided into five bays by brick piers. The windows are all 10-lite aluminum single-hung windows in good condition. Several windows on the south side of the façade have an exterior metal grate, and several of the Ground Floor windows have an exterior mesh screen.

All existing windows are to remain. Previously infilled window locations are to be replaced with new aluminum units to match the appearance, size, design, proportions, profiles, and sightlines of the existing Traco windows to maintain a consistent appearance. The same model number and finish will be used as the existing replacement windows if possible. All exterior mesh and grates shall be removed.

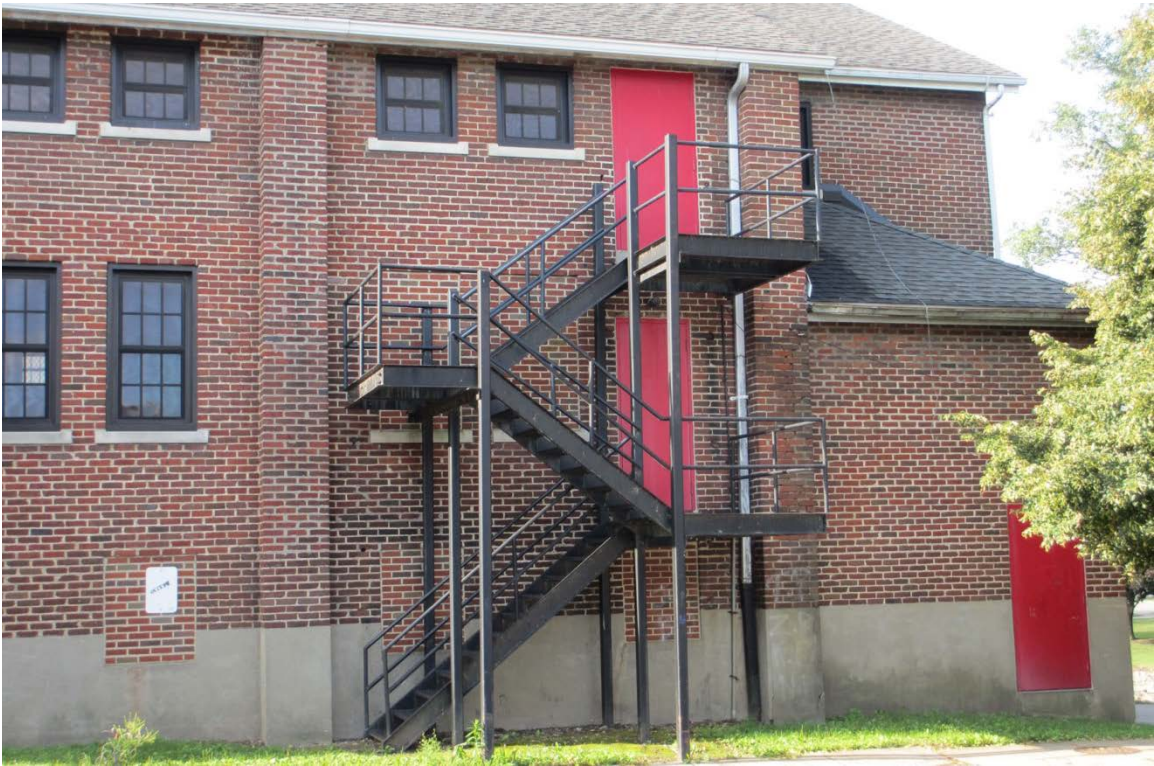
Figure #8: North Elevation Exterior Egress Stair, looking south. 8/8/13.

There are two sets of exterior egress stairs on the building running from the Mezzanine to the exterior ground level, with an additional exit at the 1st Floor Drill Deck. One stair is on the South Elevation and exits toward the river, and the other stair is on the North Elevation and exits toward N. Water St. Both egress stairs are painted black metal in fair condition.

Existing egress stairs are to be retained and rehabilitated as a means of egress from the building. Connections to the building shall be rehabilitated as necessary to ensure structural stability. Any loose or spalling masonry units shall be repaired or reinstalled as necessary. Loose paint shall be stripped and the stairs shall be given a new coat of black paint.

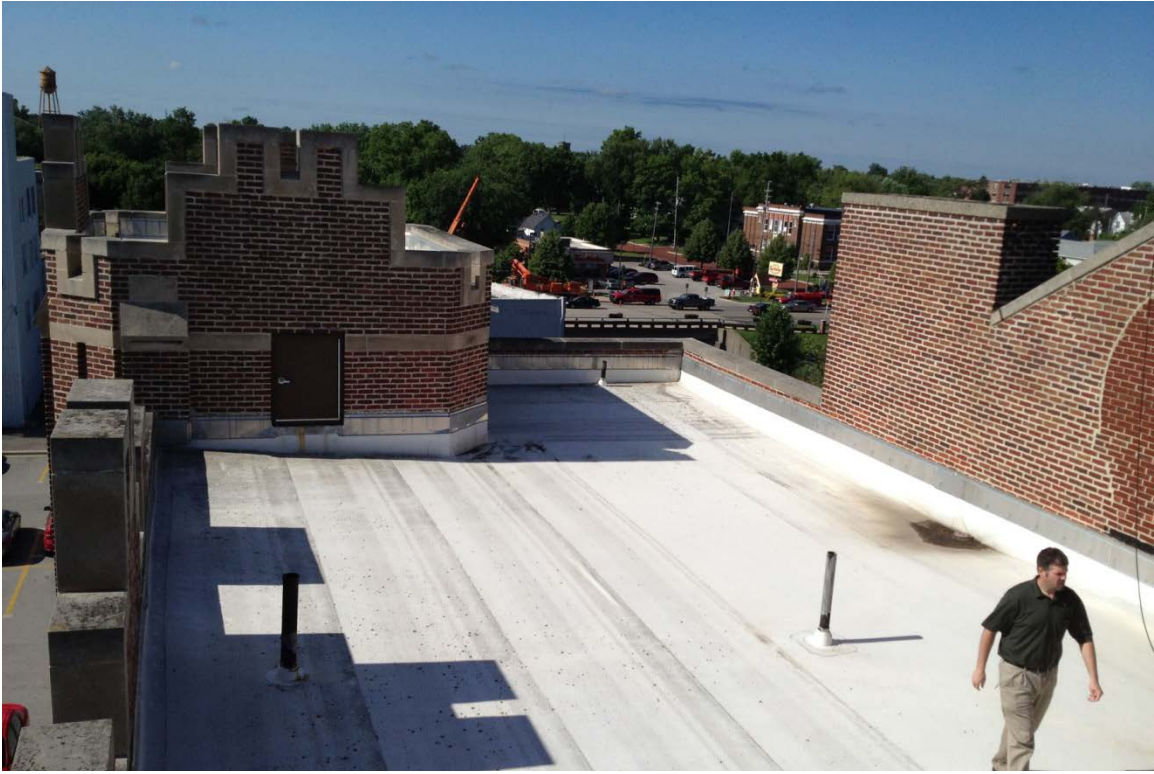
Figure #13: Administration Section Roof, looking south. 8/8/13.

The Administrative Section has a flat white membrane roof in fair condition. Access to the roof is through a roof hatch and ladder on the 2nd Floor. The roof is surrounded on three sides with a crenelated brick parapet and on the fourth by the masonry wall supporting the adjacent hip roof. There are two masonry turrets with partial height access doors on the north east and south east corners of the roof. The brick on the turrets is in fair condition, with few areas of spalling or cracking. See **Item Number #** for masonry work. A skylight is located at the north end of the roof and is in fair condition.

All parapets, turrets, and roof structures will be retained, inspected for damage, and repaired as necessary. See masonry **Item Number #** for the work. The existing roof material on both the Drill Deck and Administrative Section will be left in place and repaired as necessary. Drainage will remain the same but all gutters and downspouts will be removed and replaced with new to match the existing in shape and style as closely as possible. New rooftop mechanical equipment and any required screen walls will not be a noticeable feature when viewed from any of the public streets within a block of the building.

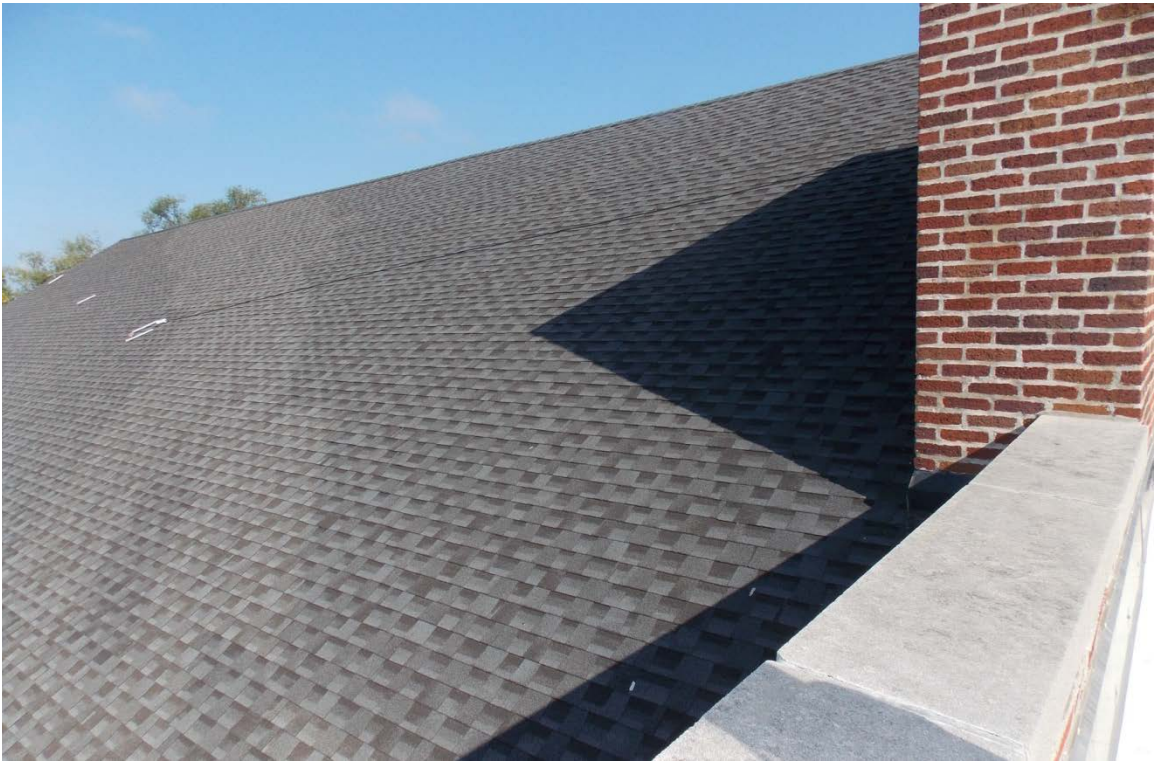
Figure #20: Drill Deck Roof, looking west. 8/29/13.

The Drill Deck roof is a pitched roof clad in gray shingles in fair condition. The roof over the stage in the drill deck is dropped several feet below the main drill deck roof but has the same slope, and is clad in the same gray shingles. The old basement egress stair at the west side of the North Elevation has a separate, shorter hipped roof, also clad in gray shingles, in fair condition. Gutters and downspouts are located on the edges of the roof, and are in poor condition.
