A. GOULD HISTORIC
HOME REPORT

INSPECTION AND ESTIMATE COMPILATION

515 N WASHINGTON, OWOSSO MI 48867

Home Inspection Report

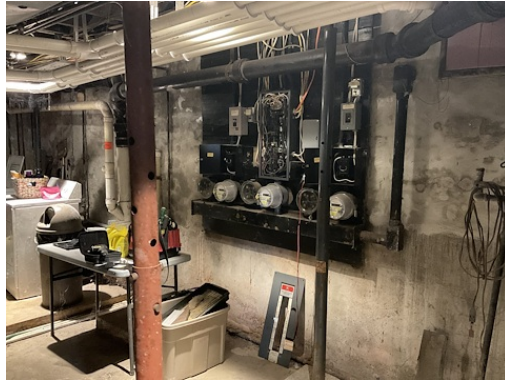
Meter Socket

In basement, all service equipment appears to be original to home. These meters should be outside of home and accessible to power company.

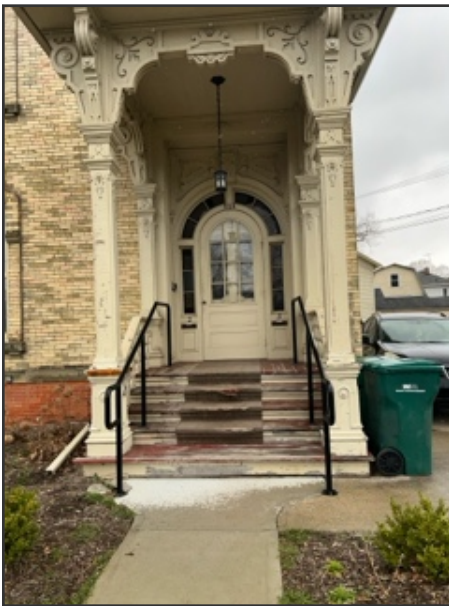
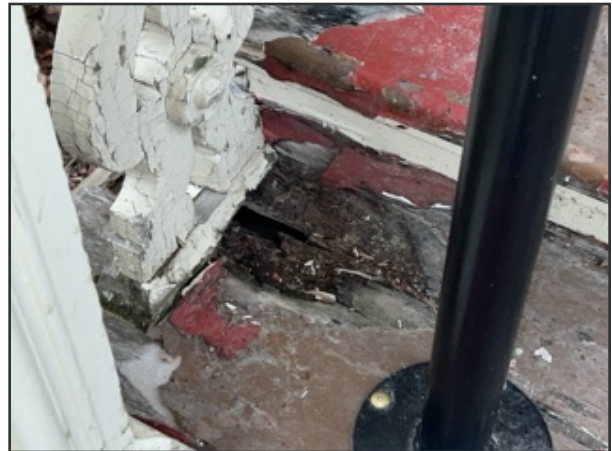
Patios/Decks:

Wood

Condition: Repair or Replace

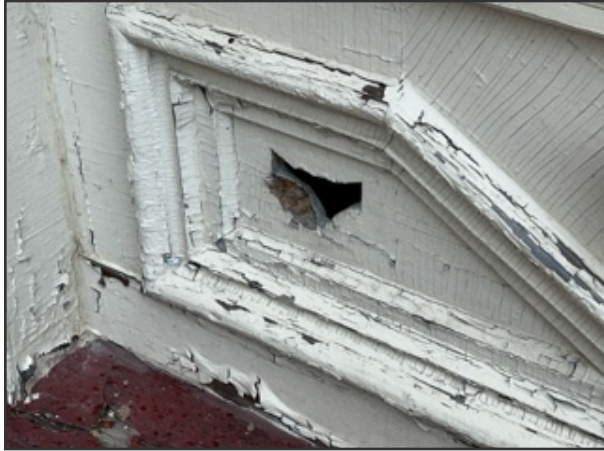
Comment 1:
Side entry.

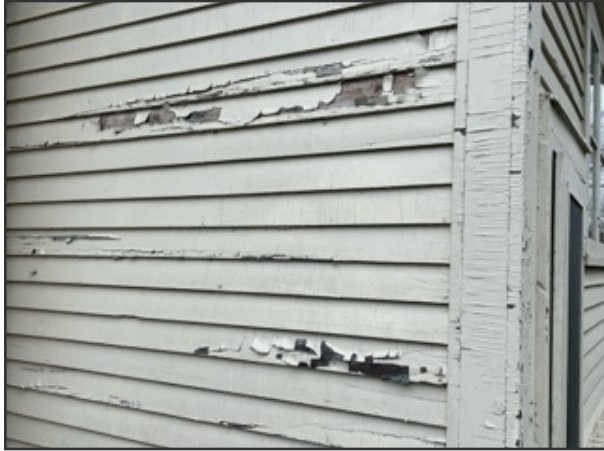
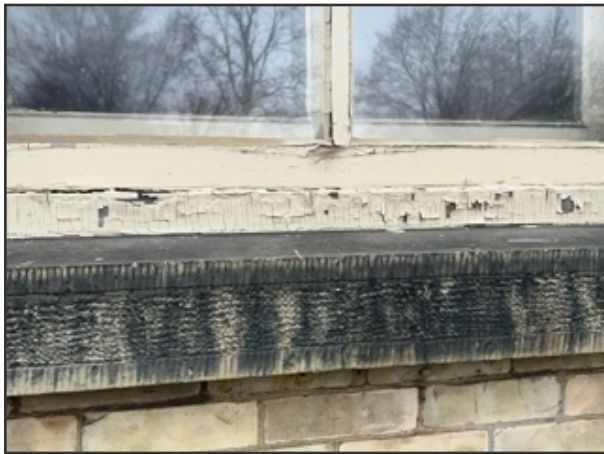
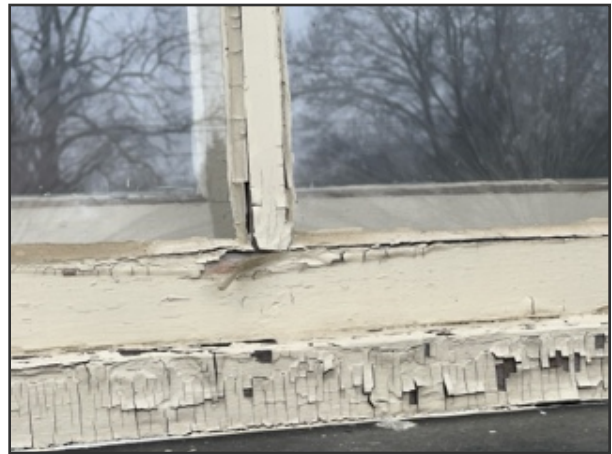
Exterior Trim Material:

Wood

Condition: Further Evaluation Required

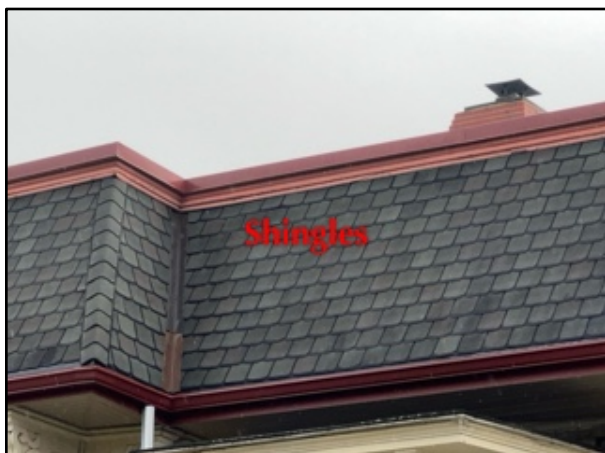
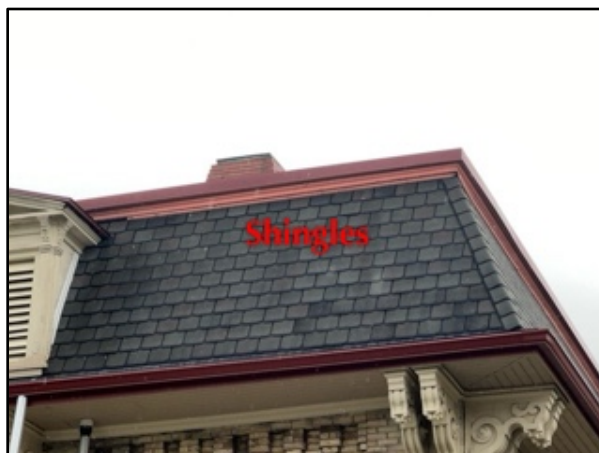
Comment 6:
Picture of the visible shingles.

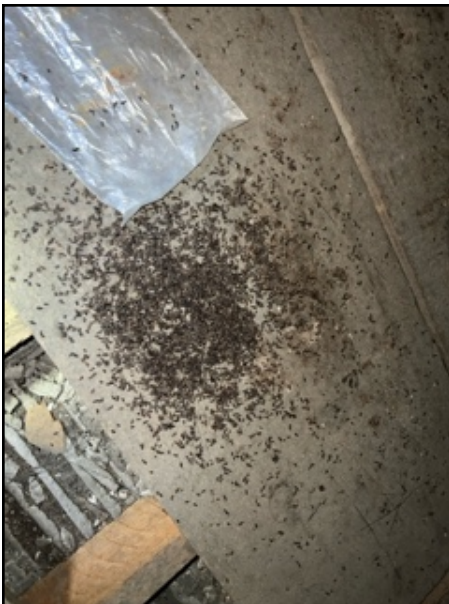
Figure 9-1

Comment 9:
Batt guano .

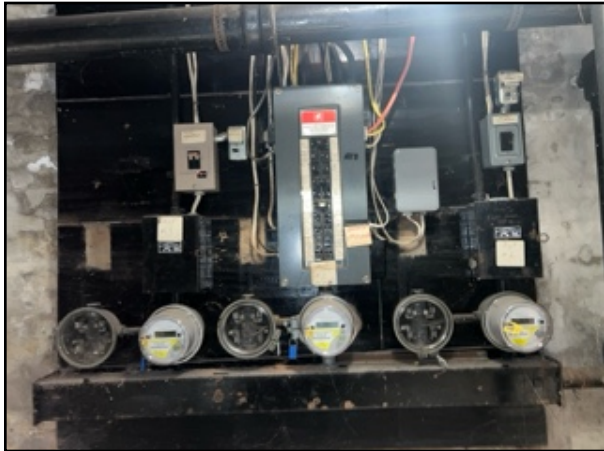
Figure 14-1

A pushmatic Panel is present. This is a panel that was used primarily between the 1950s and early 1980s. Unlike today's panels it does not operate from left to right. It pushes inward. A significant safety issue is the spring located behind the breaker. Over the years it can become corroded, rusted and brittle. This can result in the breaker not tripping if needed or if tripped by hand the circuit may not reset and remain with no power. Replacement parts are almost impossible to find and there are parts that are labeled pushmatic compatible. However these parts are not approved under the electrical code. Pushmatic breakers use a thermal design mechanism to trip the breakers and current breakers use a thermal and magnetic mechanism to trip the breakers which is safe and reliable. A licensed electrician will be needed to upgrade the electrical panel to meet current standards for safety.

Comment 14:
Picture of the electrical in the basement.

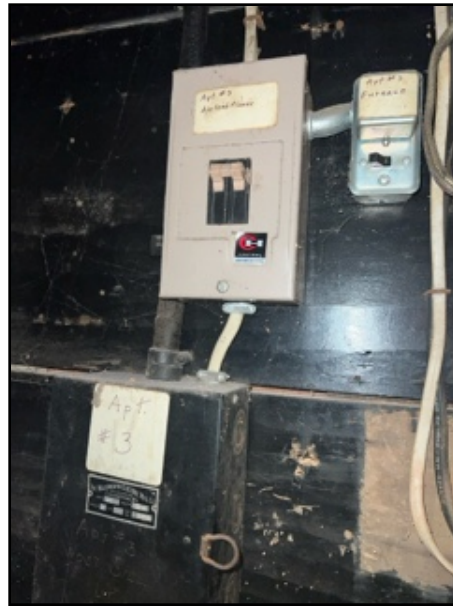
Figure 16-2

Comment 16:
Pictures of the sub panels in the basement. Sub panels are used for the air conditioner and units number two and three. Unit number one has the air conditioner powered from the main panel.

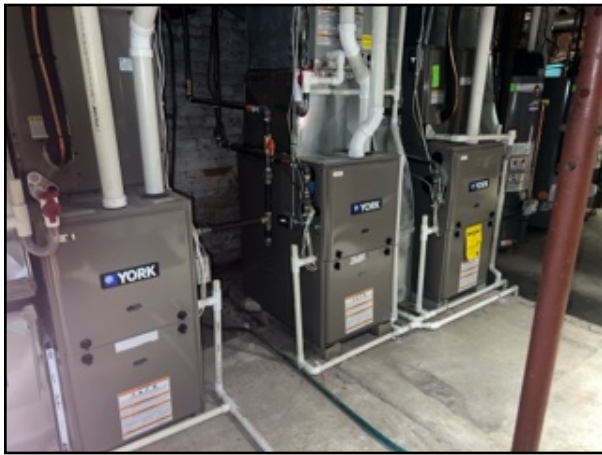
Figure 17-1

Pictures of the three furnaces. The furnaces operate at this time. The furnace is functional today, but this does not guarantee that the furnace will function properly in the future. A Furnace must be maintained and serviced by a licensed heating and cooling technician each year prior to use. The heat exchanger is not visible during a home inspection, and it is beyond the scope and ability of this home inspector to dismantle a furnace and view a heat exchanger. Therefore, the heat exchanger should be considered not inspected at this time.

Furnaces over 10 years old should be checked, cleaned and serviced yearly by a licensed contractor.

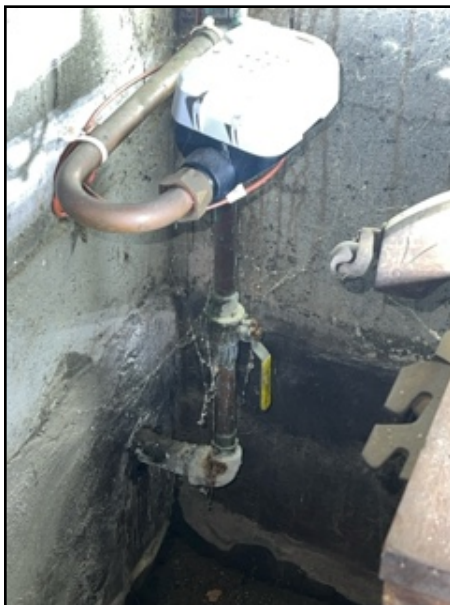
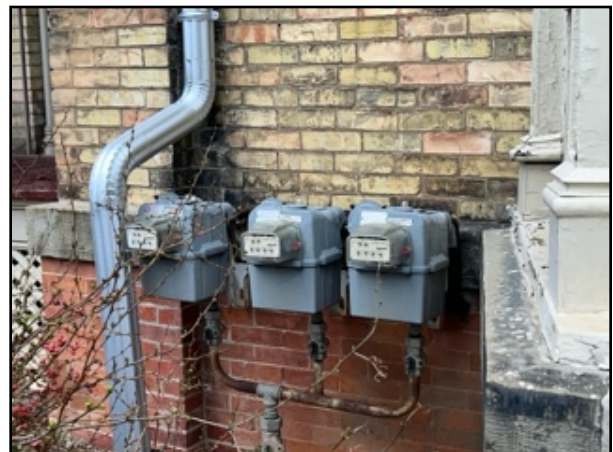
Galvanized supply lines are outdated and no longer used in today's construction. Galvanized piping can corrode from within and reduce water pressure depositing the metal flakes into the water. The pictures are examples of areas with corrosion.

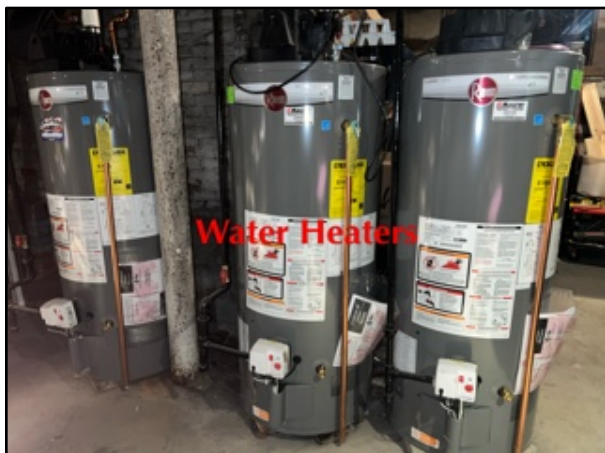
Figure 22-1

Comment 22:
Picture of the three water heaters.

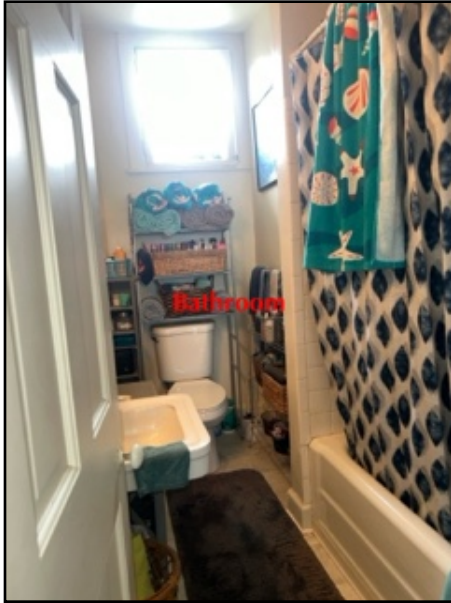
Figure 23-1

Comment 23:
Picture of the bathroom in unit #3 .

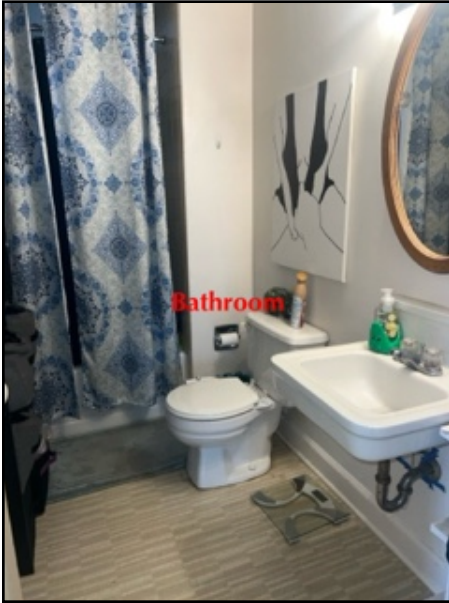
Figure 27-1

Comment 27:
Pictures of the bathroom and unit #2.

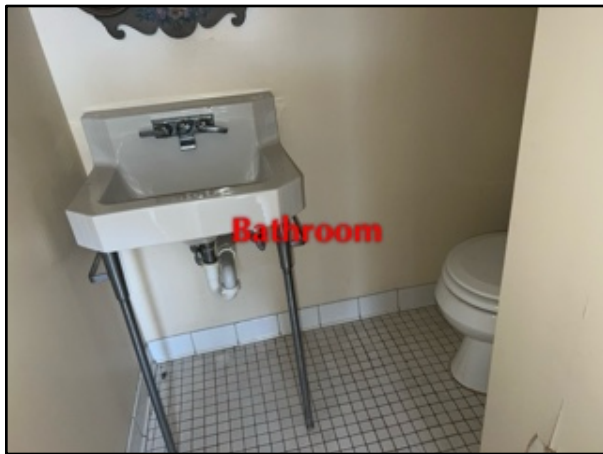
Figure 28-1

Comment 28:
Picture of the bathroom to the first floor area.

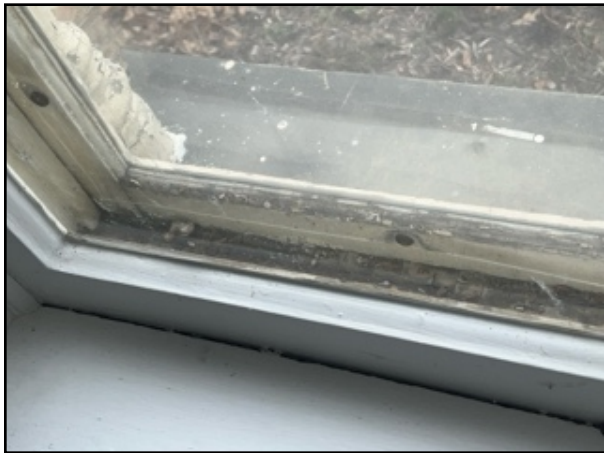
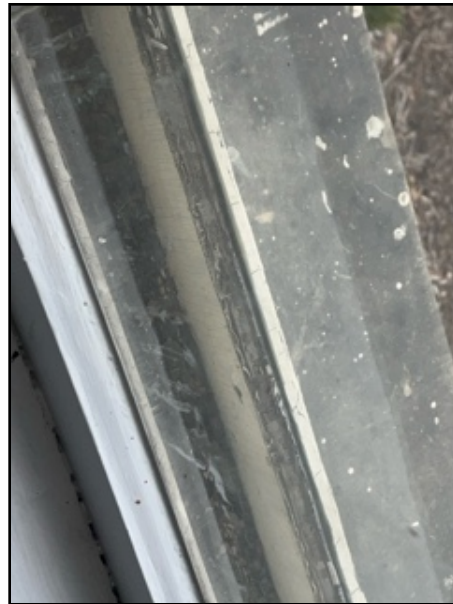
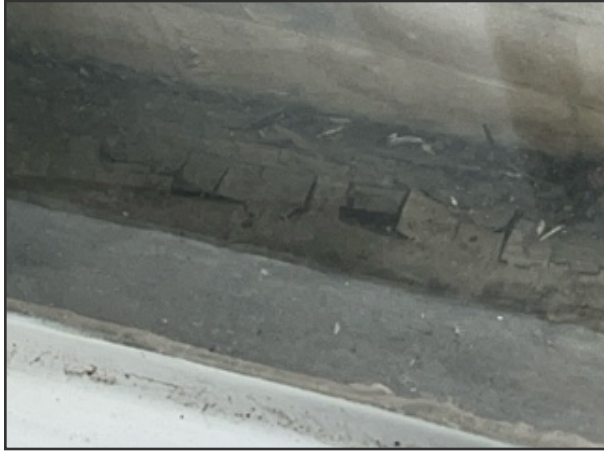
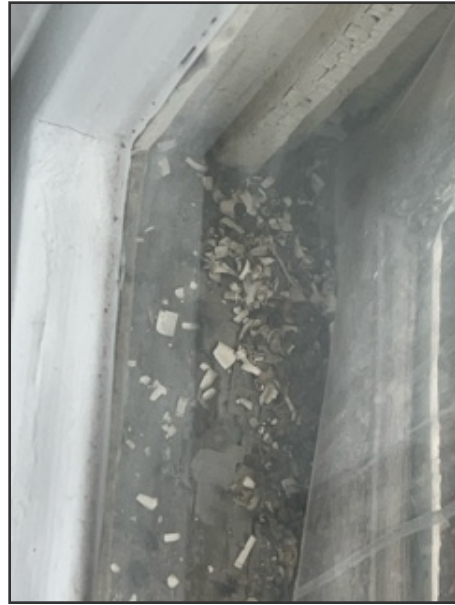
The windows will not open. Peeling paint is present in some windows. The pictures are examples. Are they

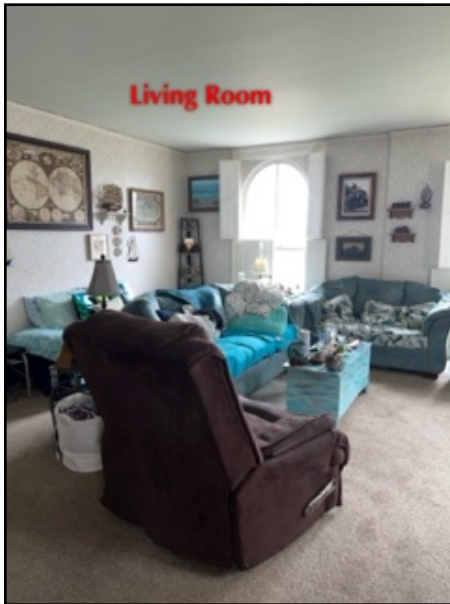
Figure 31-1

Comment 31:
Pictures of the living room unit #3 .

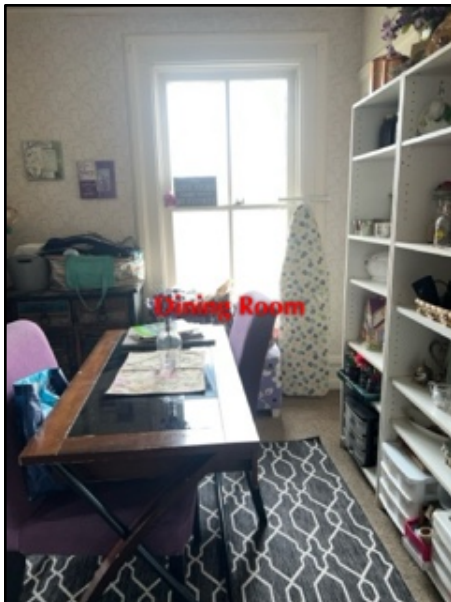
Figure 35-1

Comment 35:
Picture of the dining room in Unit 3.

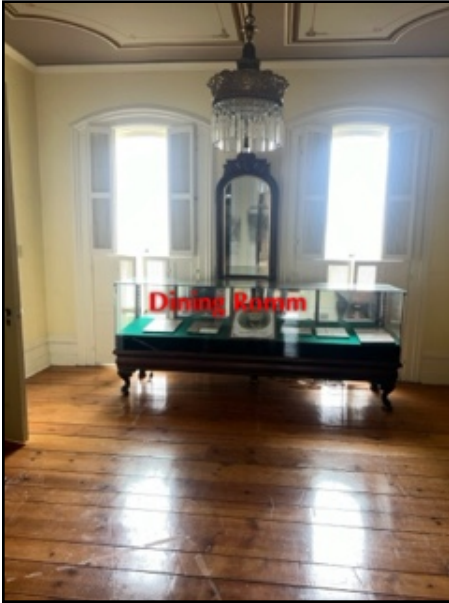
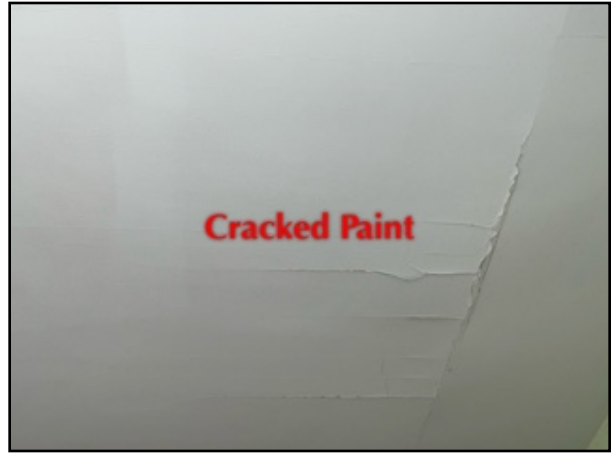
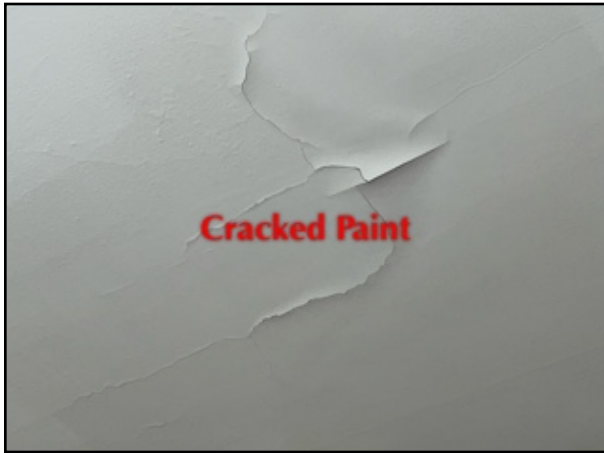
Comment 37:
Picture of the dining room Unit 1.

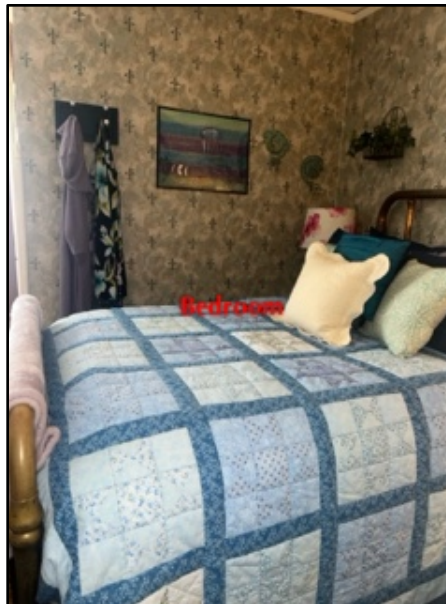
Comment 39:
Unit 3.

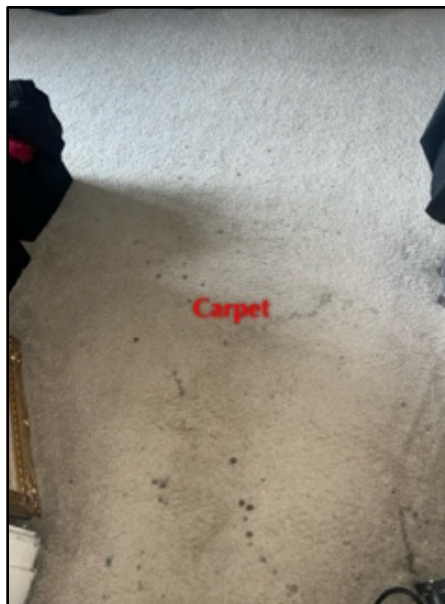
Comment 41:
Unit 2.

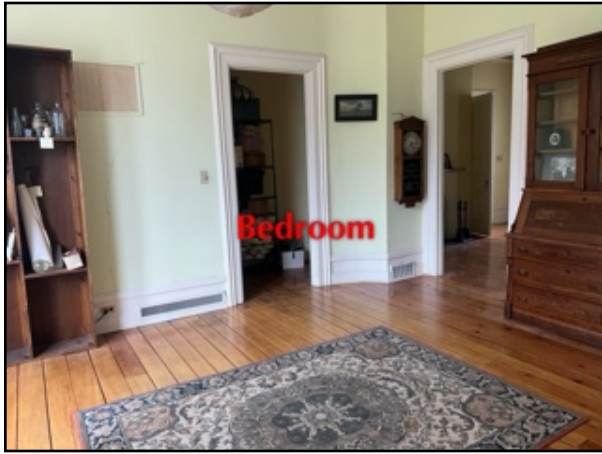
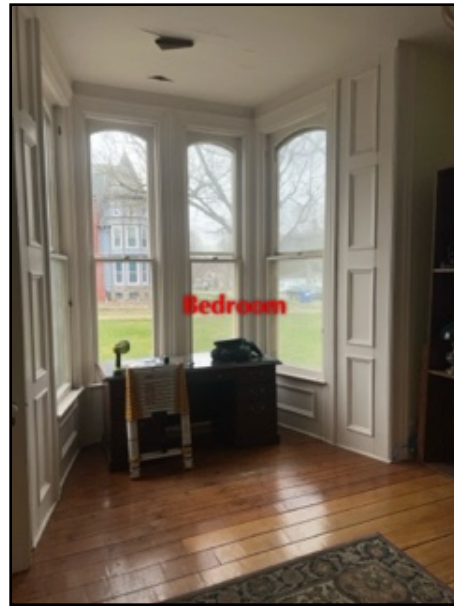
Comment 44:
Unit 1.

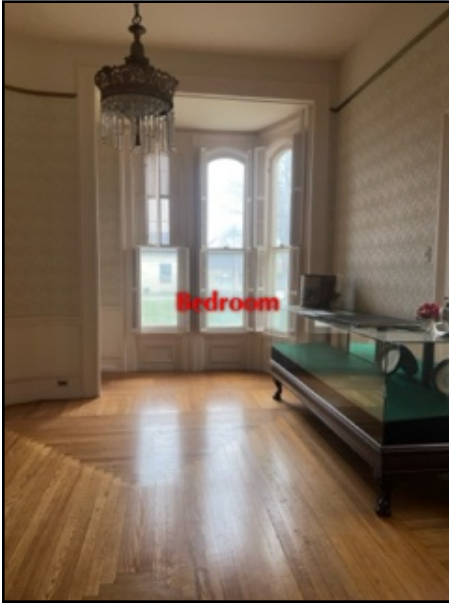
Figure 45-1

Picture of the bedroom in unit number one off the kitchen.

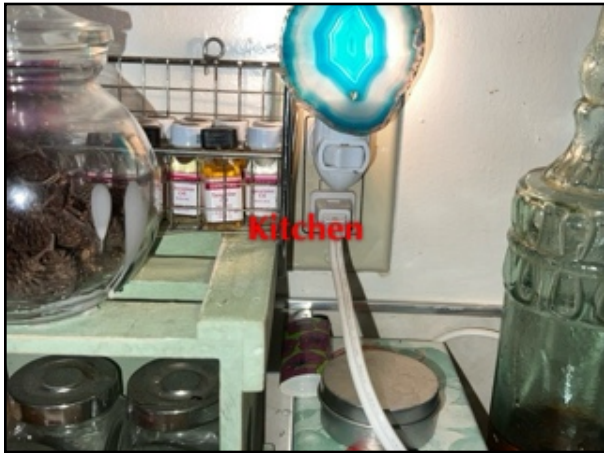
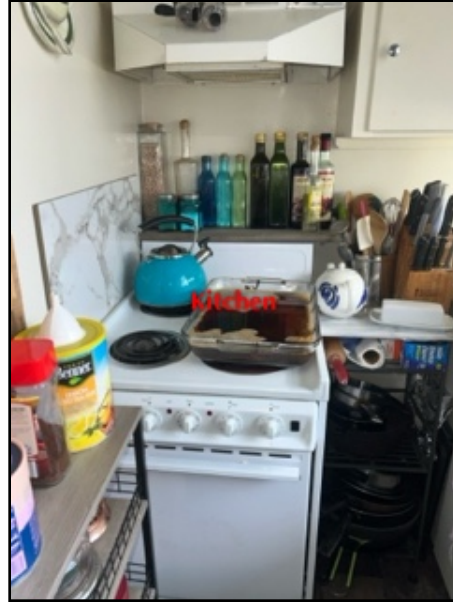
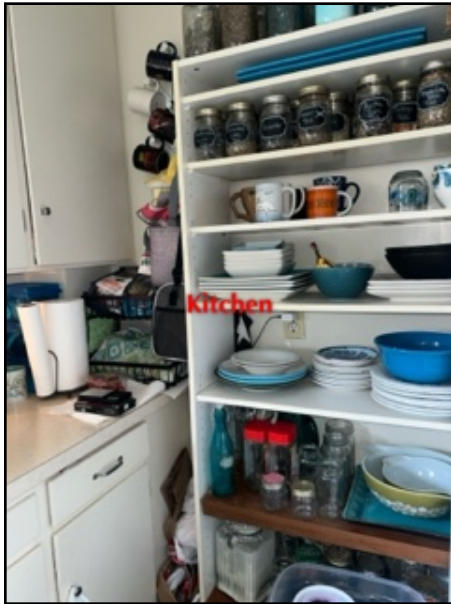
**Comment 46:**
The GFCI outlet shows an open ground and does not trip when tested with a diagnostic tester.

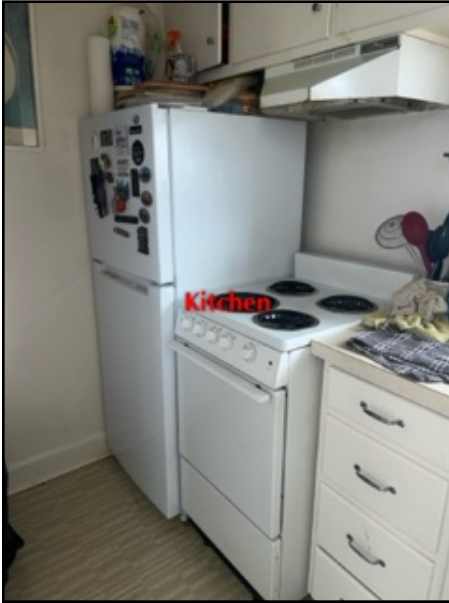
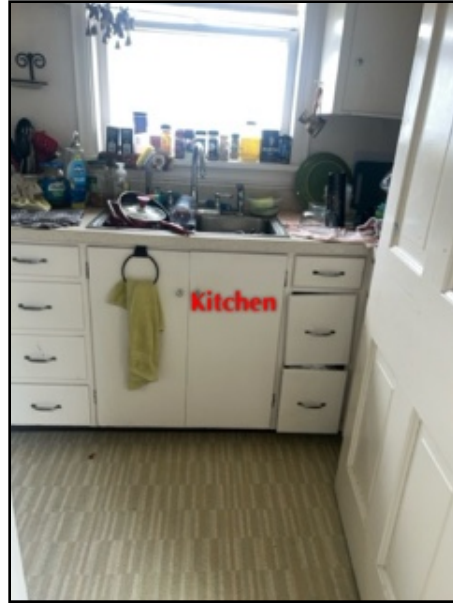
Comment 47:
Unit 2.

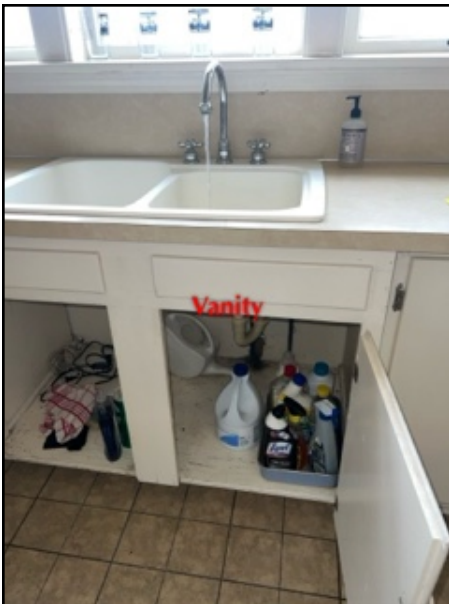
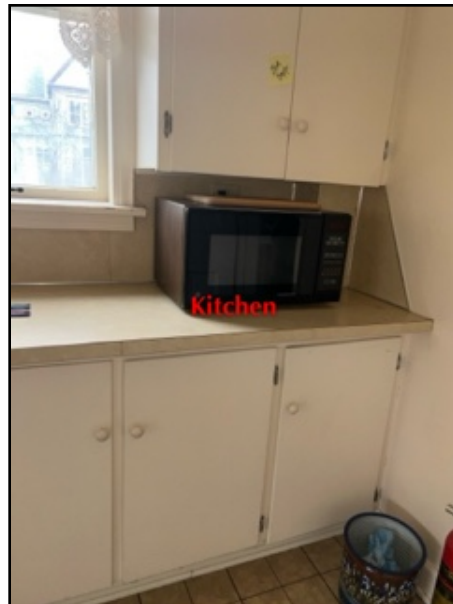
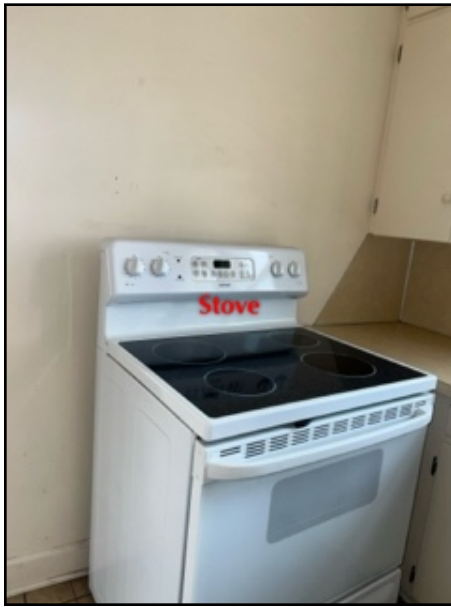
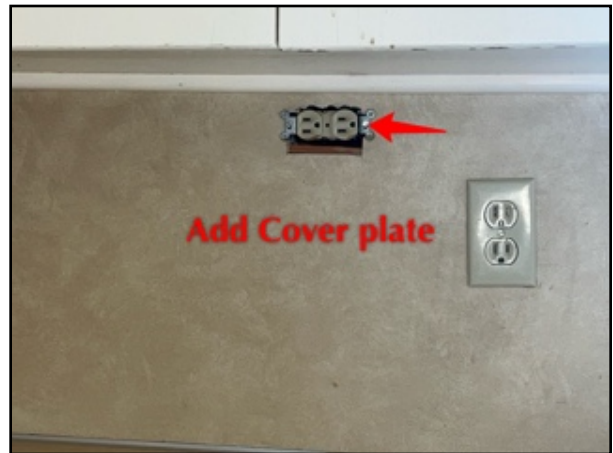
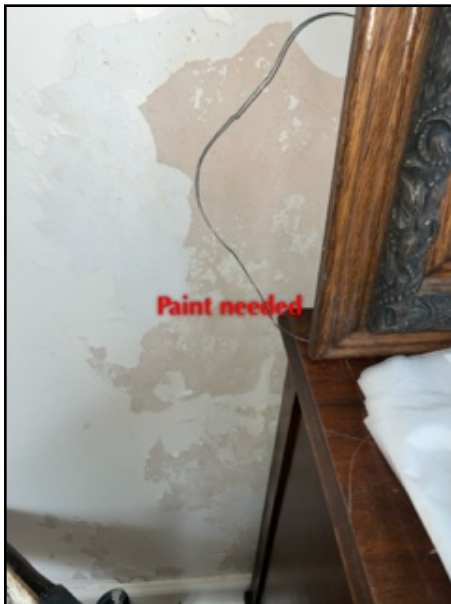
Comment 48:
Unit 1.

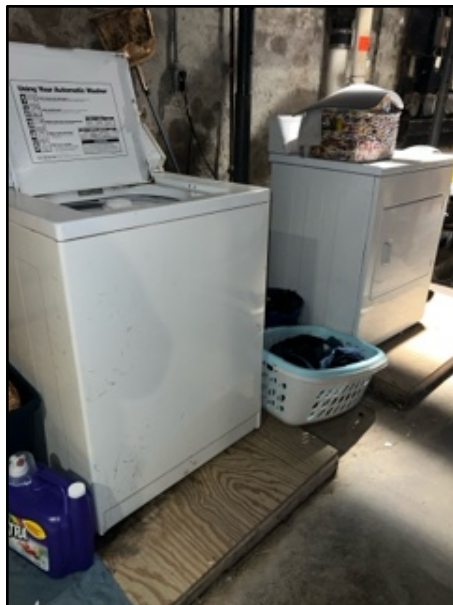
Figure 50-1

Comment 50:
Picture of the laundry area in the basement.

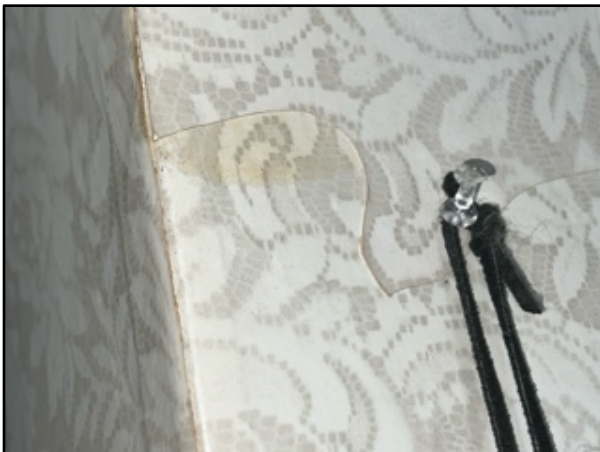
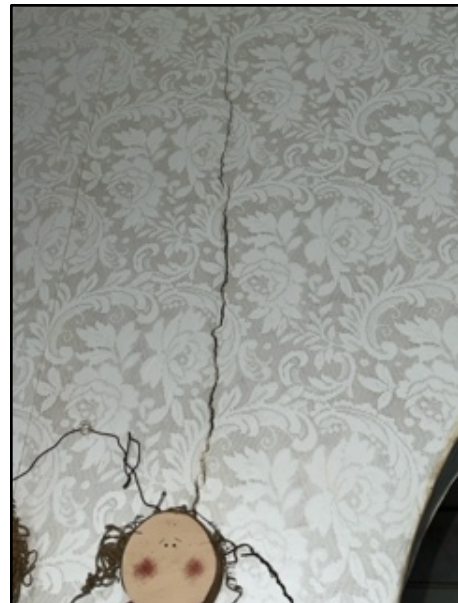
Comment 52:
Unit 3.

Comment 53:
I did notice some common settling cracks in unit number three.

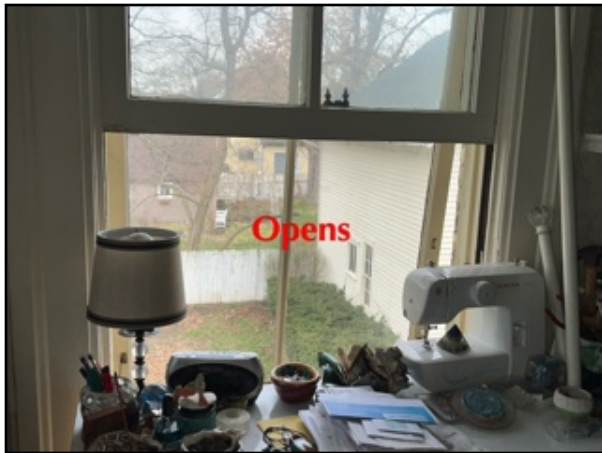
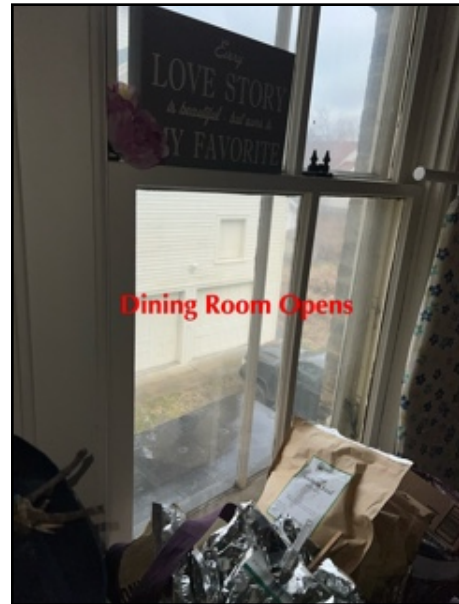
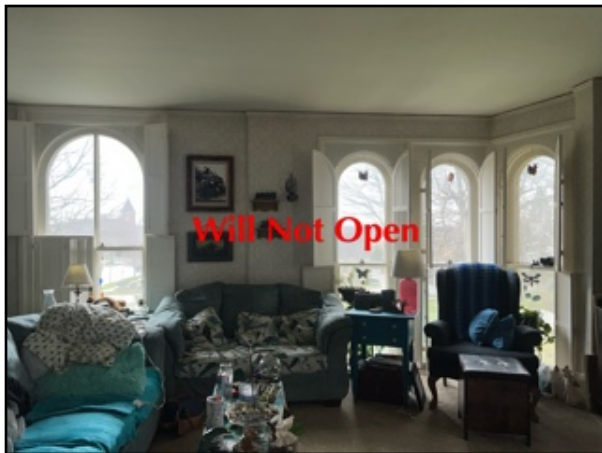
Window Types: Double Hung, Casement
Condition: Repair or Replace

Most of the wood windows do not open in unit 3.

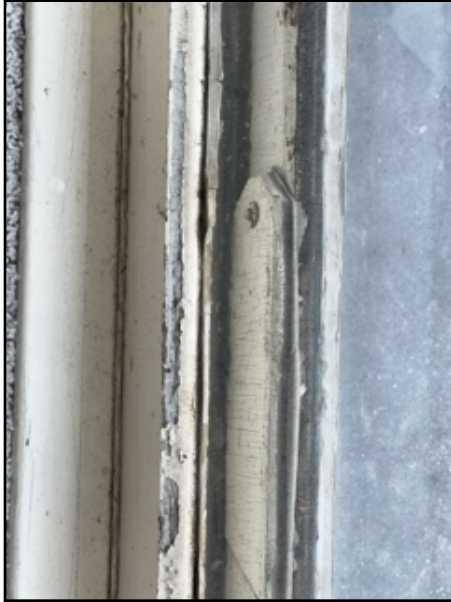
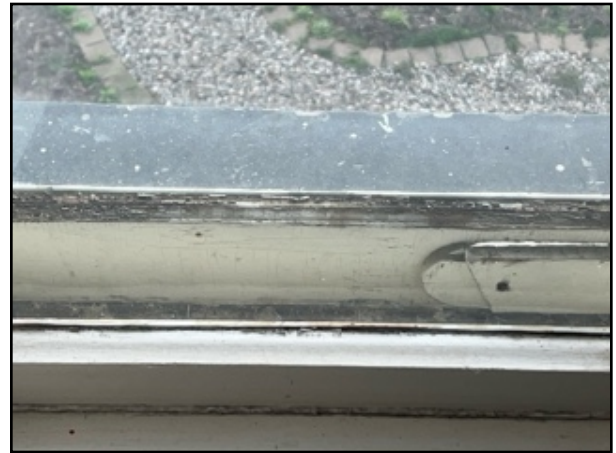
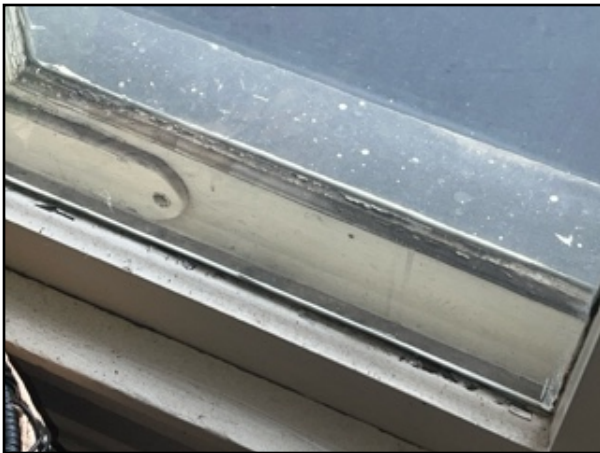
Most of the windows in unit number two will not open and peeling paint is present.

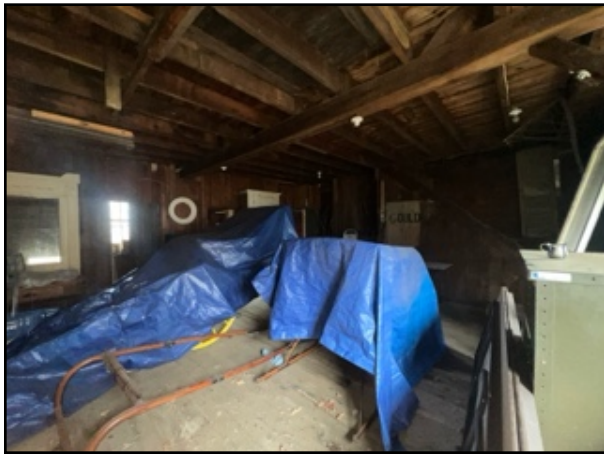
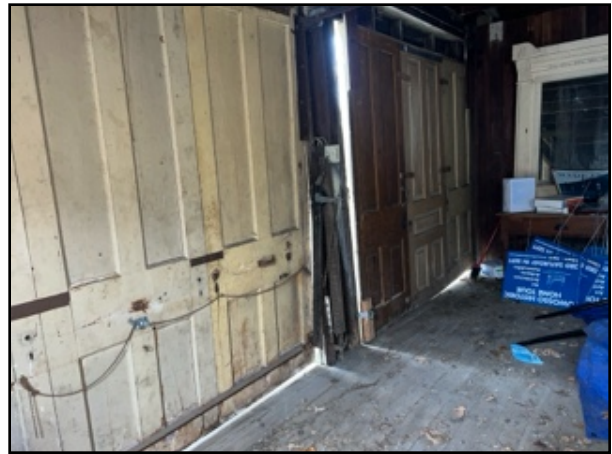
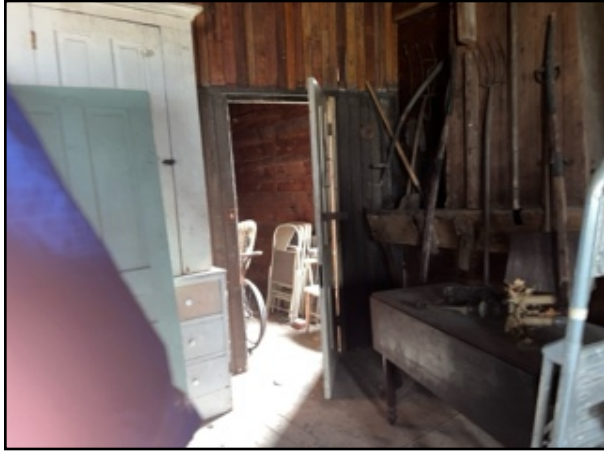
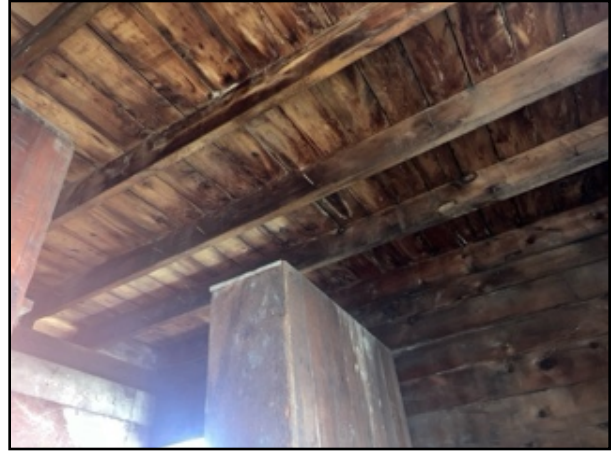
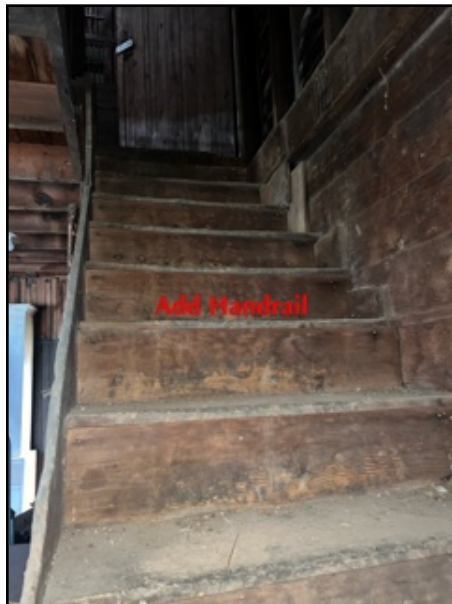
Comment 59:
Interior.

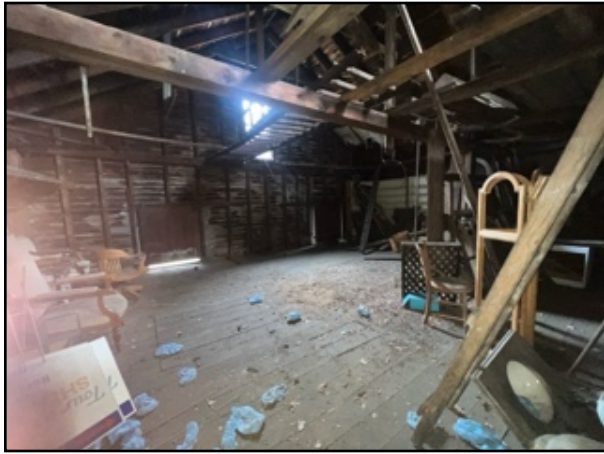
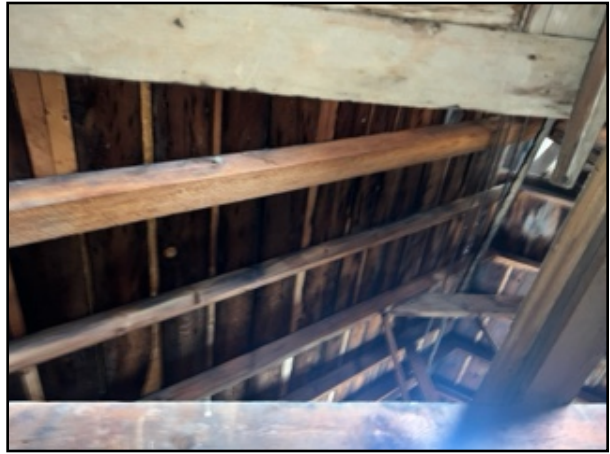
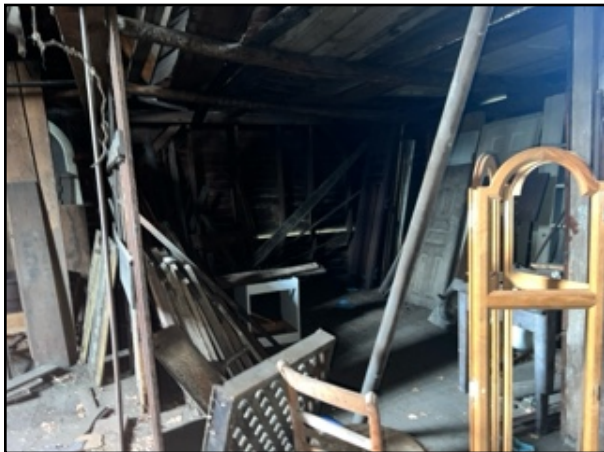
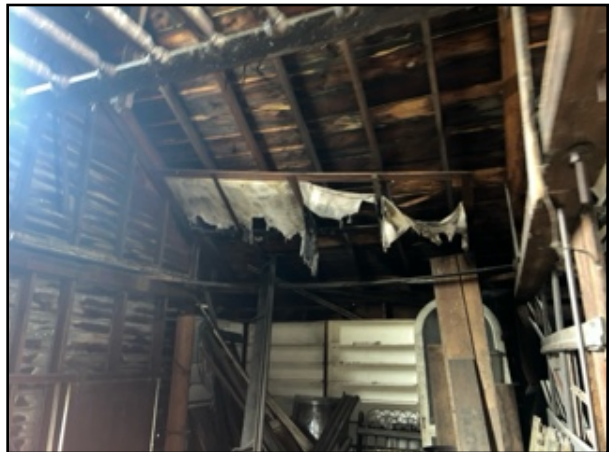
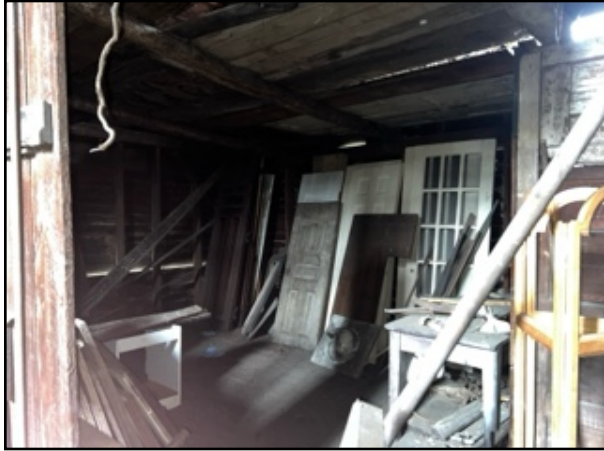
Comment 60:
Second floor.

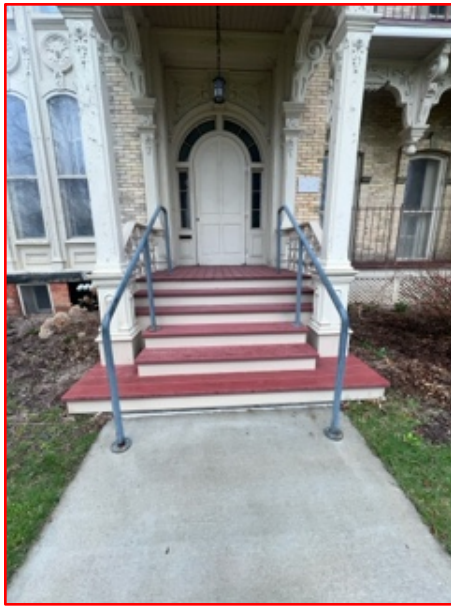
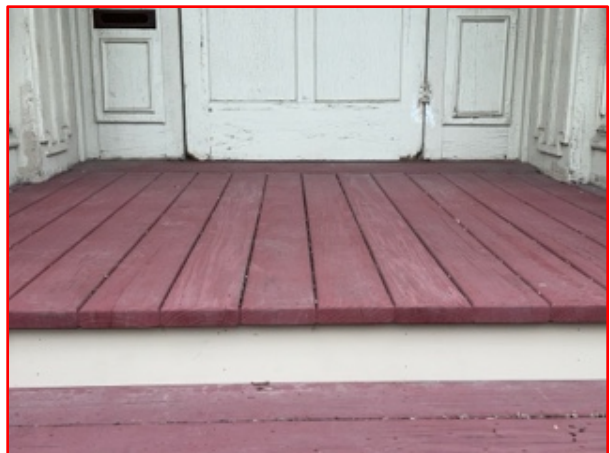
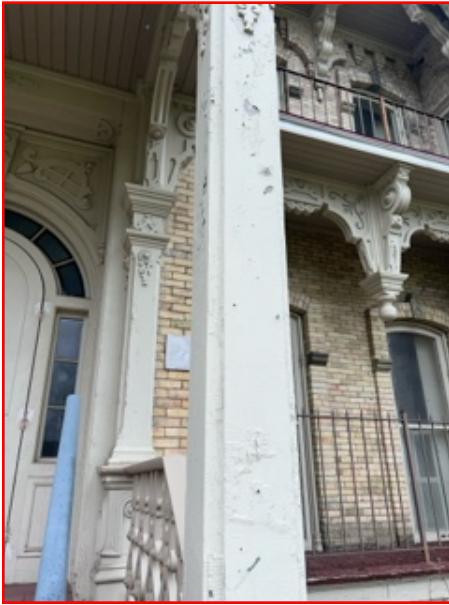
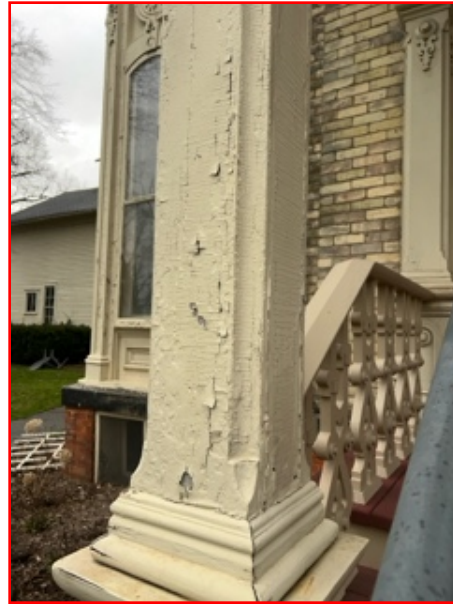
1) Side entry.

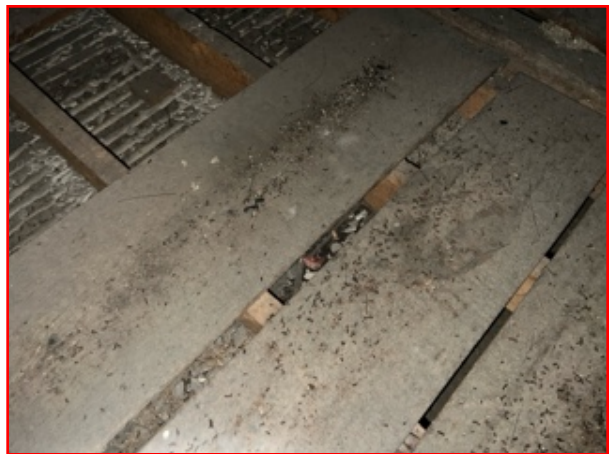
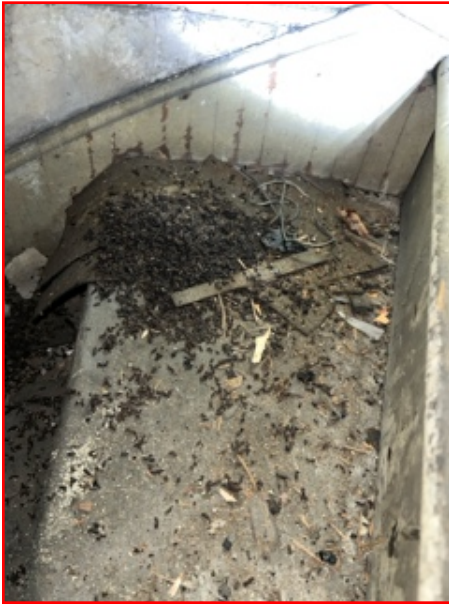
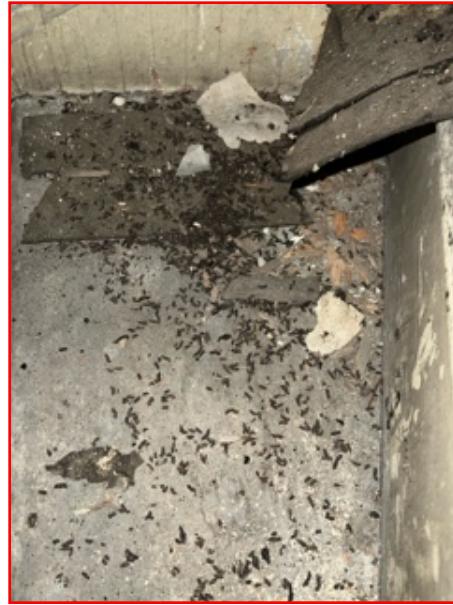
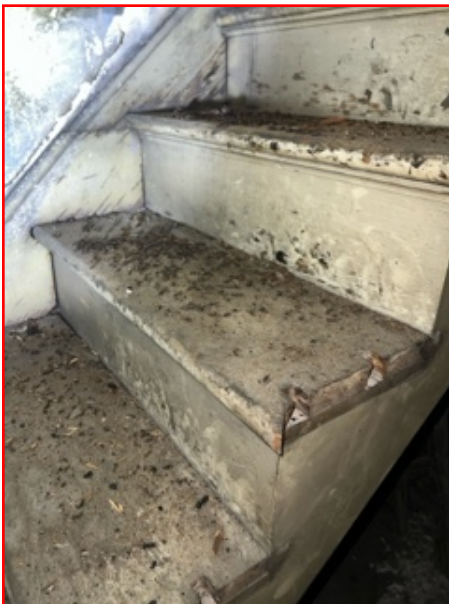
7) Batt guano .

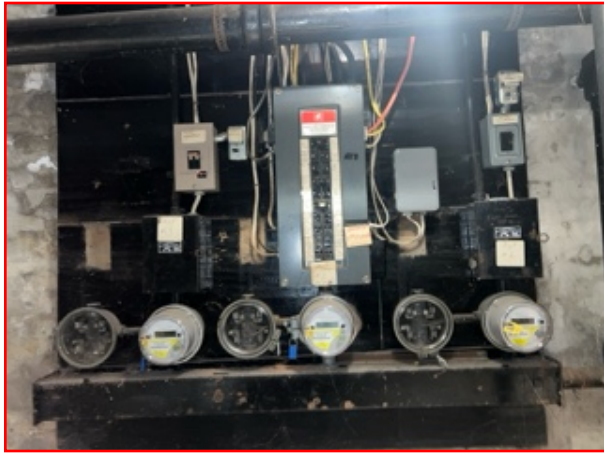
Figure 14-1

12) Picture of the electrical in the basement.

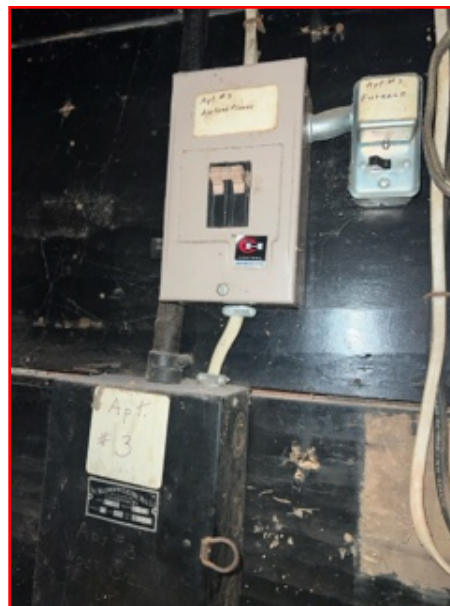
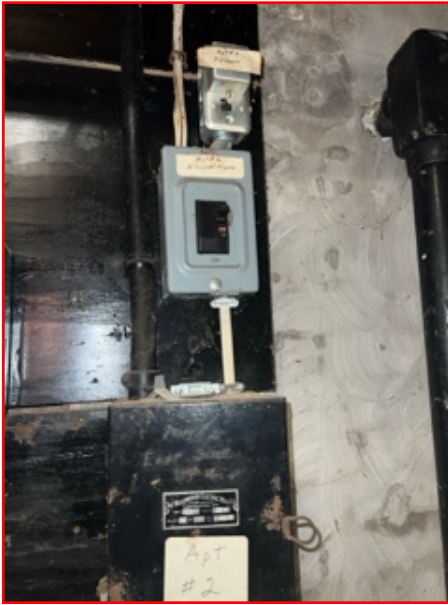
14) Pictures of the sub panels in the basement. Sub panels are used for the air conditioner and units number two and three. Unit number one has the air conditioner powered from the main panel.

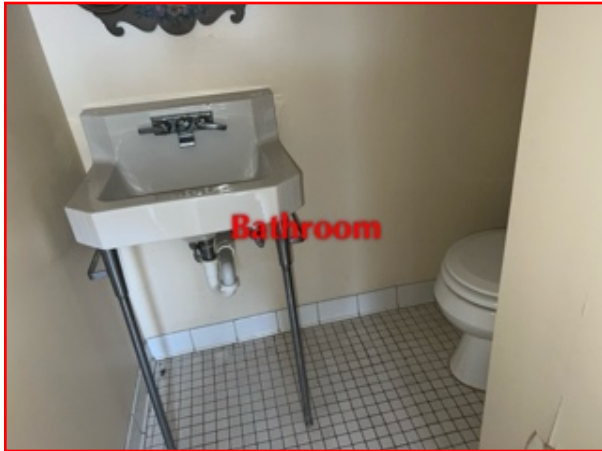
Figure 28-1

18) Picture of the bathroom to the first floor area.

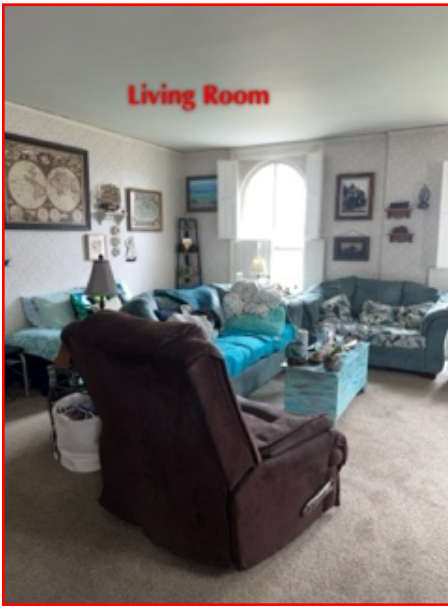
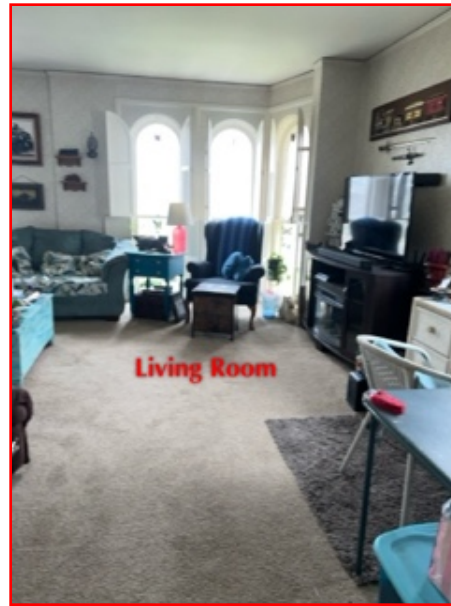
21) Pictures of the living room unit #3 .

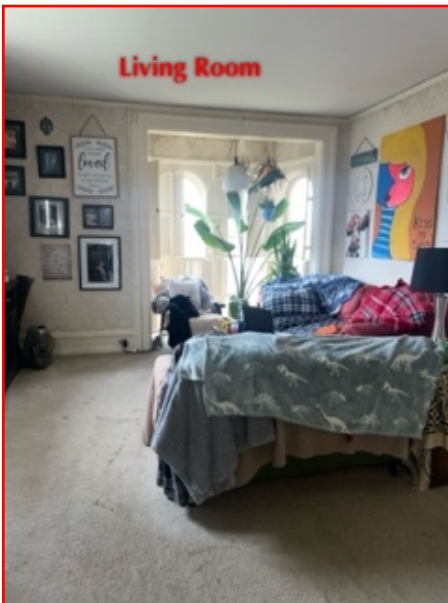
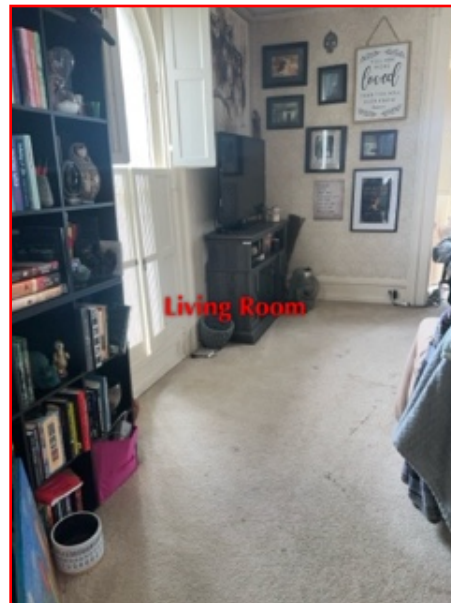
22) Pictures of the living room to Unit 2.

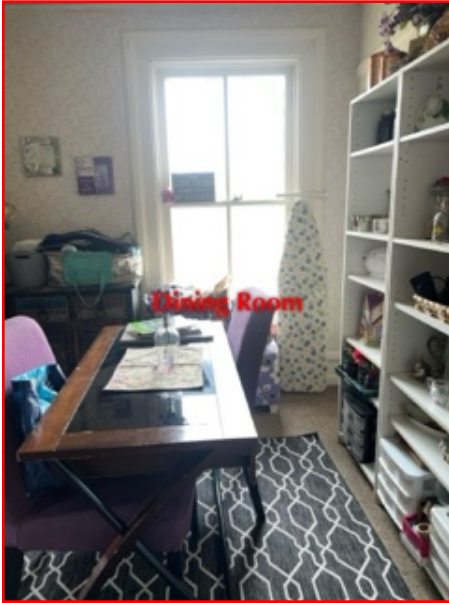
Figure 35-1

25) Picture of the dining room in Unit 3.
