A. GOULD HISTORIC
HOME REPORT

INSPECTION AND ESTIMATE COMPILATION

515 N WASHINGTON, OWOSSO MI 48867

Home Inspection Report

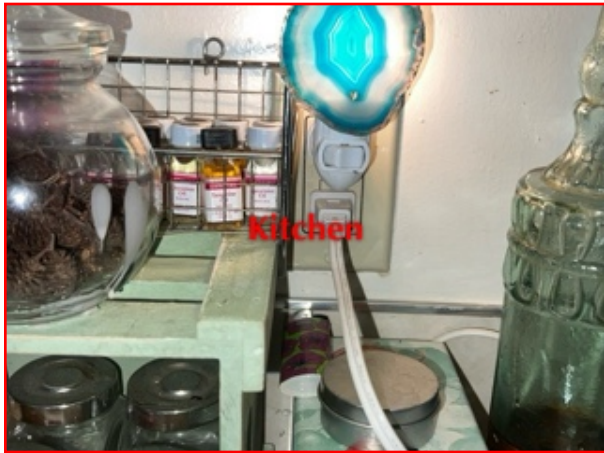
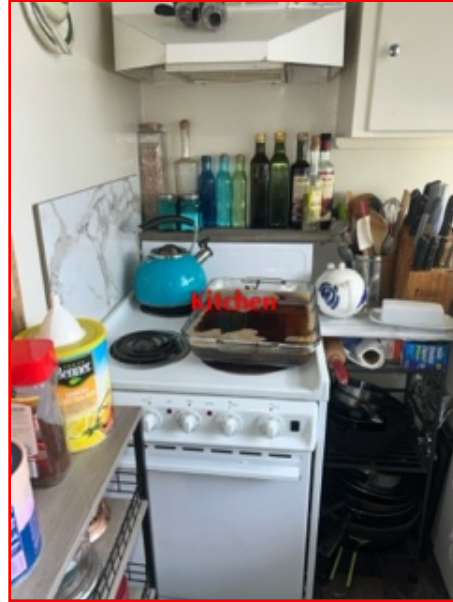
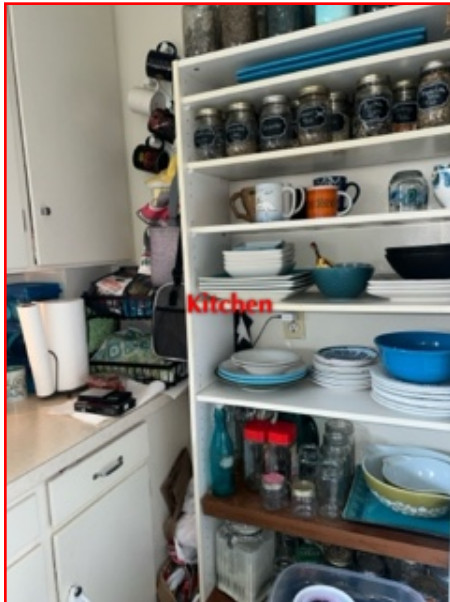
34) The GFCI outlet shows an open ground and does not trip when tested with a diagnostic tester.

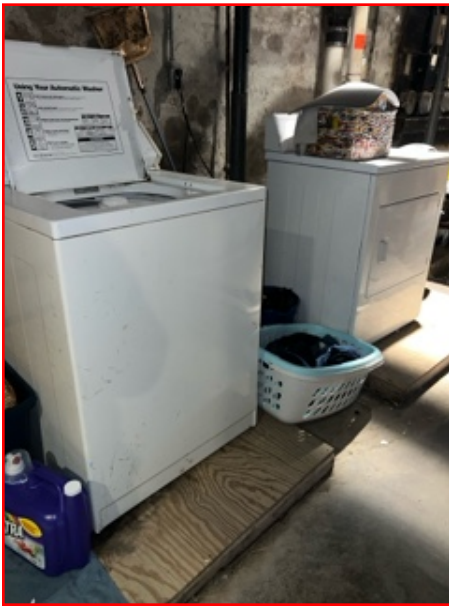
Figure 50-1

37) Picture of the laundry area in the basement.

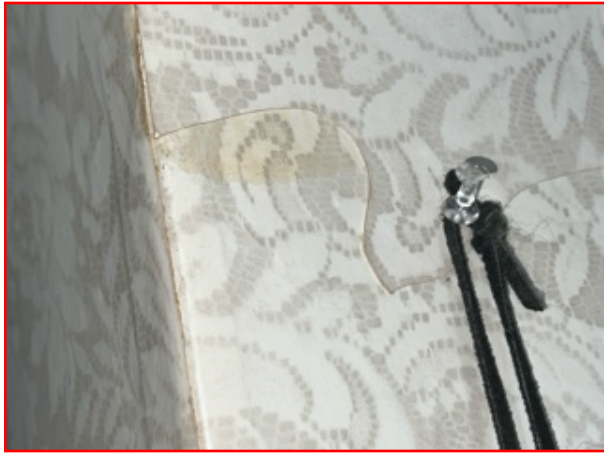
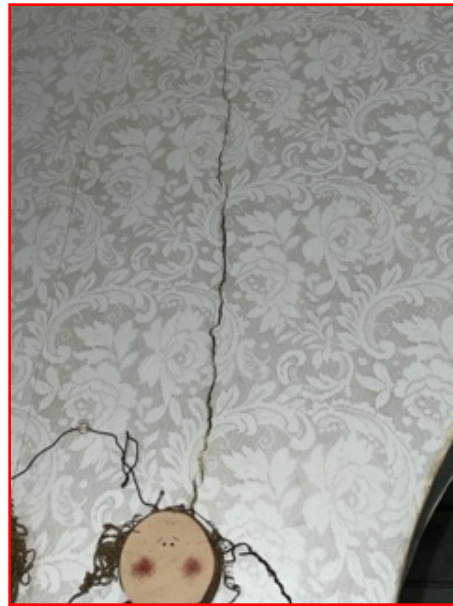
Comment 53:
I did notice some common settling cracks in unit number three.

39) Unit 3.

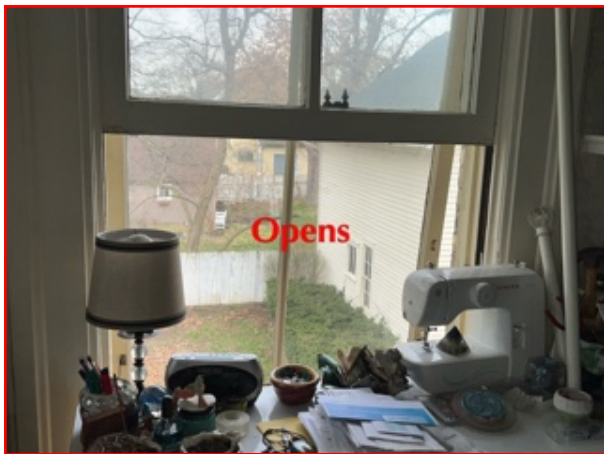
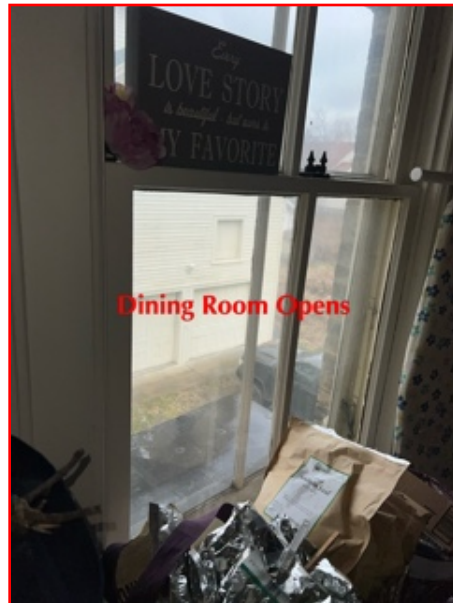
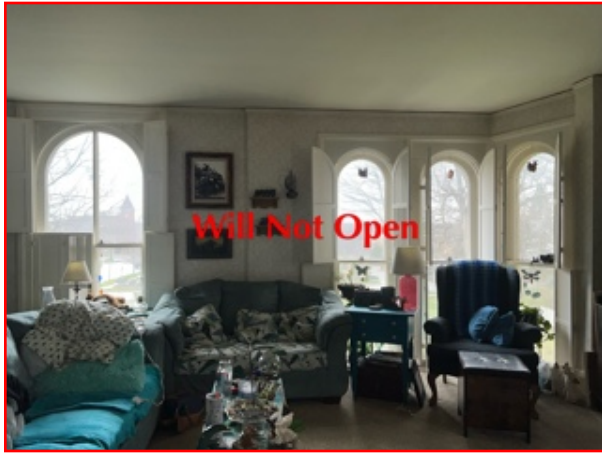
40) Most of the wood windows do not open in unit 3.

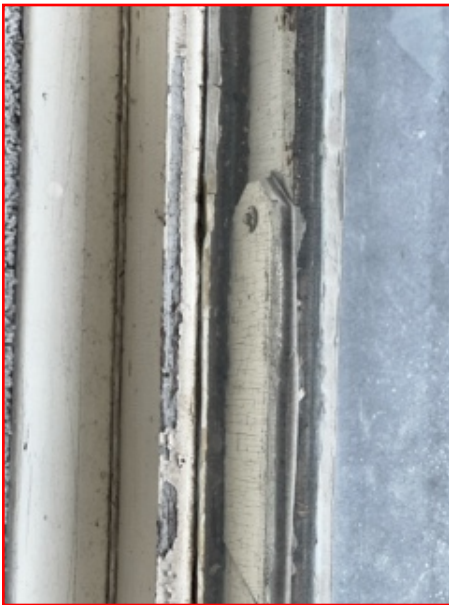
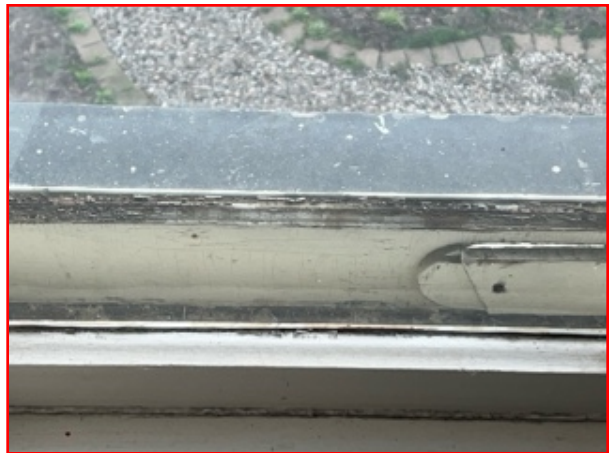
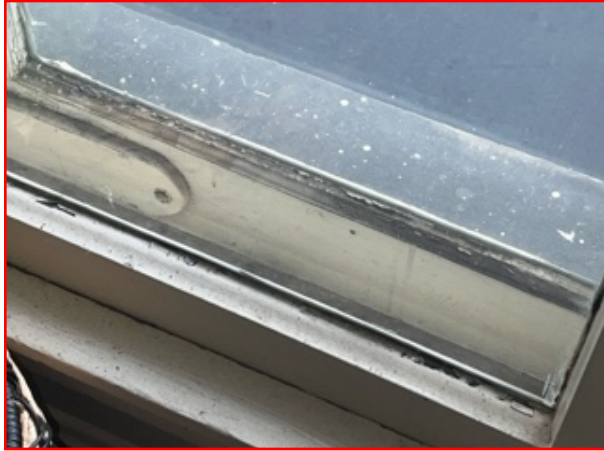
41) Most of the windows in unit number two will not open and peeling paint is present.
