SUBJECT: 21 Day Posting – \$237,000 offer to purchase the Gould House

A. GOULD HISTORIC HOME REPORT

INSPECTION AND ESTIMATE COMPILATION

A. GOULD HOMESTEAD
 FOR SEAN & JANEL HARRINGTON
 515 NORTH WASHINGTON ST
 OWOSSO, MICHIGAN 48867
 APRIL 6, 2024 SHEET 2

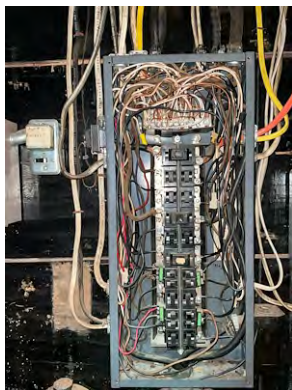
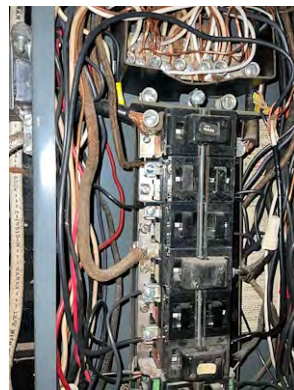
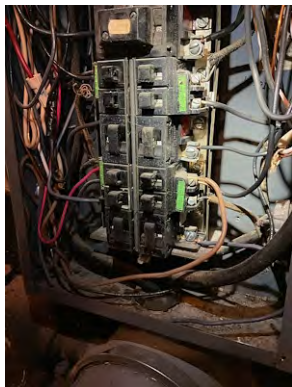
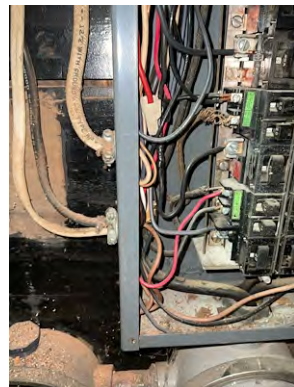
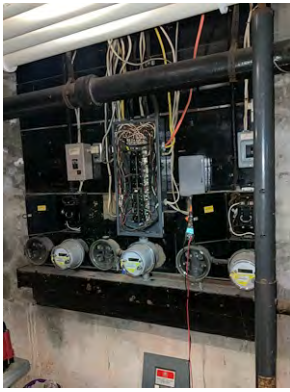
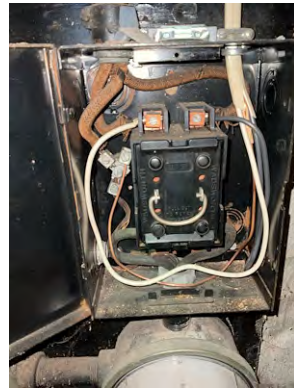
Main panel is an outdated Pushmatic panel. There is double tapping and improper connections throughout panel. There is a basement meter bank that feed disconnects that feed to sub panels. Disconnects are not proper, wiring feeding sub panels was not updated when sub panels were put in, there is double tapping at sub panel disconnects. I did meter all breakers throughout panel with proper voltage being sent out and performed a thermal imaging exam with no signs of overheating. I think that this entire area needs to be gutted with new equipment properly installed. Sub panels will need refer with 4 wire, current wire is original. Drain pipe directly above panel, plumber was on site and I did speak to him about moving pipe.

Could not get to sub panels.

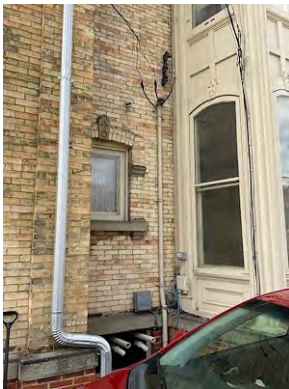
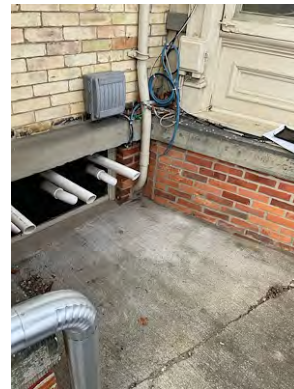
Meter Socket

In basement, all service equipment appears to be original to home. These meters should be outside of home and accessible to power company.

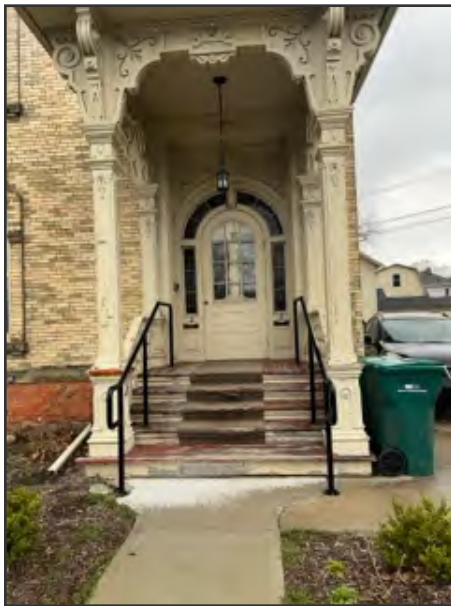
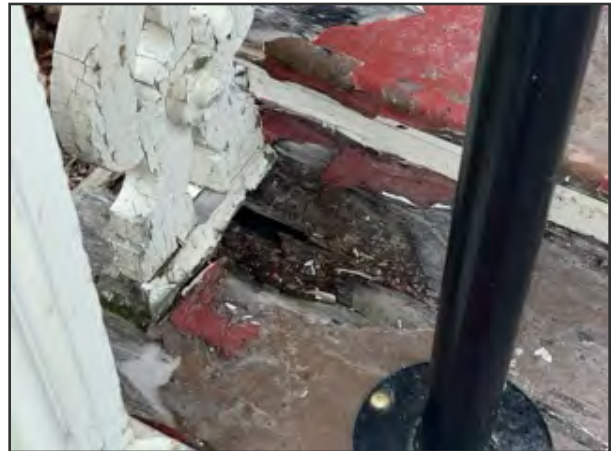
Patios/Decks:

Wood

Condition: Repair or Replace

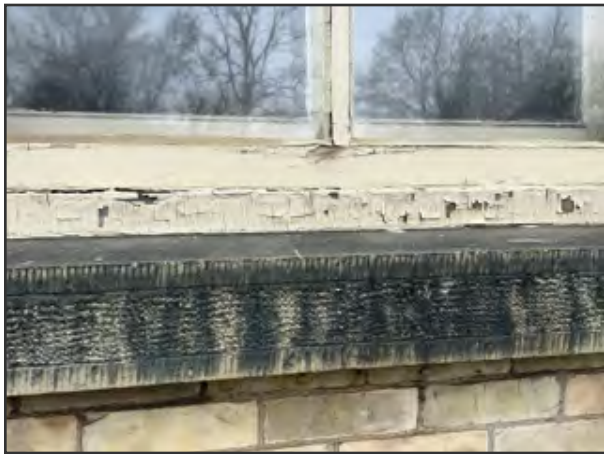
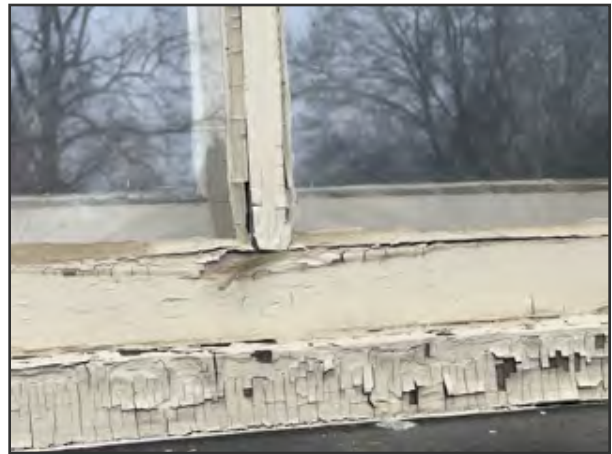
Exterior Trim Material:

Wood

Condition: Further Evaluation Required

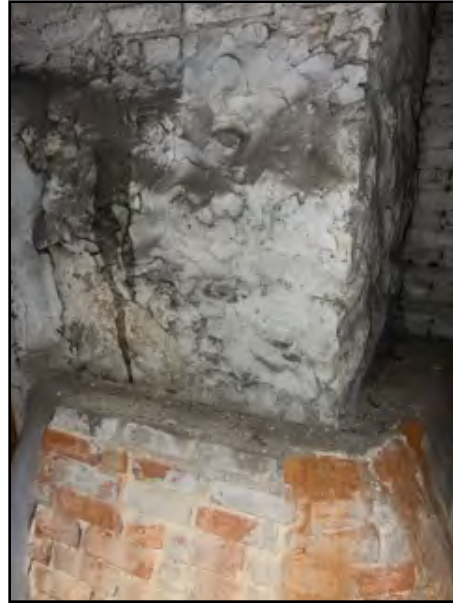
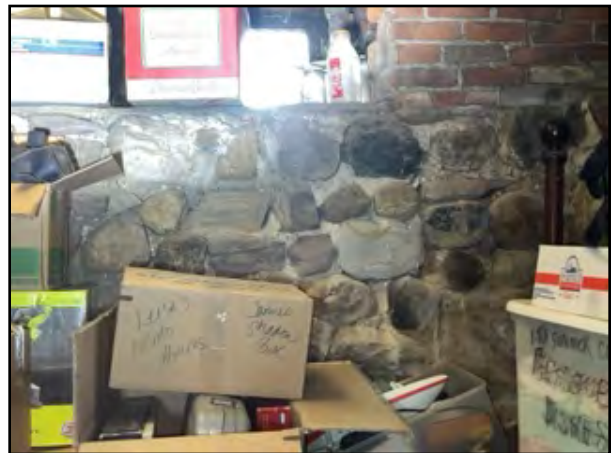
Foundation Material:

Concrete Block, Stone, Brick
Condition: Satisfactory

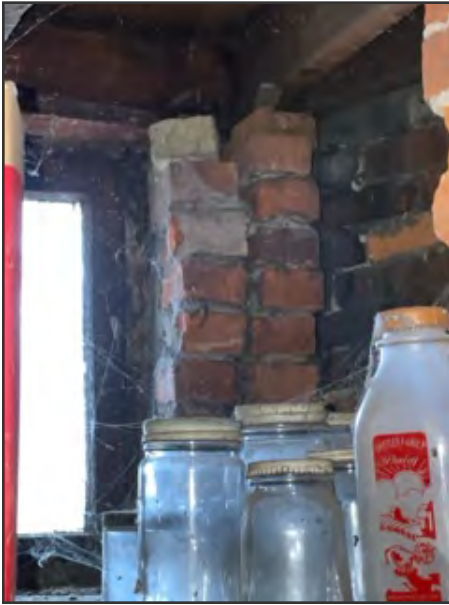
Signs of Water Penetration:

Dampness, Stains, Water
Condition: Repair or Replace

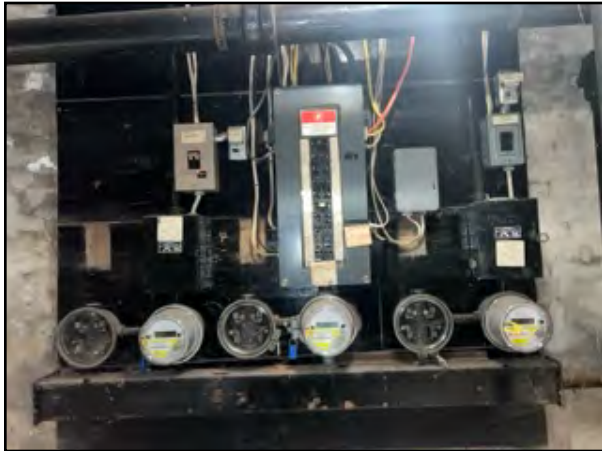
Figure 14-1

A pushmatic Panel is present. This is a panel that was used primarily between the 1950s and early 1980s. Unlike today's panels it does not operate from left to right. It pushes inward. A significant safety issue is the spring located behind the breaker. Over the years it can become corroded, rusted and brittle. This can result in the breaker not tripping if needed or if tripped by hand the circuit may not reset and remain with no power. Replacement parts are almost impossible to find and there are parts that are labeled pushmatic compatible. However these parts are not approved under the electrical code. Pushmatic breakers use a thermal design mechanism to trip the breakers and current breakers use a thermal and magnetic mechanism to trip the breakers which is safe and reliable. A licensed electrician will be needed to upgrade the electrical panel to meet current standards for safety.

Comment 14:
Picture of the electrical in the basement.

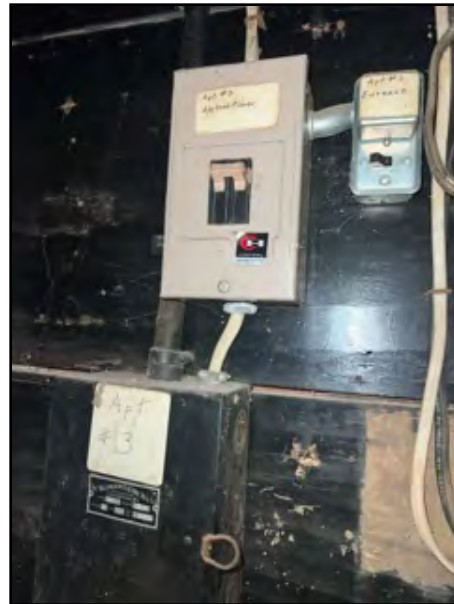
Figure 16-2

Comment 16:
Pictures of the sub panels in the basement. Sub panels are used for the air conditioner and units number two and three. Unit number one has the air conditioner powered from the main panel.

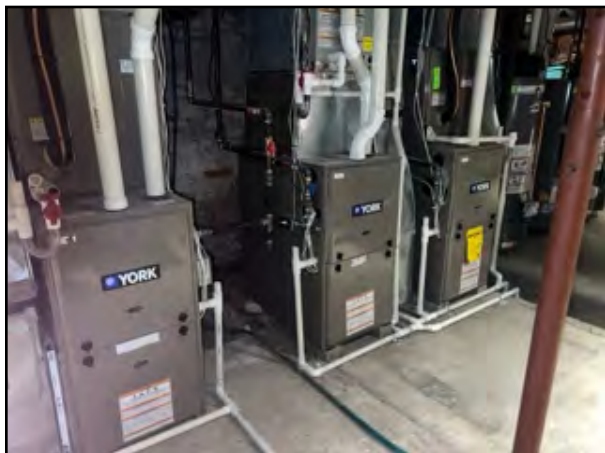
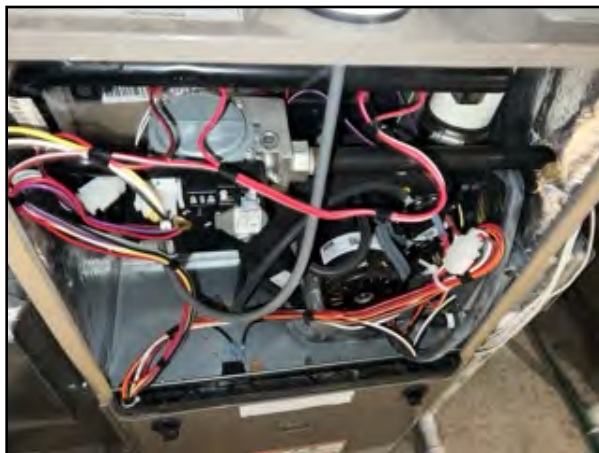
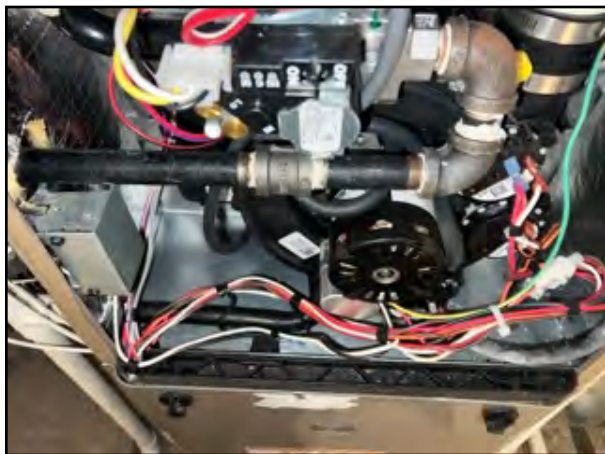
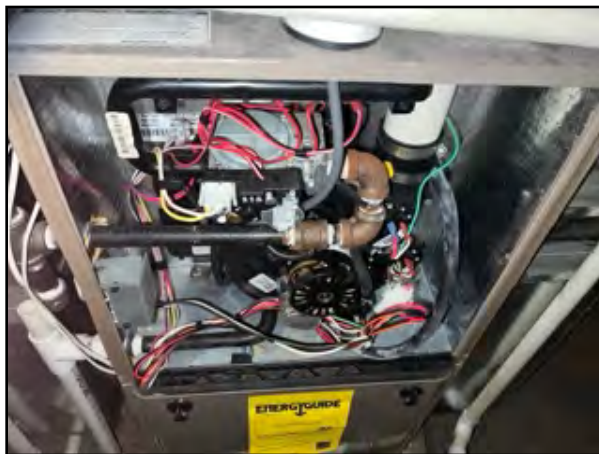
Pictures of the three furnaces. The furnaces operate at this time. The furnace is functional today, but this does not guarantee that the furnace will function properly in the future. A Furnace must be maintained and serviced by a licensed heating and cooling technician each year prior to use. The heat exchanger is not visible during a home inspection, and it is beyond the scope and ability of this home inspector to dismantle a furnace and view a heat exchanger. Therefore, the heat exchanger should be considered not inspected at this time.

Furnaces over 10 years old should be checked, cleaned and serviced yearly by a licensed contractor.

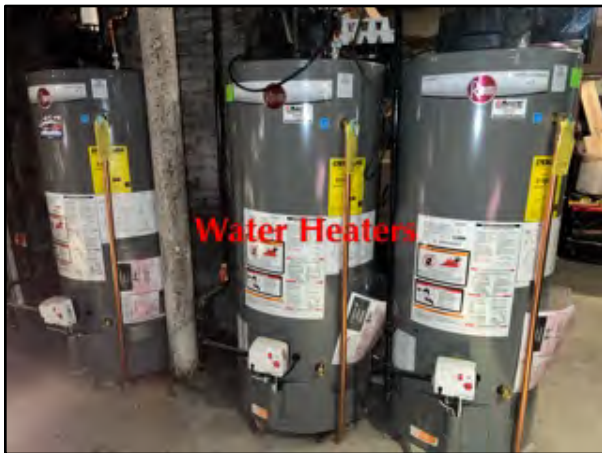
Figure 22-1

Comment 22:
Picture of the three water heaters.

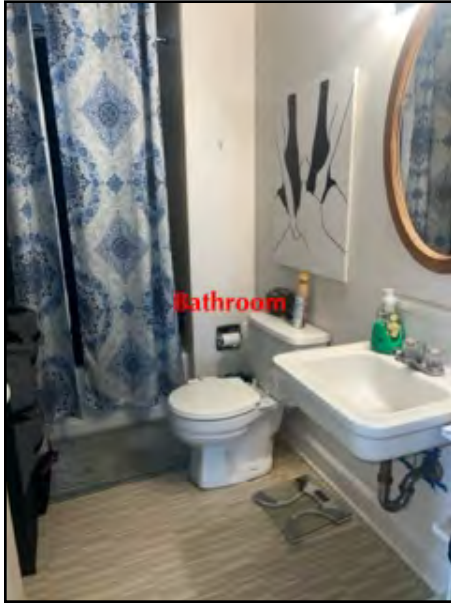
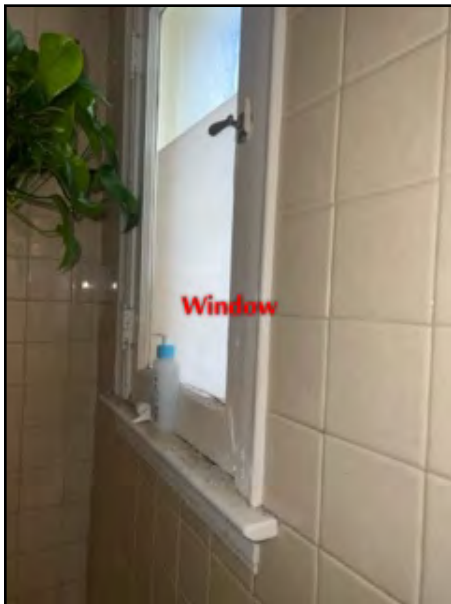
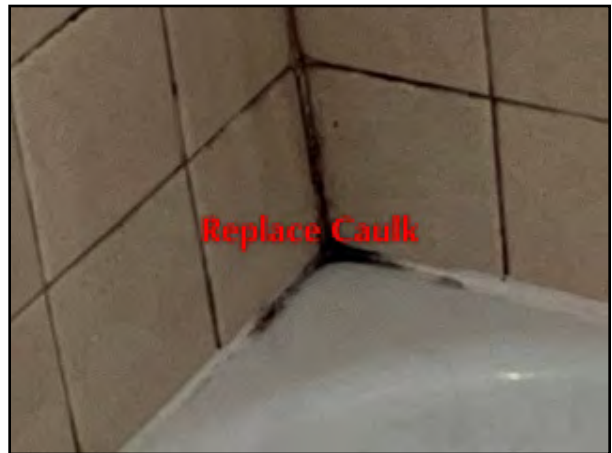
Comment 27:
Pictures of the bathroom and unit #2.

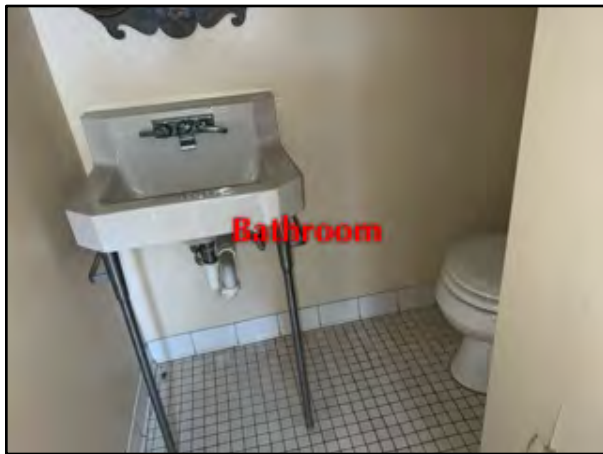
Figure 28-1

Comment 28:
Picture of the bathroom to the first floor area.

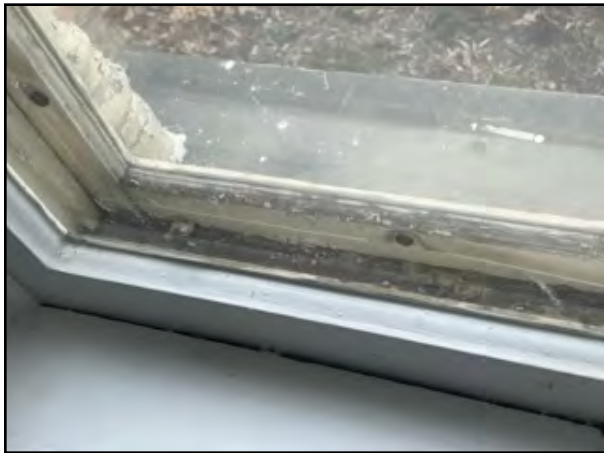
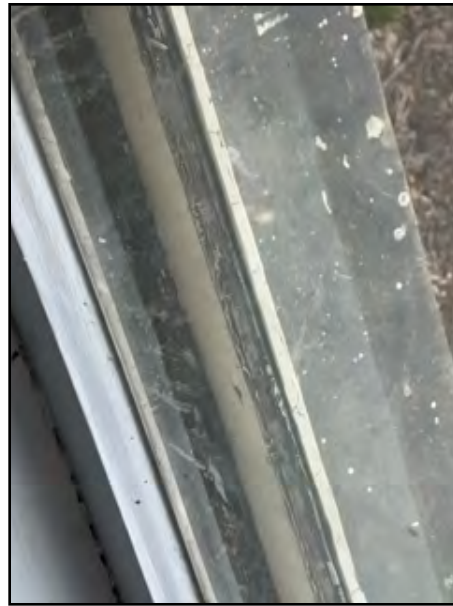
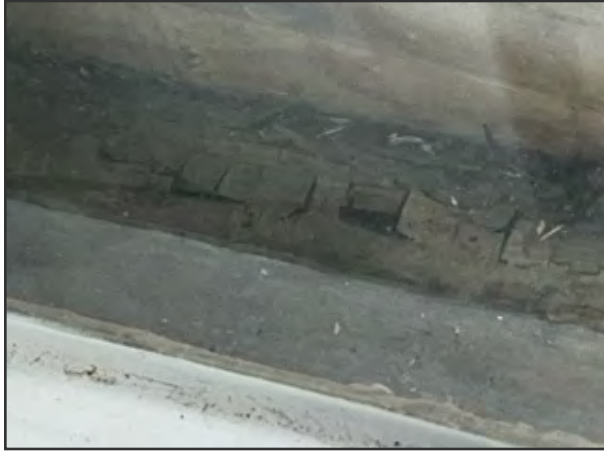
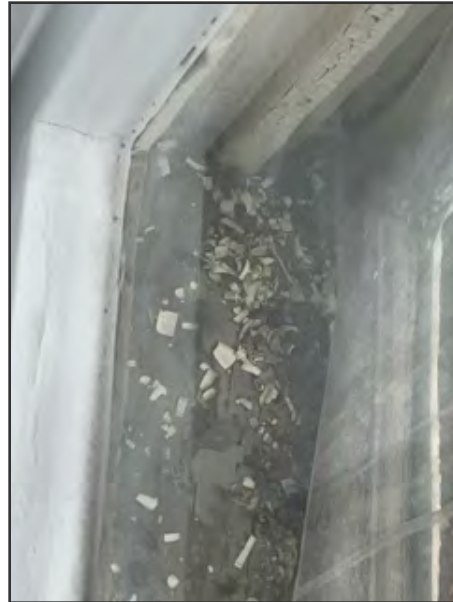
Windows: Double Hung
Condition: Repair or Replace

The windows will not open. Peeling paint is present in some windows. The pictures are examples. Are they

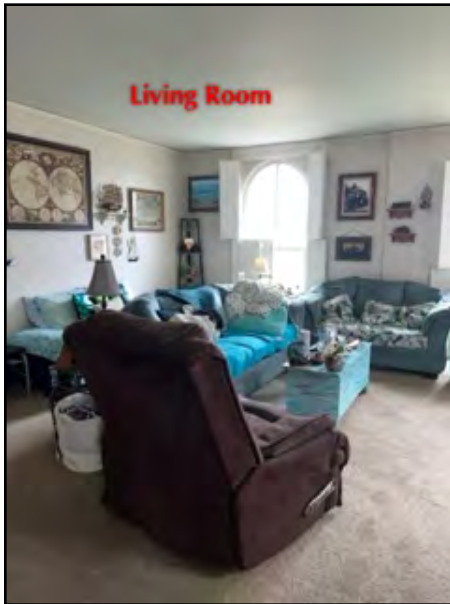
Figure 31-1

Comment 31:
Pictures of the living room unit #3 .

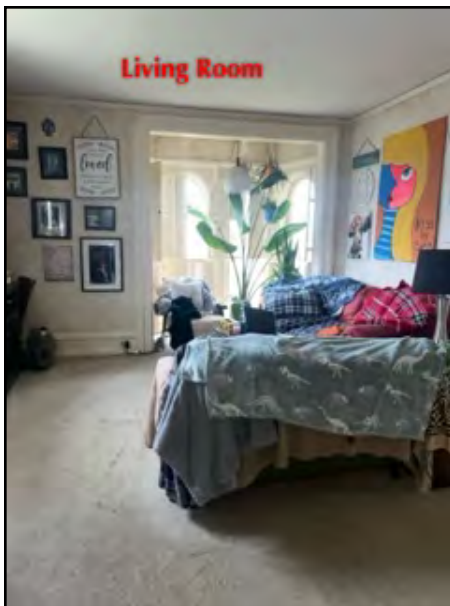
Figure 32-1

Comment 32:
Pictures of the living room to Unit 2.

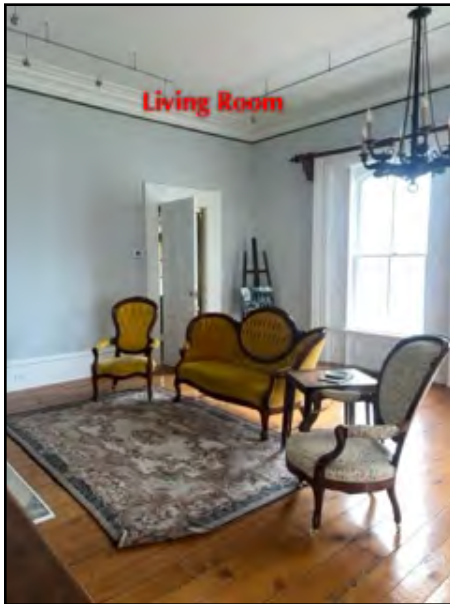
Figure 33-1

Comment 33:
Pictures of the living room To Unit 1.

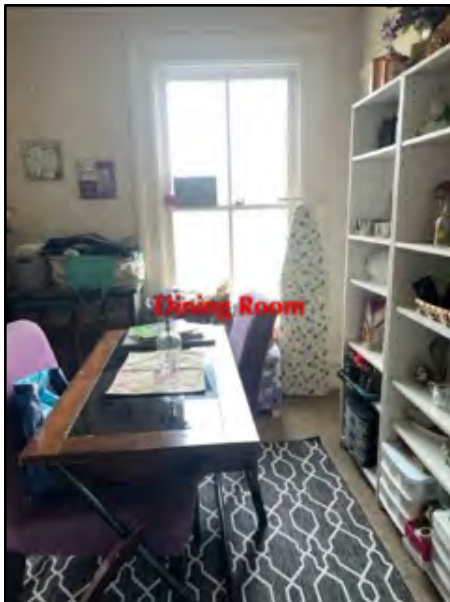
Figure 35-1

Comment 35:
Picture of the dining room in Unit 3.

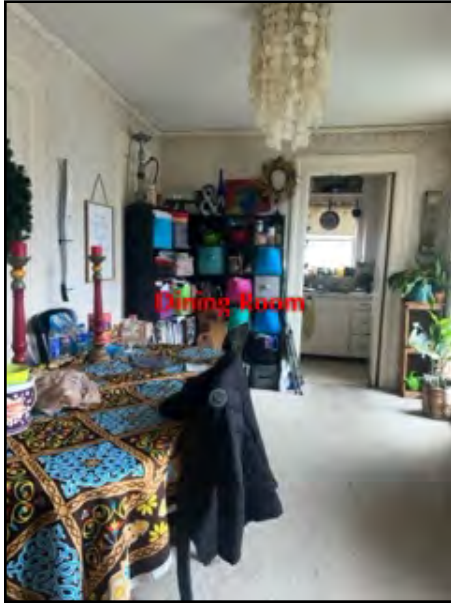
Figure 36-1

Comment 36:
Picture of the dining room Unit 2.

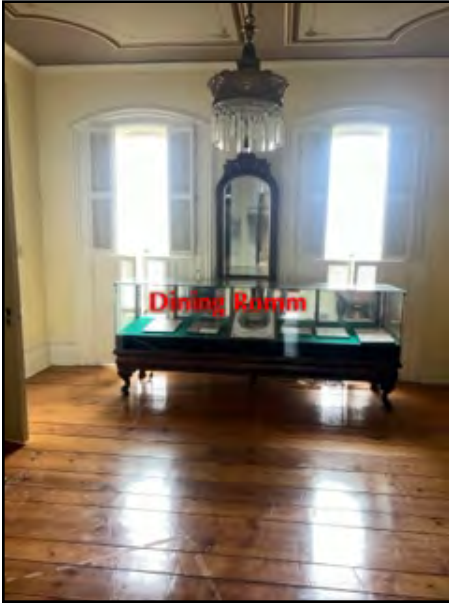
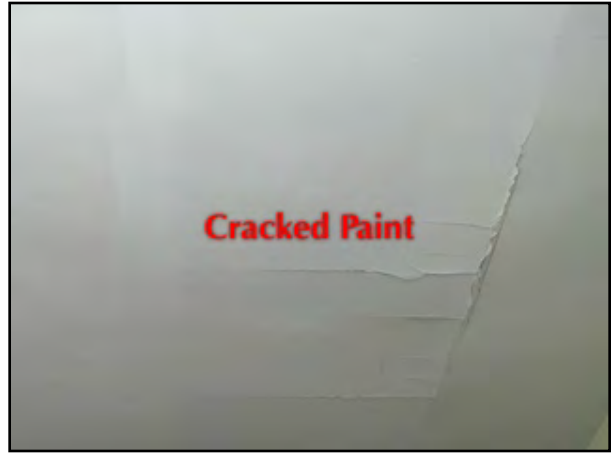
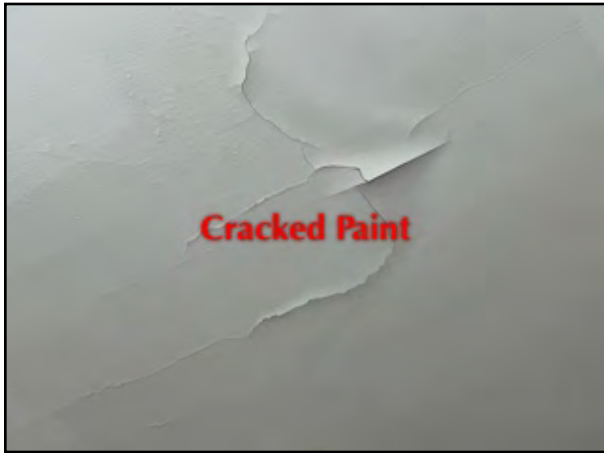
Comment 37:
Picture of the dining room Unit 1.

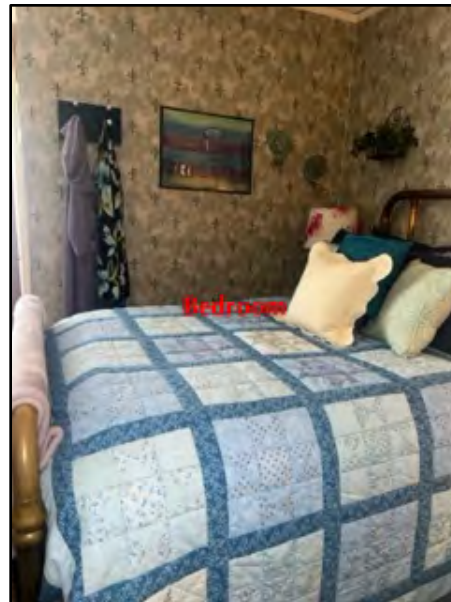
Comment 39:
Unit 3.

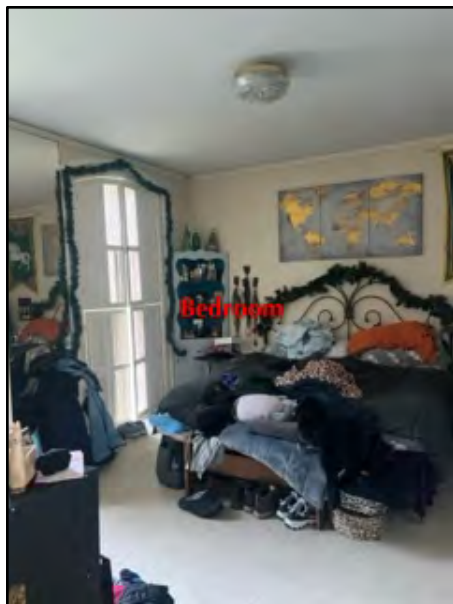
Comment 41:
Unit 2.

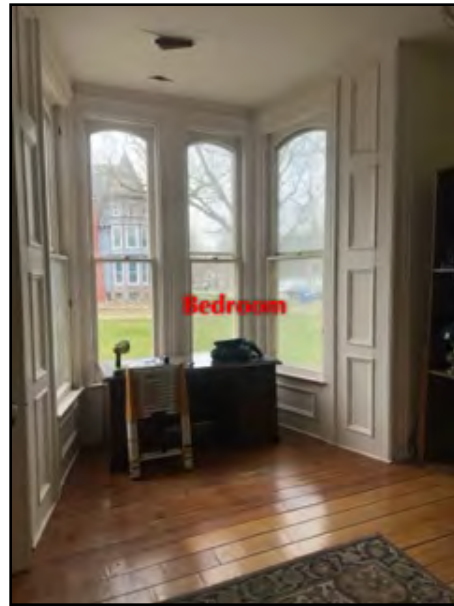
Comment 44:
Unit 1.

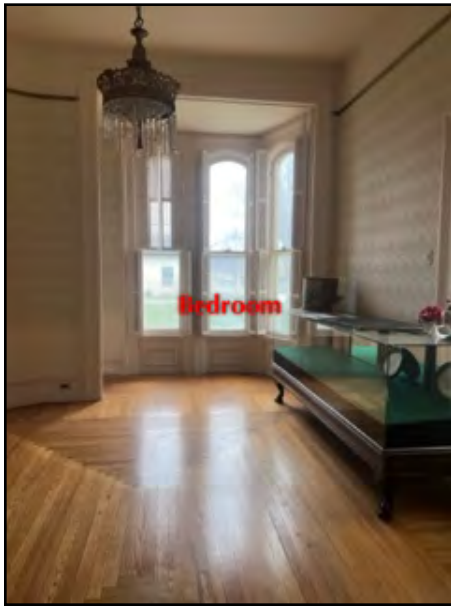
Figure 45-1

Picture of the bedroom in unit number one off the kitchen.

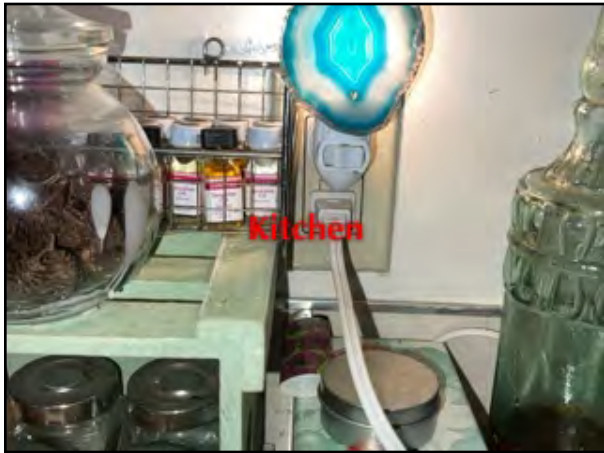
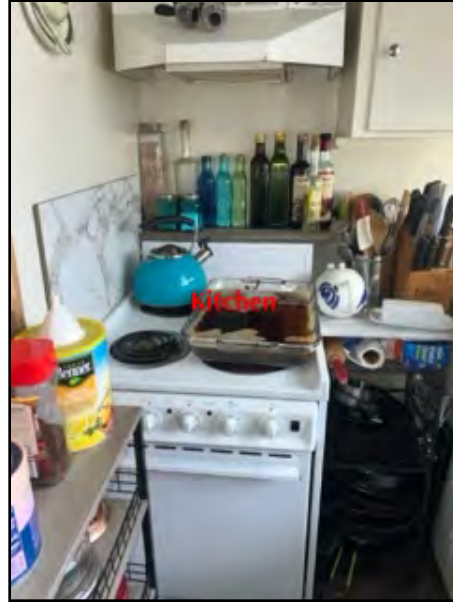
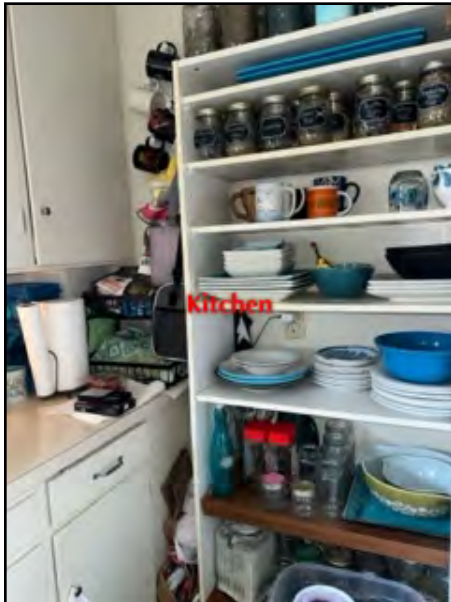
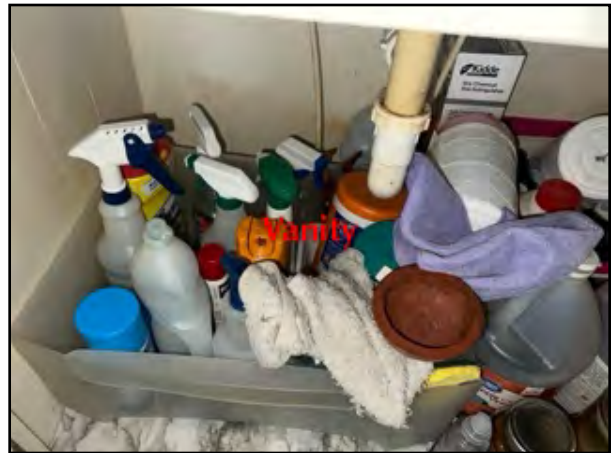
Comment 46:
The GFCI outlet shows an open ground and does not trip when tested with a diagnostic tester.

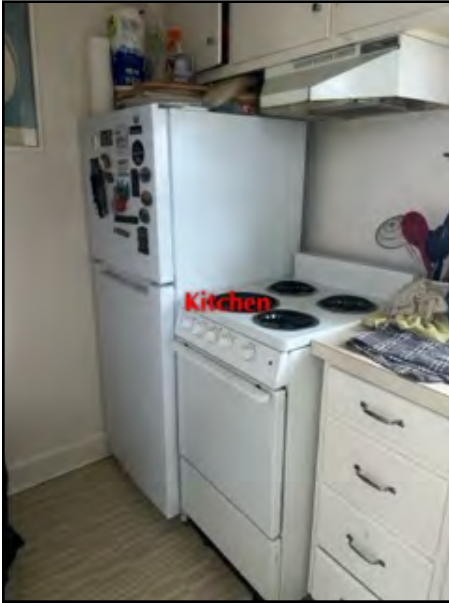
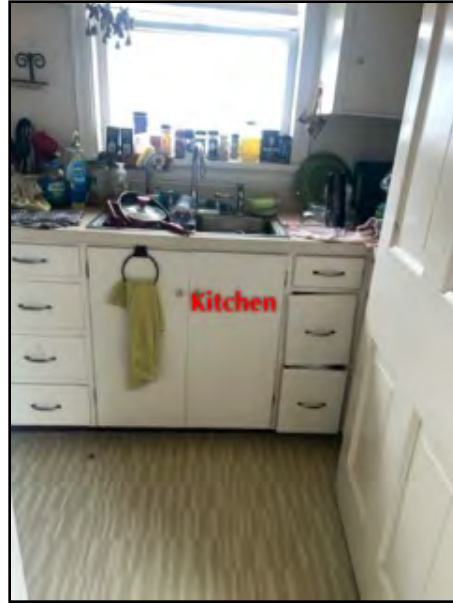
Comment 47:
Unit 2.

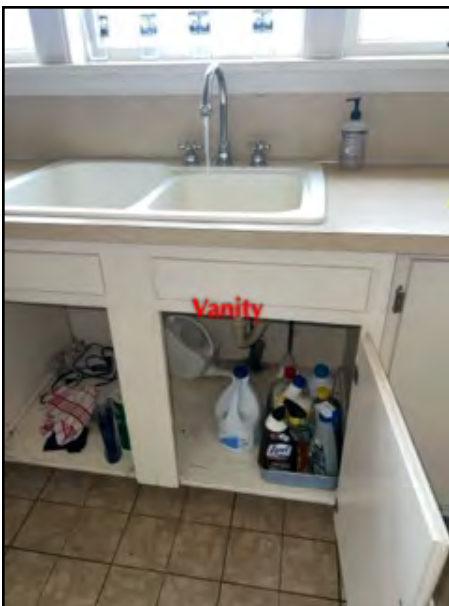
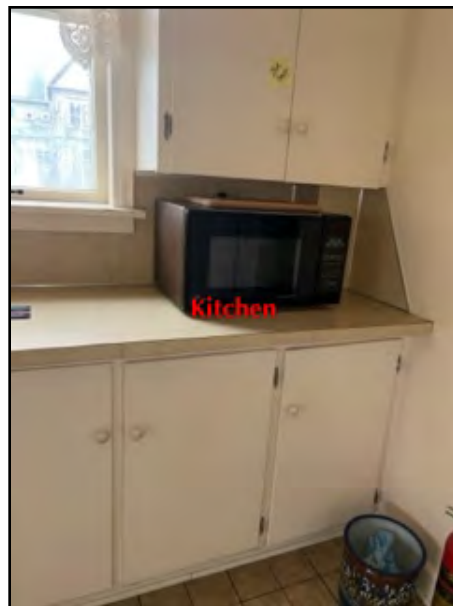
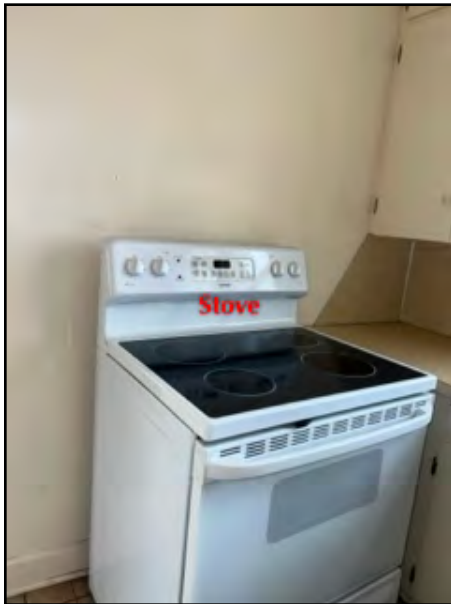
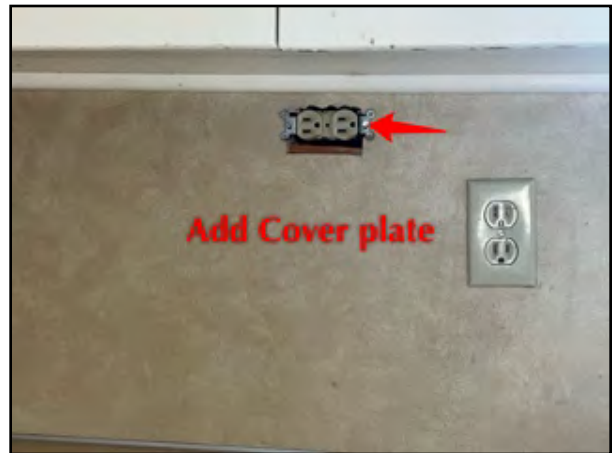
Comment 48:
Unit 1.

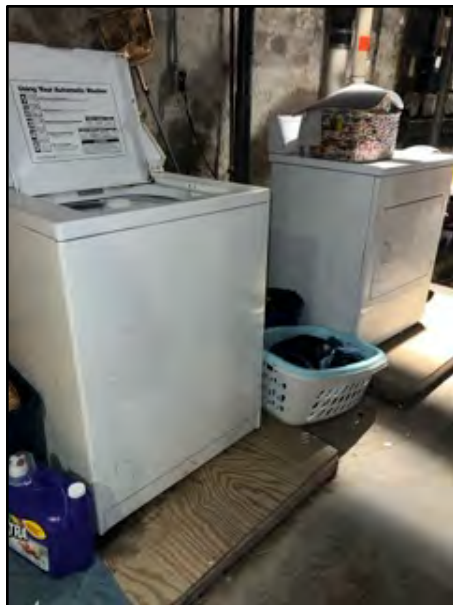
Figure 50-1

Comment 50:
Picture of the laundry area in the basement.

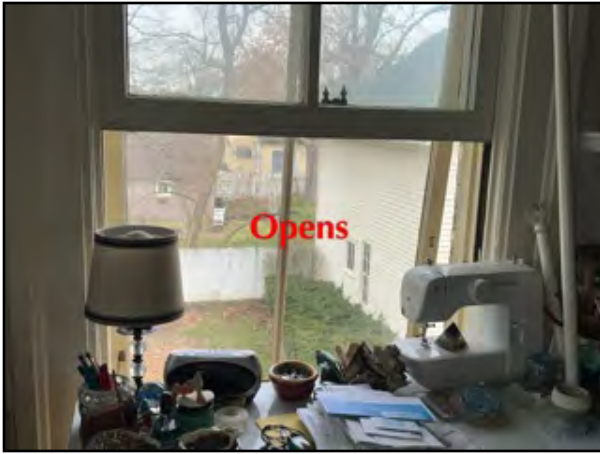
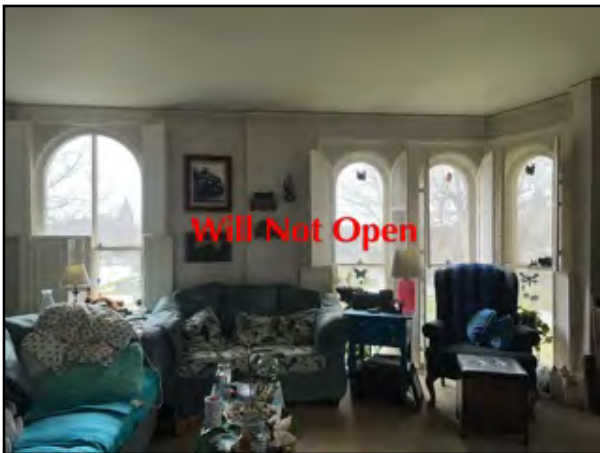
Most of the wood windows do not open in unit 3.

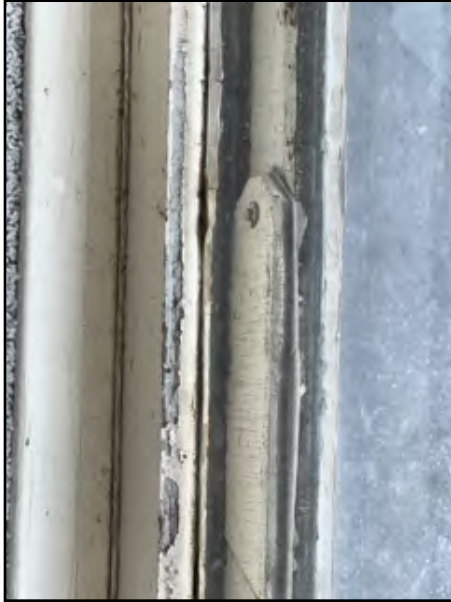
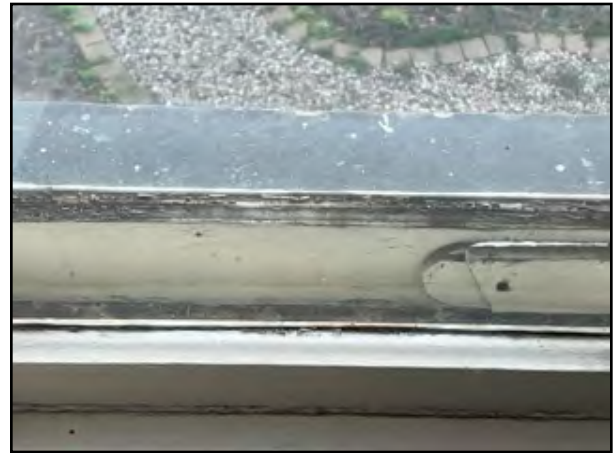
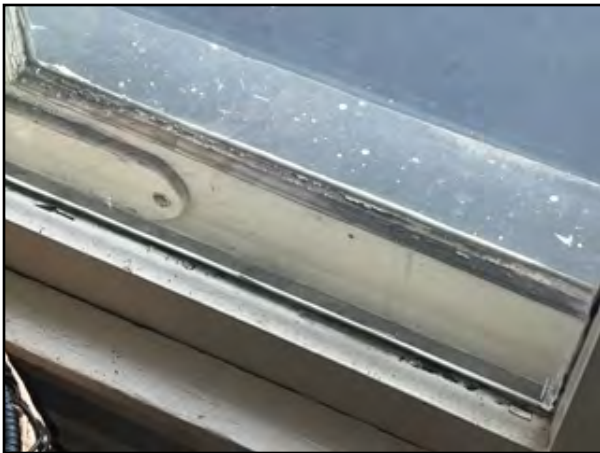
Most of the windows in unit number two will not open and peeling paint is present.

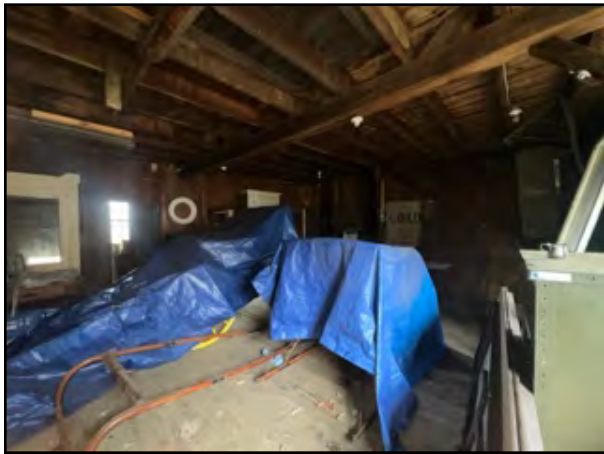
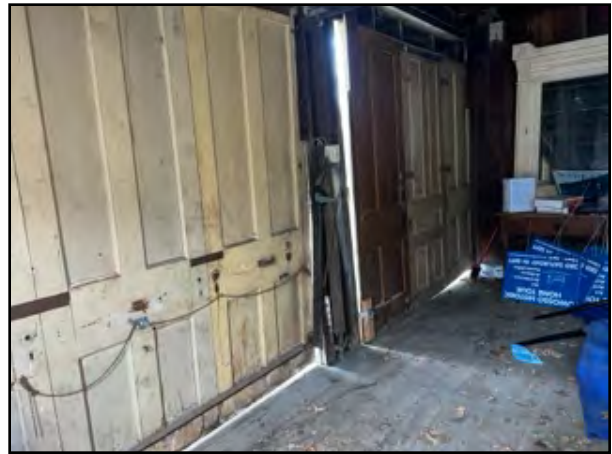
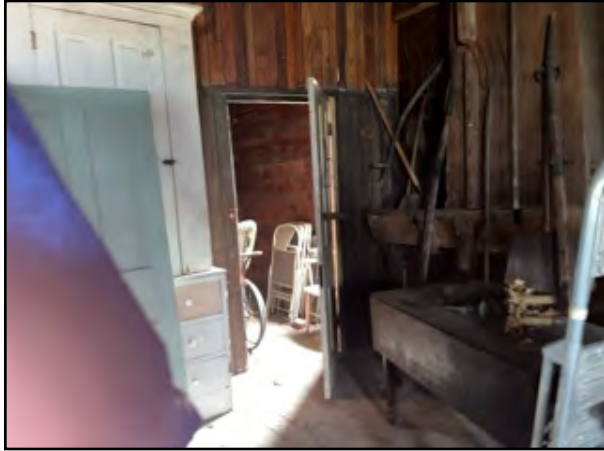
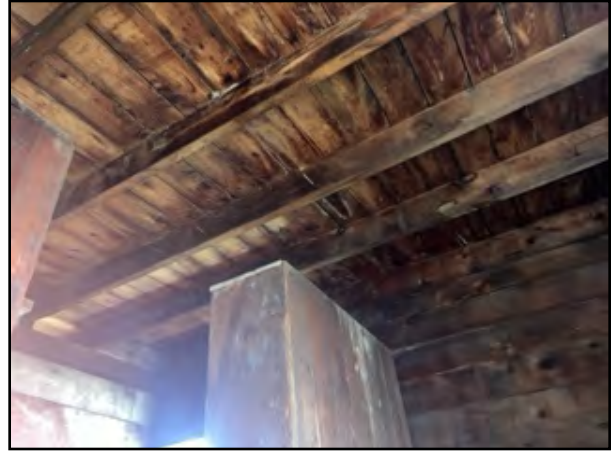
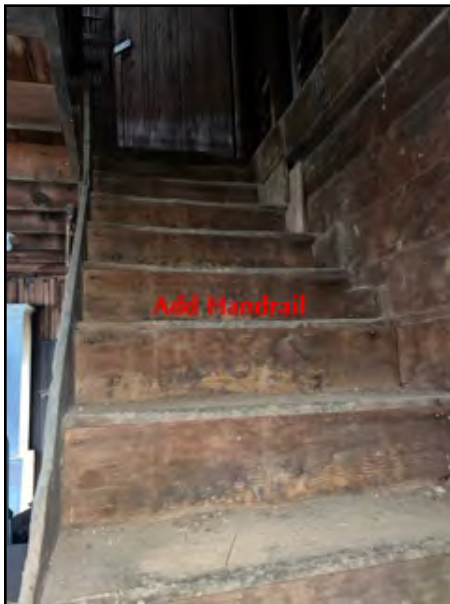
Comment 59:
Interior.

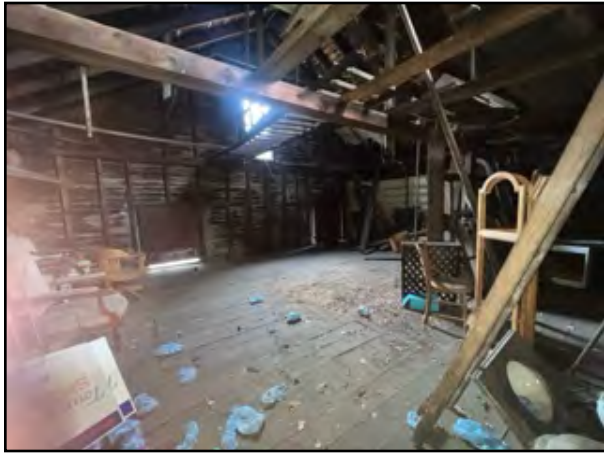
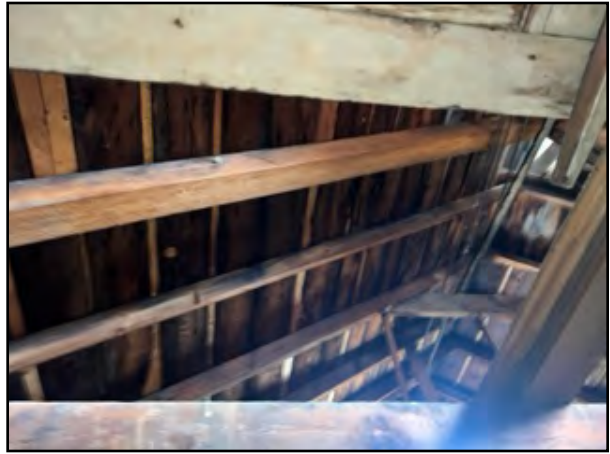
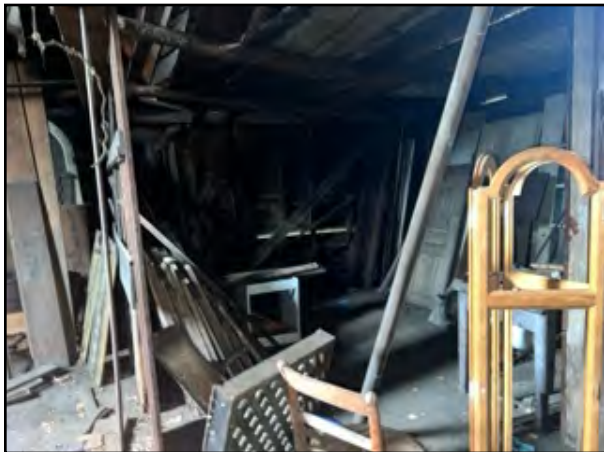
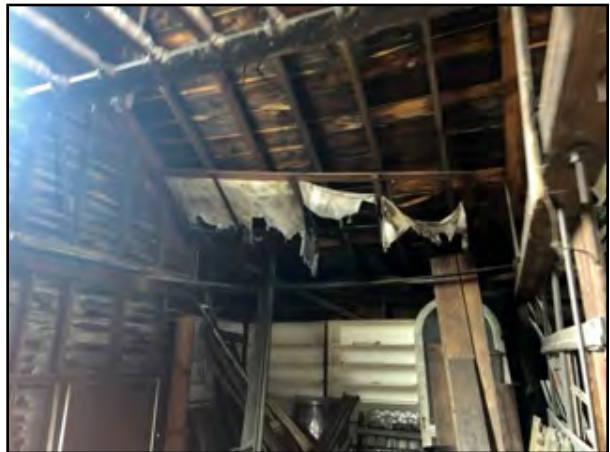
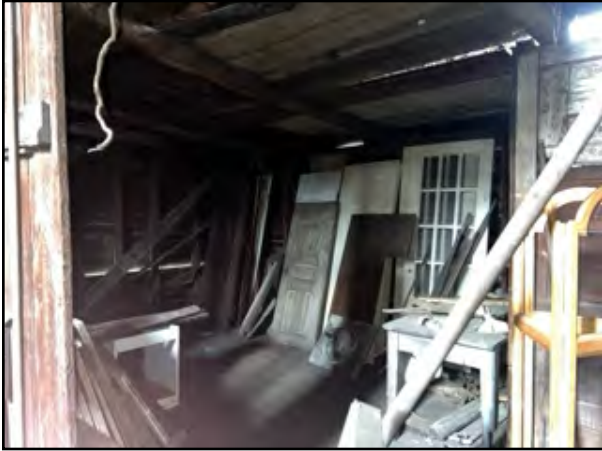
Comment 60:
Second floor.

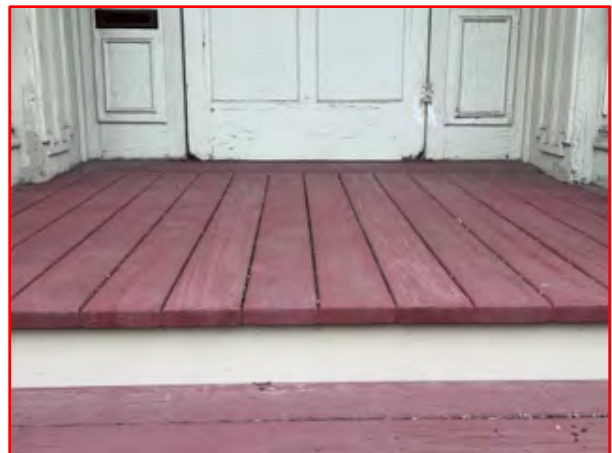
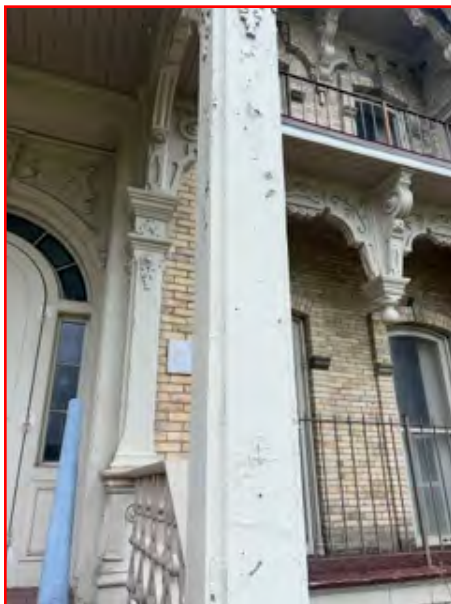
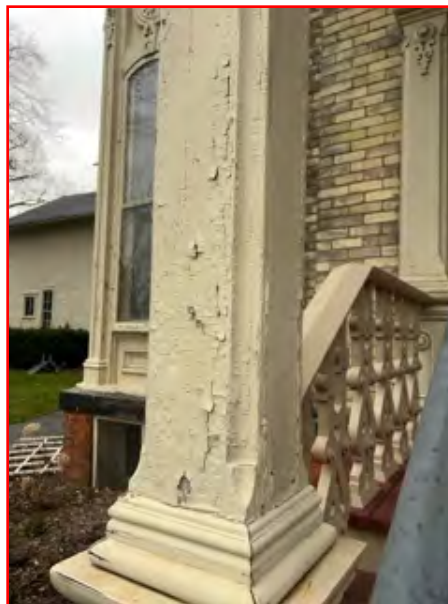
1) Side entry.

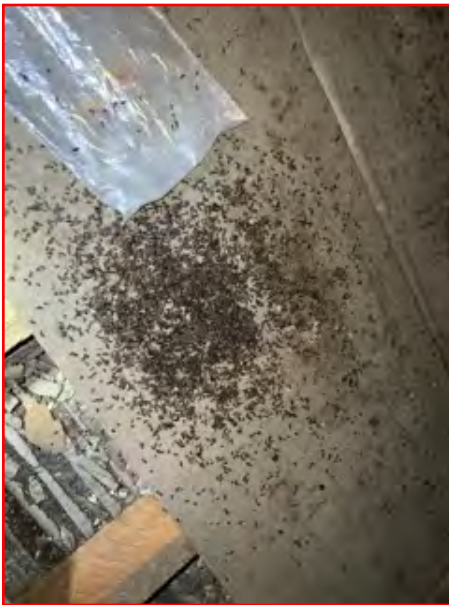
Figure 9-1

7) Batt guano .

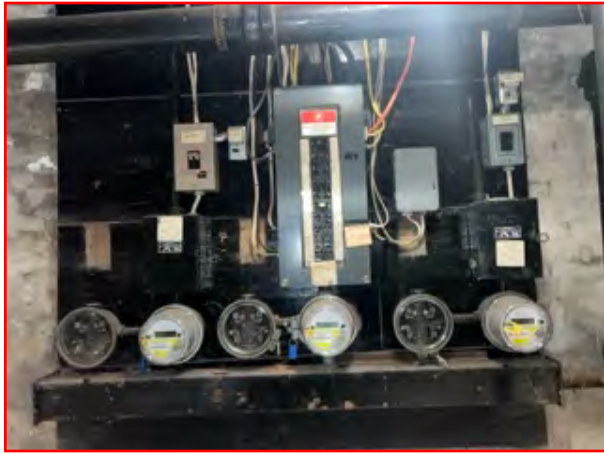
Figure 14-1

12) Picture of the electrical in the basement.

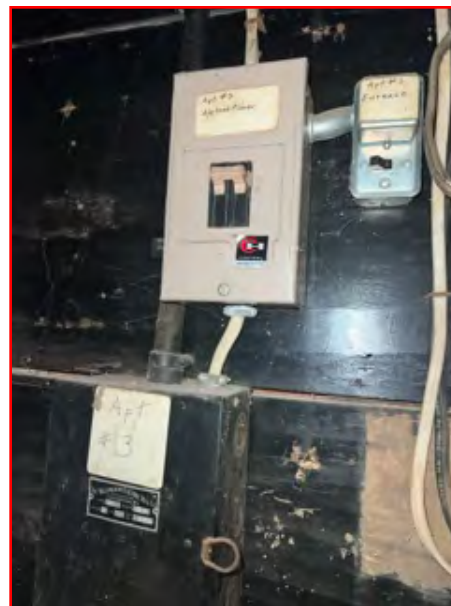
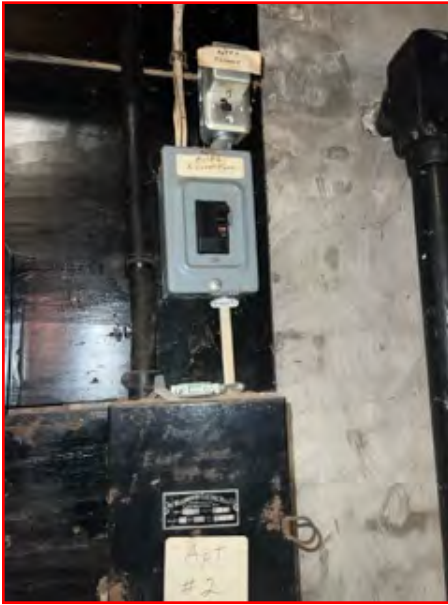
14) Pictures of the sub panels in the basement. Sub panels are used for the air conditioner and units number two and three. Unit number one has the air conditioner powered from the main panel.

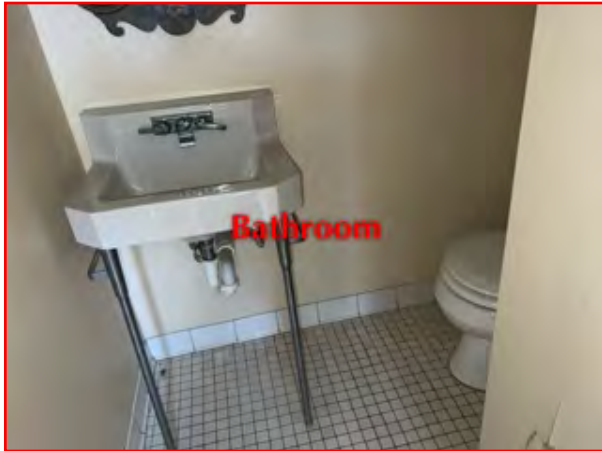
Figure 28-1

18) Picture of the bathroom to the first floor area.

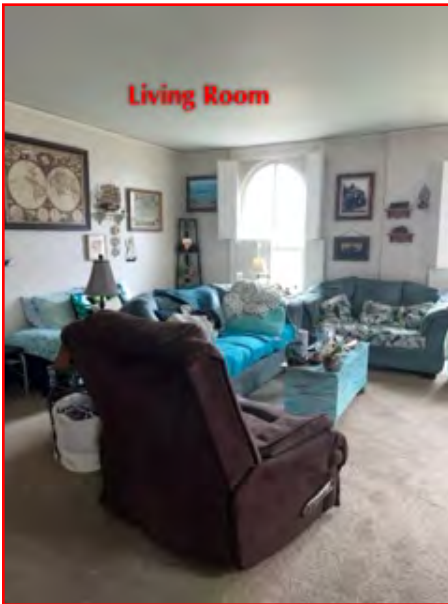
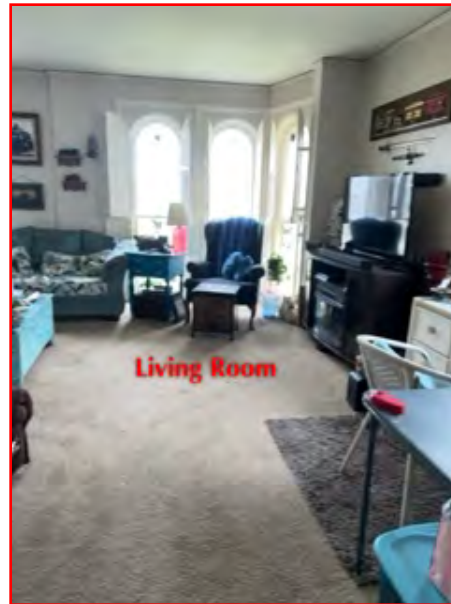
21) Pictures of the living room unit #3 .

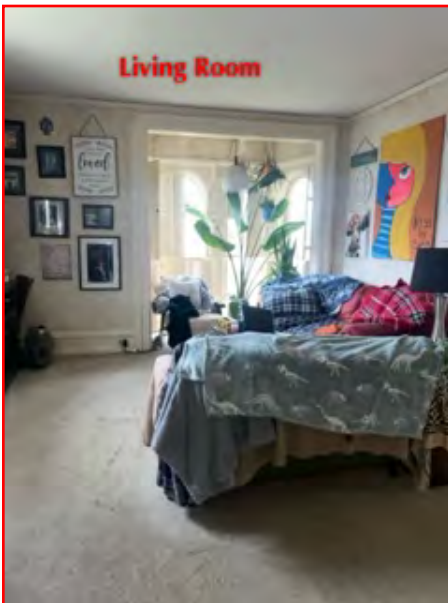
22) Pictures of the living room to Unit 2.

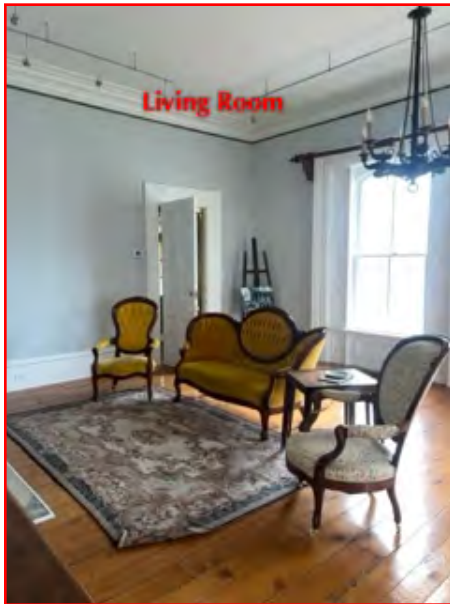
23) Pictures of the living room To Unit 1.

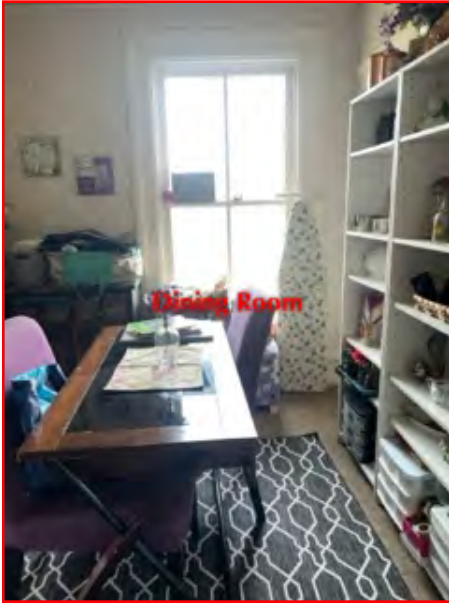
Figure 35-1

25) Picture of the dining room in Unit 3.

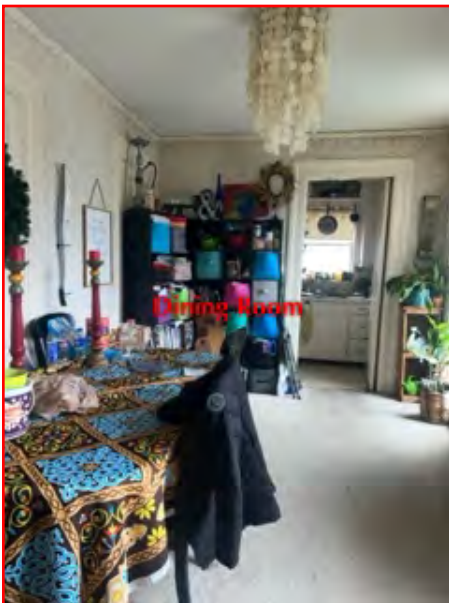
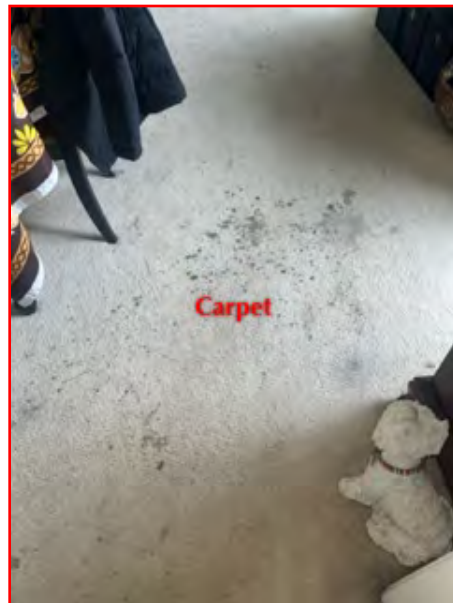
26) Picture of the dining room Unit 2.
