SUBJECT: 21 Day Posting – \$237,000 offer to purchase the Gould House

A. GOULD HISTORIC HOME REPORT

INSPECTION AND ESTIMATE COMPILATION

A. GOULD HOMESTEAD
 FOR SEAN & JANEL HARRINGTON
 515 NORTH WASHINGTON ST
 OWOSSO, MICHIGAN 48867
 APRIL 6, 2024 SHEET 2

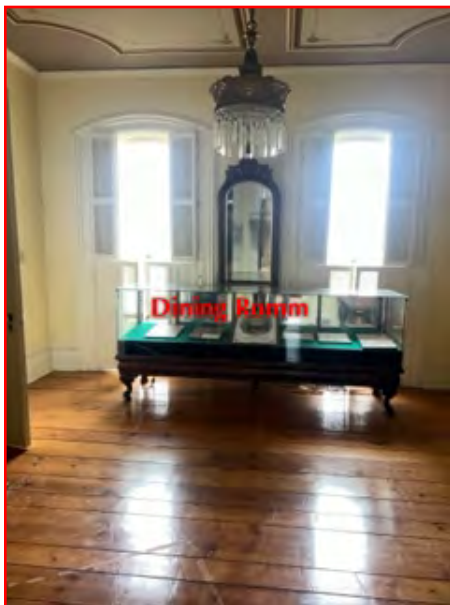
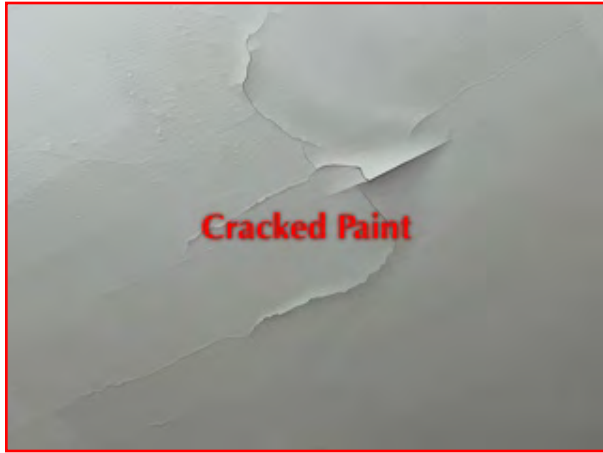
27) Picture of the dining room Unit 1.

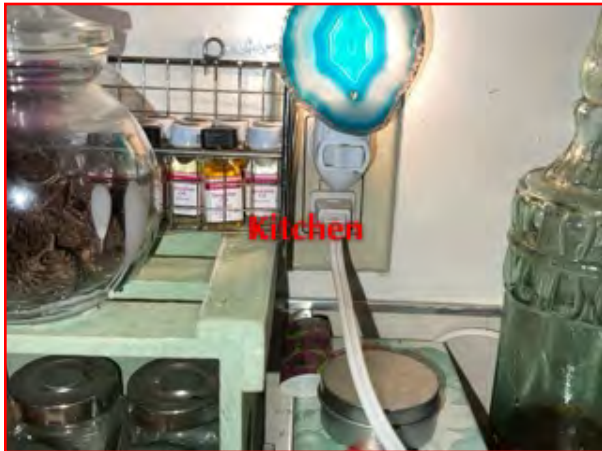
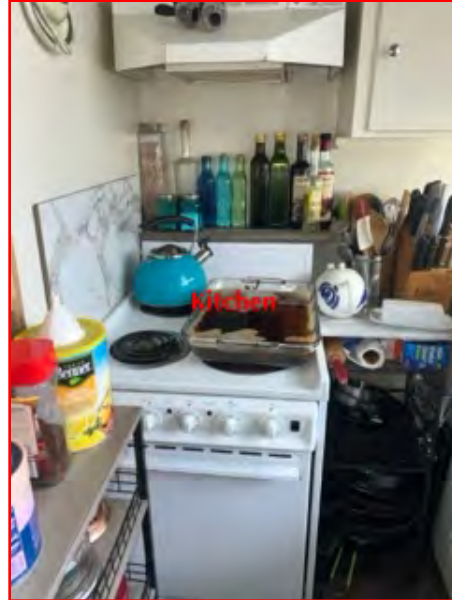
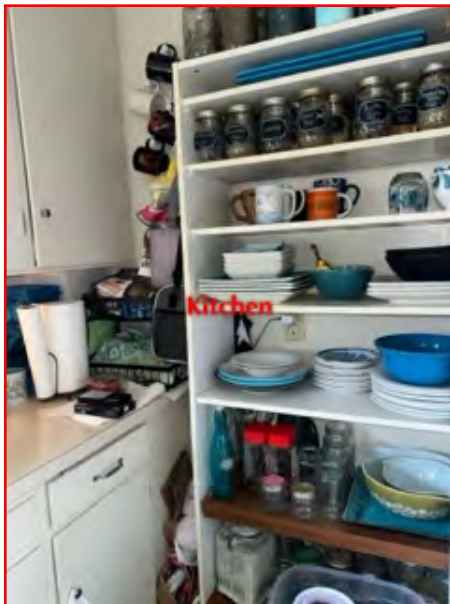
34) The GFCI outlet shows an open ground and does not trip when tested with a diagnostic tester.

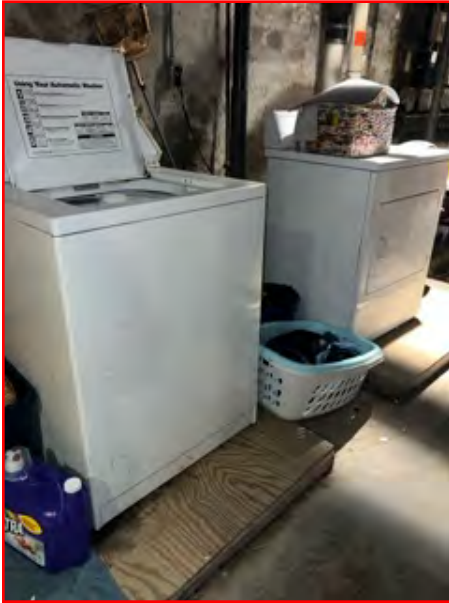
Figure 50-1

37) Picture of the laundry area in the basement.

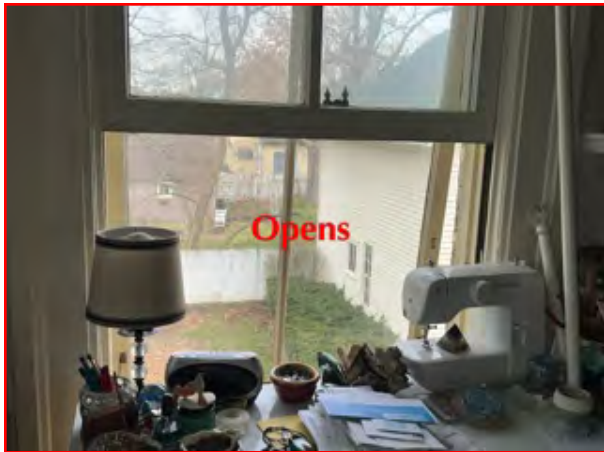
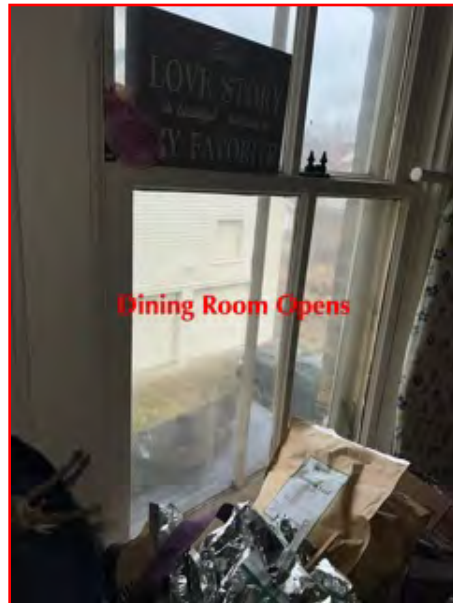
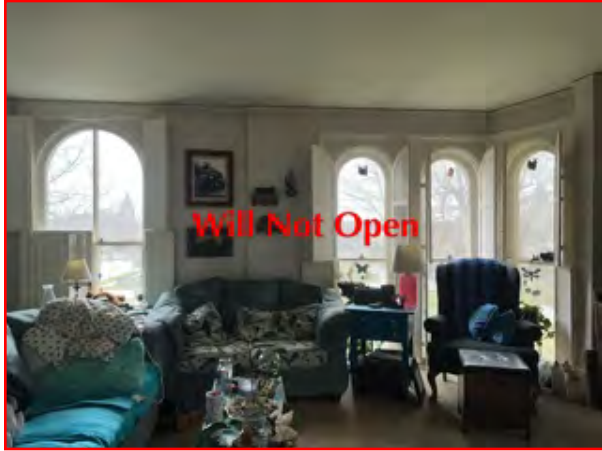
40) Most of the wood windows do not open in unit 3.

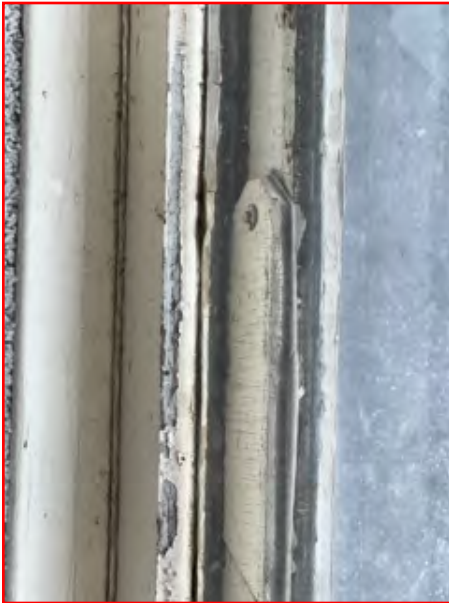
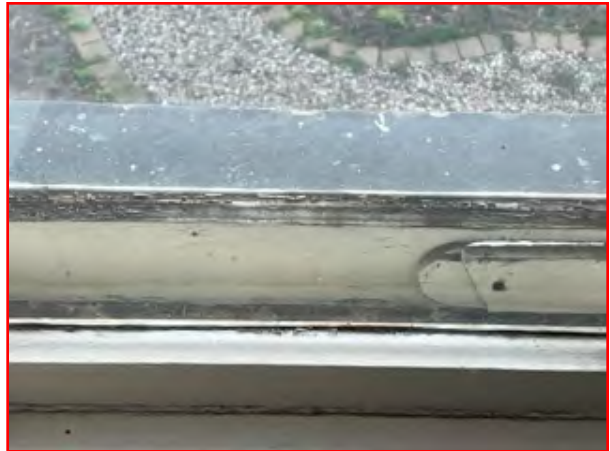
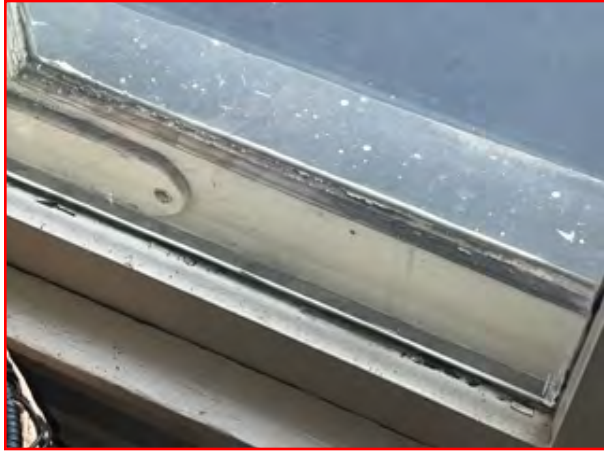
41) Most of the windows in unit number two will not open and peeling paint is present.
